MICROSTRUCTURAL AND TOMOGRAPHIC ANALYSES IN GEOTECHNICAL ASSESSMENT OF SOIL MEDIA

MACIEJ KORDIAN KUMOR

University of Technology and Life Sciences, Geotechnical Department, Bydgoszcz, Poland,
e-mail: maciej.kumor@engeo.com.pl

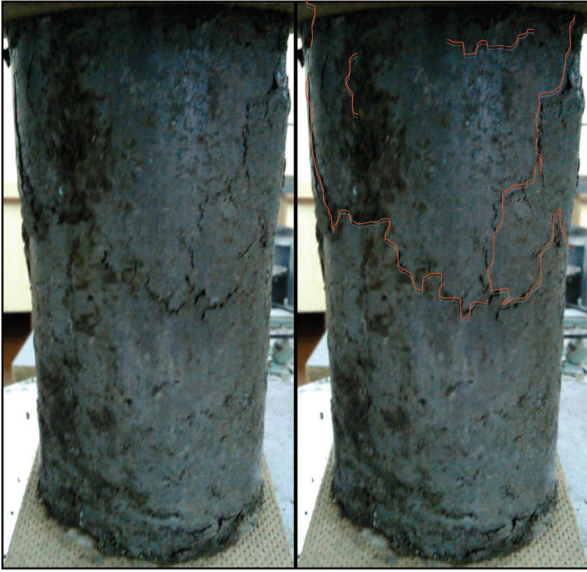
Fig. 9. Destroyed samples of composite K1 immediately after strength testing

sive strength. Formed deformation fractures are marked in red. Based on the macroimages we may identify the range of fractures, as well as the type of deformation formed as a result of damage. We may see the characteristic surface of brittle shear damage – slant surfaces at an angle of 45° .
