ASSESSMENT OF TECHNICAL CONDITION OF FORKLIFT TYRES USED IN INTERNAL TRANSPORT BY STUDYING DAMAGES AND OPERATING CONDITIONS

DOI: 10.15611/nit.2019.2.03

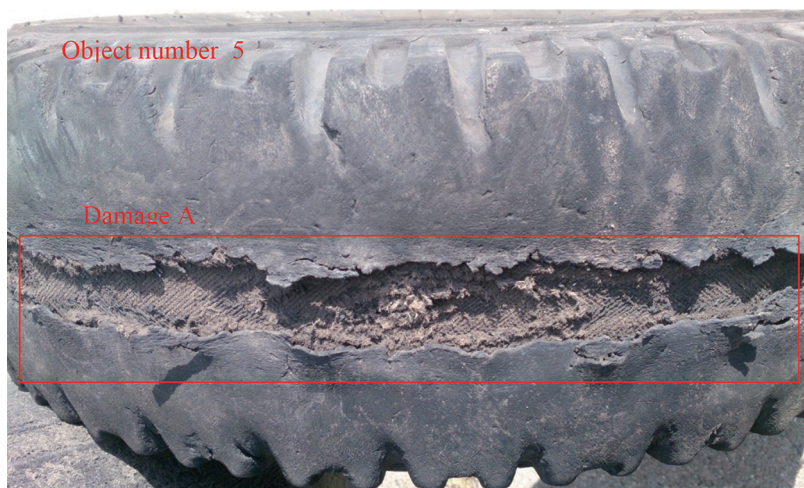
Fig. 9. Damage in object 5

At the test of object 5, very serious circumferential damage to the tire face can be seen, referred to as damage A.

The tested tires also had mechanical damage, which all occurred in the group of tires with a lower tread height than the allowable value. Object 5 had peripheral damage on the front, which was probably caused by the friction of the tire against a stationary forklift. On object 7 object one can see a significant burst on the sidewall of the tire. Such damage was probably caused by contact with a sharp solid element in the transport area. Object 16 has deep puncture damage located on its front which could have been created by a forklift driving onto a sharp element lying freely on its

- Damage A and D in object No. 5 and 18, eliminates them from further use. In addition, such damage should urge the technical inspection of forklifts. All solid parts of the vehicle that are probably in contact with the tire should be eliminated.

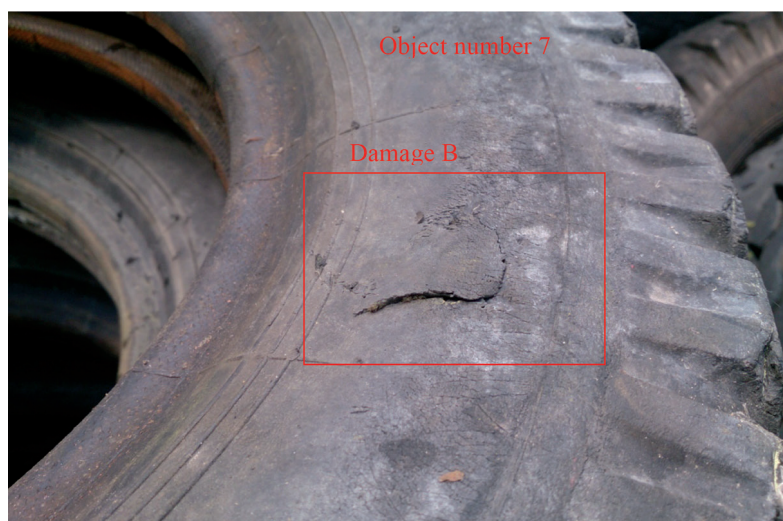
Fig. 10. Damage in object 7

At the test of object 7, serious damage can be seen on the sidewall of the tire, later referred to as damage B.

- Damage B, C and E on objects 7, 16 and 25 were caused by sharp elements in the transport area. Their further use is unacceptable, therefore they should be replaced as soon as possible. Persons driving forklifts in the transport area should pay particular attention to sharp elements located on the route of the forklift.

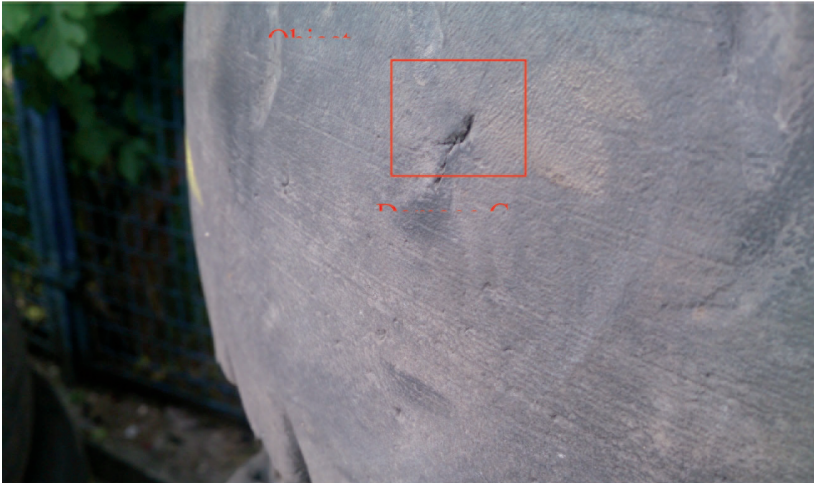
Fig. 11. Damage in object 16

At the test of object 16, a serious tire front puncture can be seen, later referred to as damage C.

path. Total tire tread wear could also contribute to such damage. On object 18 one can see similar damage as with object 5, which probably arose as a result of contact between the tire and the fixed part of the forklift. Object 25 has deep puncture damage on the side that may have arisen as a result of the tire being in contact with a sharp solid element in the transport area.

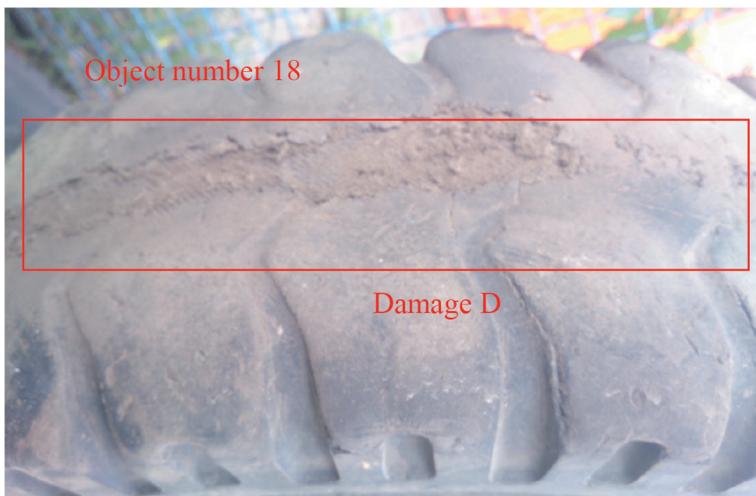
Fig. 12. Damage in object 18

Very serious peripheral damage to the front of the tire can be seen at the test of no. 18, later referred to as damage D.

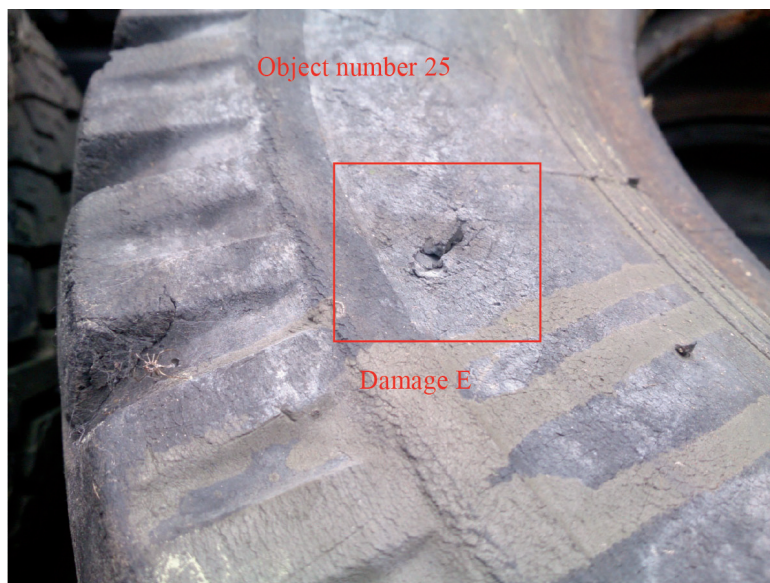
Fig. 13. Damage in object 25

At the test of object 16, a serious puncture can be seen in the side of the tire, later referred to as damage E.

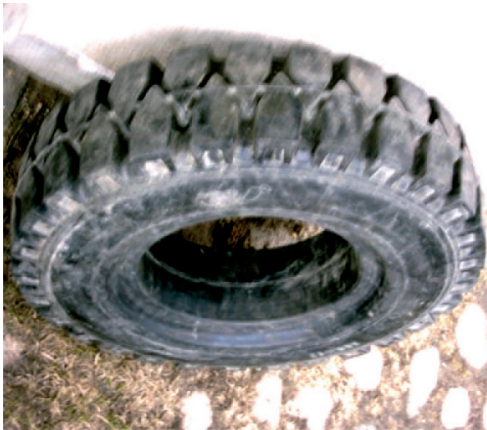
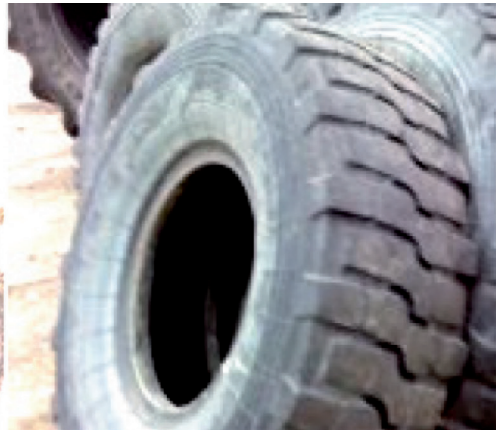
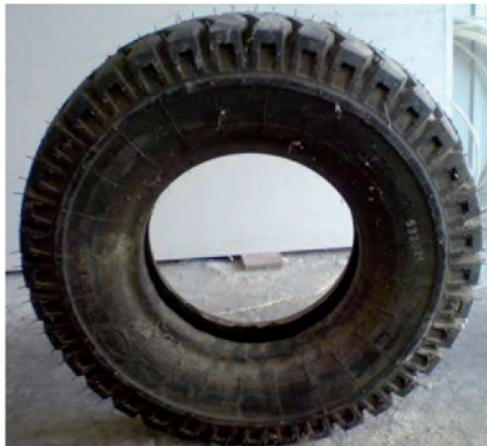
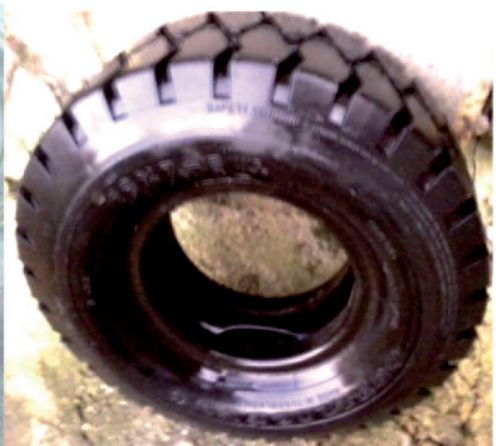
As one can see, there are several tires with severe damage in the test group. Additionally, there are also tires in a very good technical condition as seen below.
