THE IMPACT OF THE LOW THROW FAULT ON THE STABILITY OF ROADWAYS IN A HARD COAL MINE

Key words: fault, roadway stability, roadway convergence, floor heaving

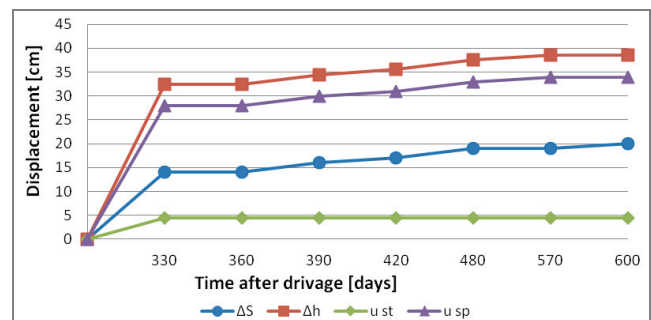
Convergence measurements in the measurement base located at 930 m of the D-2 maingate, located outside geological disturbance zones, have been carried out for 270 days. During this period, low values of roadway convergence have been noted. They were, respectively: roadway width change (ΔS_w) – 20 cm, roadway height change in the opening (Δh_w) – 38.5 cm, average floor heaving (u_{sp}) – 25.8 cm, and the cross section change (ΔP_w) – 2.87 m². The dynamics of those changes is shown in Fig. 3, and the values obtained are presented in Table 2. After ca. 600 days from roadway drivage, its height was 384 cm, which constituted ca. 91% of the nominal height of the opening. The width of the roadway, in July 2016, constituted 96.7% of the nominal width S , which was 610 cm.

Fig. 3. Maingate D-2 convergence – base on 930 m (ΔS – roadway width change, Δh – roadway height change, u_{st} – roof displacement, u_{sp} – floor heaving)

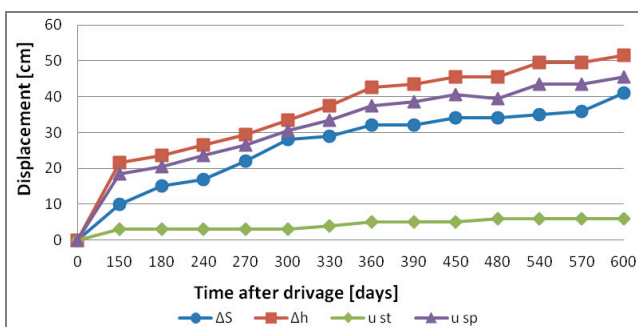
The measurement base in the fault area was installed at 790 m of the D-2 maingate. The roadway support, in this area, was additionally reinforced with a V29 steel beams. Research conducted in this base lasted 16 months; 13 measurements were taken. Results are shown in Table 3. During 450 days of observations, the width of the roadway was reduced by 41 cm, which constitutes around 7% of the original width. The roadway height, in the cross-sectional area of working, as a result of the influence of a single fault, was reduced by 12% (52 cm). Reduction of both the width and the height of the roadway in the impact zone of the fault caused the roadway cross section to decrease. As a result of steel yielding support convergence, the cross section of the roadway, after 600 days from drivage in the above-mentioned area, was at 17.5 m² (ca. 81% of the original value), which caused the ventilation conditions and the roadway functionality to deteriorate. Floor heaving, compared to the 930 m base located on the section free of geological disturbance, technically rose 1.5 times (Table 3) on its entire width. The average value of

floor heaving is 34 cm. The rate of those changes is presented in Fig. 4.

Fig. 4. Maingate D-2 convergence – base on 790 m (ΔS – roadway width change, Δh – roadway height change, u_{st} – roof displacement, u_{sp} – floor heaving)

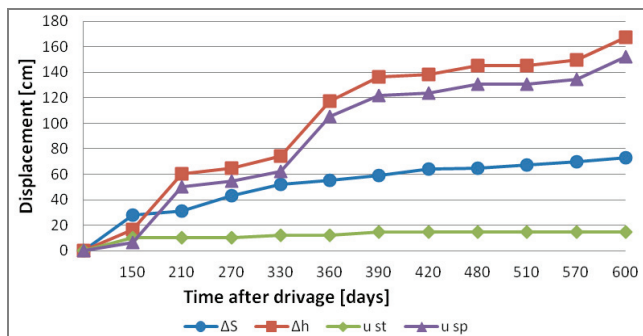
Studies conducted in the fault zone lasted 16 months; 11 measurements were taken. During 450 days of observations, the biggest dimension change has been obtained (Table 4). The drivage of the D-2 maingate in the fault zone has caused its 71 cm horizontal convergence, which is around 12% of the nominal width of the roadway. The weakening of rocks and extensive stress in the fault zone have considerably influenced the vertical convergence of the roadway. Roadway height, since its drivage, has decreased by ca. 170 cm, which resulted in additional works that would ensure stability of the roadway – floor brushing has been carried out three times; its values were

taken into account in the results obtained. Thus, total average floor heaving for the roadway located in the fault zone would be 150 cm. If rocks had not been brushed from the floor, the roadway cross section would have been at as little as 45% of its original value, which means almost complete loss of the roadway functionality.

Fig. 5. Maingate D-2 convergence – base on 757 m (ΔS – roadway width change, Δh – roadway height change, u_{st} – roof displacement, u_{sp} – floor heaving)

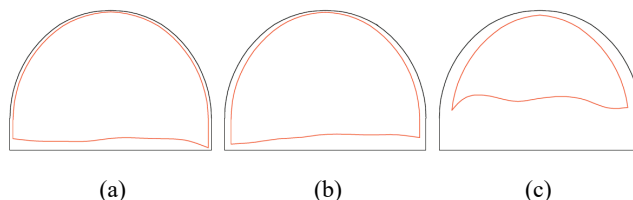
On the basis of mining research conducted during a long period (450 days), it may be observed that vertical convergence has the strongest influence on relocation in the vicinity of the roadway. Floor heaving constitutes around 90% of vertical convergence, both for bases located in fault zones and for the base located outside that zone, which was also proved in other studies [11]–[13]. The value of roadway roof lowering, in each case, is from a few to around a dozen centimeters. For the base installed under the impact zone of a single fault or a fault zone, the vertical convergence does not exceed 40 cm. For the base located at the 0.7 fault, the value of vertical convergence is ca. 52 cm – 30% higher than at the base outside the impact zone of the fault. Vertical convergence occurs evenly, almost linearly. Meanwhile, the roadway located in the fault zone is characterized by an increase in vertical convergence that is close to linear, but with a lower correlation coefficient. The value is ca. 167.5 cm and is more than 4 times higher than in the case of roadway section free of the impact of the fault. A comparison of cross section sizes of roadways in different sections is shown in Fig. 6.

Fig. 6. Maingate D-2 convergence: (a) base on 930 m, (b) base on 790 m, (c) base on 757 m

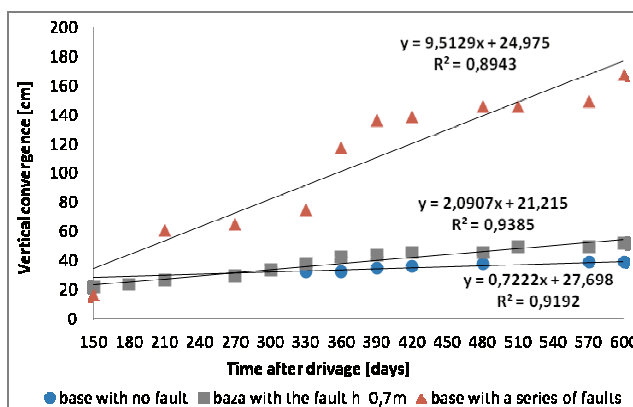
A comparison of the results of vertical convergence measurements is presented in the chart in Fig. 7. Although the roadway in the area of measurement bases located at 930 m and 790 m sections may be

considered stable, the D-2 maingate located in the fault zone at 757 m loses its stability. It is also worth mentioning that, after each floor brushing, a periodic relaxation occurs, and the increase rate of deformations slows down for 150–200 days (Fig. 7).

Fig. 7. Vertical convergence for the measurement bases
