**Hubert Melges\*, Małgorzata Melges\*\***

***The principle of building processes staging during the renovation of church towers and the exchange of a roof framing in neo-Gothic St. Martin Church in Krzeszowice***

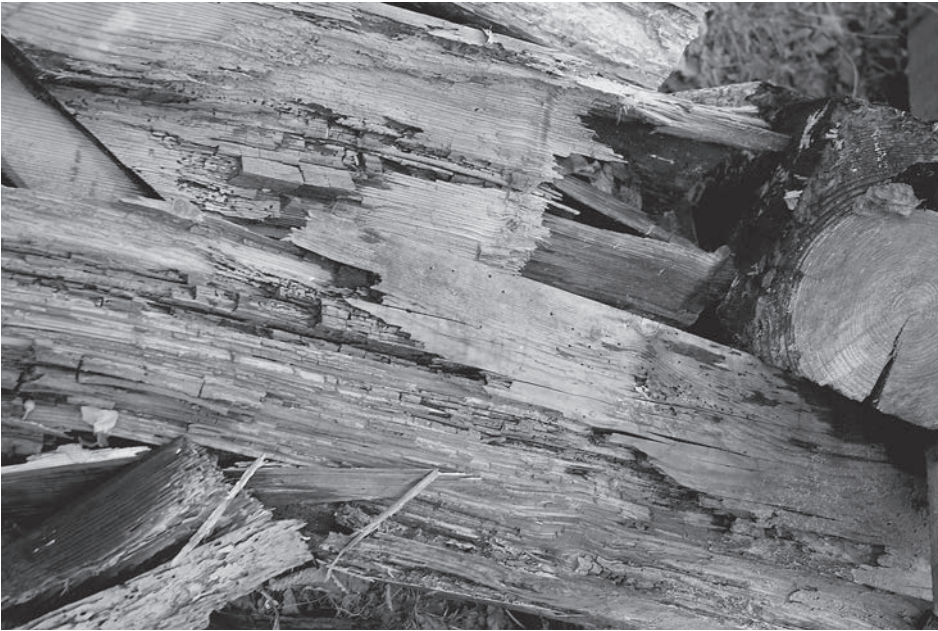
Fig. 1. Fragment of the destroyed roof framing construction

zation processes of the roof framing and cover. On the basis of this inventory, thorough entomological, phytopathological and mycological examinations of fungal condition and the extent of destruction of the wooden elements of the church roof framing were conducted. When the level of destruction of the roof framing constructional elements was specified, a constructional expertise of the roof framing technical condition was provided. Entomological and phytopathological examinations confirmed high biological wood corrosion where constructional elements were depreciated in large parts by the fungus *Coniophora cerebella* which caused brown decay as well as destructive presence of vermin called old-house borer (*Hylotrupes bajulus* L) and house grinder. Additionally, growing moulds from Micromycetes class caused complex processes of biologically depreciated elements of the roof framing [1].

On the basis of the total number of expertises and the level of damage of particular constructional elements it was ascertained that circa 60% of the construction wood was worn out and consequently the final decision was taken as to a complete replacement of the roof framing. During a demolition of the roof framing and a detailed analysis of technical condition wear and tear, it turned out that the particular constructional elements are damaged in 70%. Finally, on the basis of the inspection carried out by Provincial Monument Protection Organisation in Cracow the Restoration Opinion was issued which gave permission to conduct the renovation works. Thanks to these preparatory procedures, the parish was able to apply for a renovation works subsidy in the Ministry of Culture and National Heritage from the program of Cultural Heritage as a priority of Monuments Protection. The whole

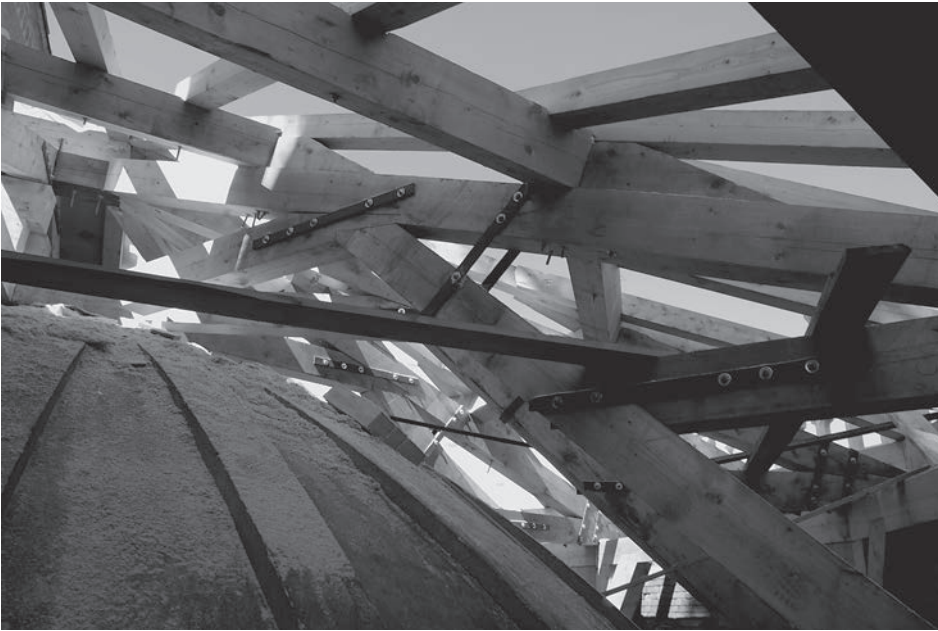
Fig. 4. One of the fixing stages of the roof truss above the presbytery

A necessary restoration requirement was a total and exact reconstruction of the roof truss (of all elements and details along with carpenter's joints). It should also be mentioned that the size of wood in the roof truss was, for example, 25×31 cm. The size and weight of these elements caused many difficulties in the execution of the works. On the designated place outside the church, a special wooden platform was made in order to conduct on it a precise process of fixing the roof trusses. All parts of the roof trusses were made on the basis of the previously detailed inventory. The smallest mistake or inaccuracy could rule out a possibility to conduct the process of fixing and connecting the roof trusses with other elements of the roof framing construction. The reconstructed elements of the roof framing were numbered and described and then the roof construction trusses were put together according to the principle regarding the roof truss typing, which was established some time earlier. The sizes of the roof trusses were very big; therefore, they had to be taken apart in order to be transported to the church. Finally, the process of the whole construction fixing took place at the yard near the church. The particular roof trusses were fixed by means of the crane according to an established order.

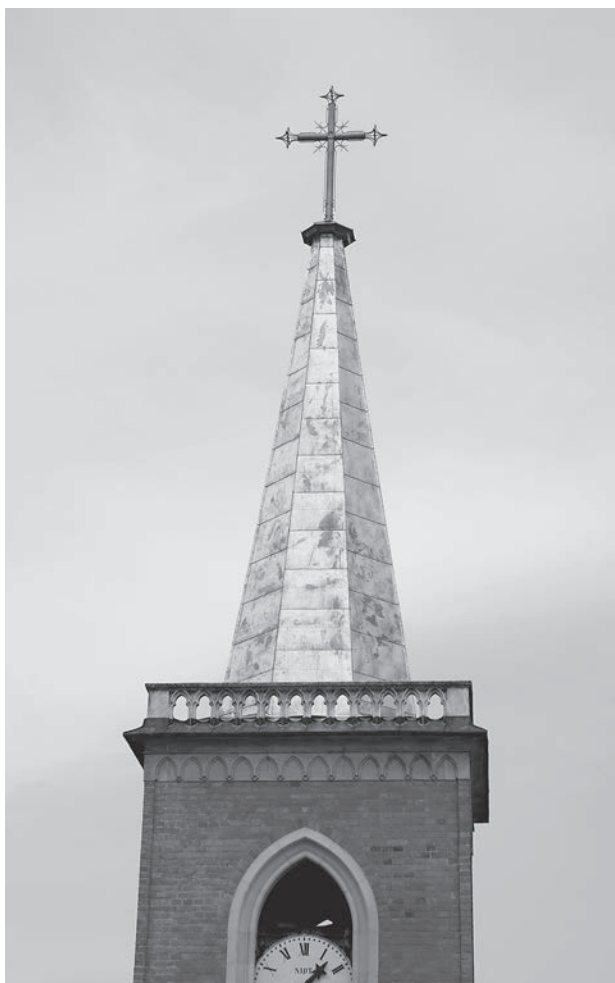
Fig. 5. Final stage of the tower copula renovation surmounted by the cross

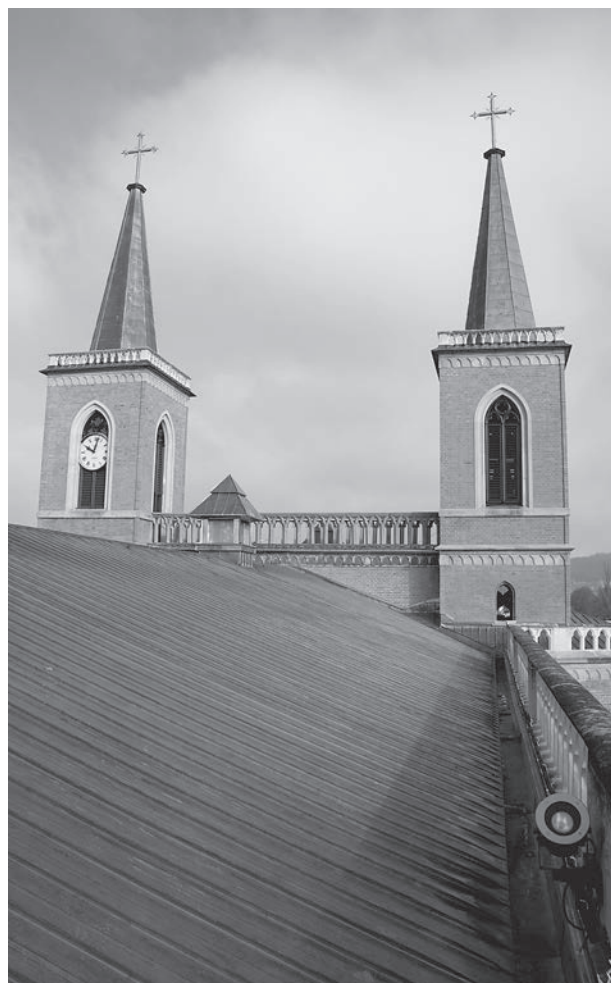
Fig. 6. Final view of the roof slope after renovation

be drained down to the newly constructed drainage basin which was in turn connected with down pipes. All of the roof framing and planking elements were subjected to whittling in order to remove characteristic 'moss' from the wood, which appeared after the wood was cut with saw blades. The reconstructed roof framing was covered with a special foil and then planking was made on which sheet copper was to be fixed. The open drain channels, which drained water from the roof by means of appropriate tilts in the direction of baskets into the down pipes, were profiled and properly located. The renovation works of the tower hexagonal copulas consisted in removing the steel, planking under sheet and the corner construction rafters specially moulded. Towers and copulas on the hexagonal projections (in form of pyramid) were made of brick. In the corners the reconstructed elements of corner rafters were fixed, which served the purpose of the support frame for planking under the sheet copper. There were also new crosses made of steel, which surmounted the church towers. The designed crosses refer to the neo-Gothic stylistics. The previous crosses with no style (secondary) were made of steel pipes. One of the reasons why they were replaced was the method of their fixing on the towers, which caused leakiness between the towers construction and the place of fixing the crosses. New crosses were fixed on the towers in such a way as to make it impossible to let the water leak into the inner parts of towers. The roof cover was made of sheet copper on full planking on the so called narrow strips on a double standing seam made of strips at the width of 25 cm. Prepared strips of sheet were additionally subject to a special method of moulding in order to improve their rigidity. Fixing the sheet to the planking was made on the so called special 'connectors' moved from the stainless sheet. All the roof sheet works on the contact between sheet and wall as well as open drain channels were made with great diligence and introduced a method of leak tightness on the contact between sheet and wall. Three additional elements of styl-
