**Ulrich Schaaf\*, Maciej Prarat\*\*, Tomasz Ważny\*\*\***

*The mediaeval roof structure over the nave  
of the cathedral in Kamień Pomorski  
in the light of architectural and dendrochronological research*

The subject of this article is the roof structure over the nave of the cathedral of St. John the Baptist in Kamień Pomorski.

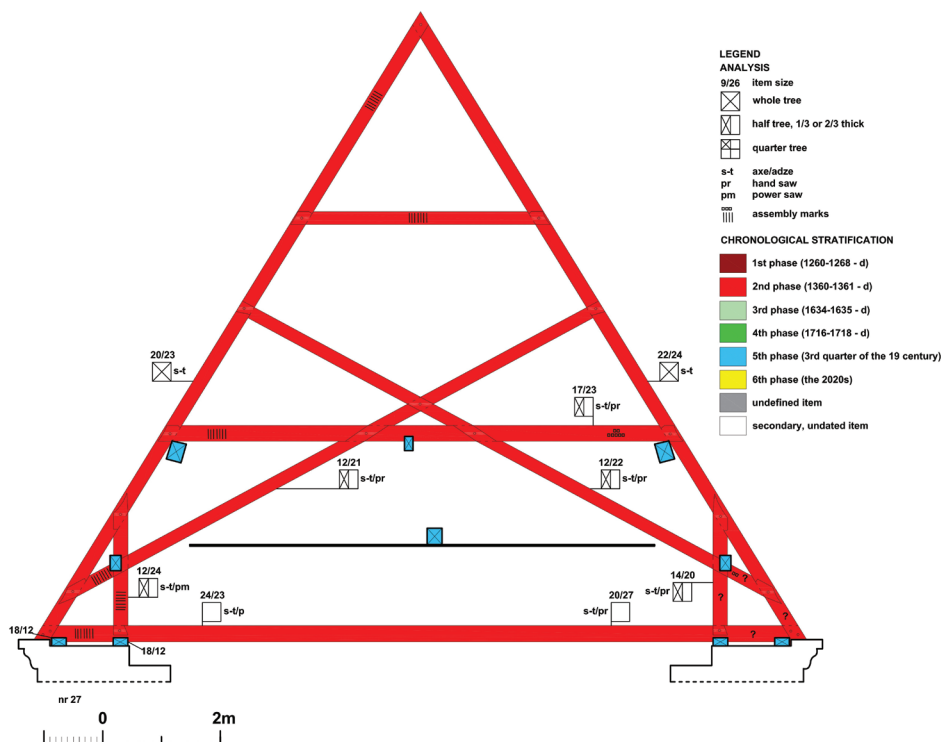
Fig. 1. Kamień Pomorski, cathedral, roof structure above the aisle, principal rafter truss, No. 27, analysis and stratification (elaborated by U. Schaaf, M. Prarat)

In the principal rafter trusses (19, 20, 27 – Fig. 1), the tie beams rest at both ends, each time on two wall plates lying on mural crown of the outer walls of the nave. These tie beams are connected with rafters with a length of about 12.50 m, which are supported by two rows of collar beams. The almost vertical down braces connect the tie beams with the rafters roughly in the axis of the inner wall plates and stiffen the trusses in the lower zones. Long intersecting passing braces form additional stiffening and at the same time support the rafters. They connect to the rafters just above the tie beams, intersect with the passing braces, the lower collar beam, and with each other, and end at the opposite rafters approximately halfway between the lower and upper collar beams. Paired common rafters (Fig. 2) differ from the principal rafter trusses only

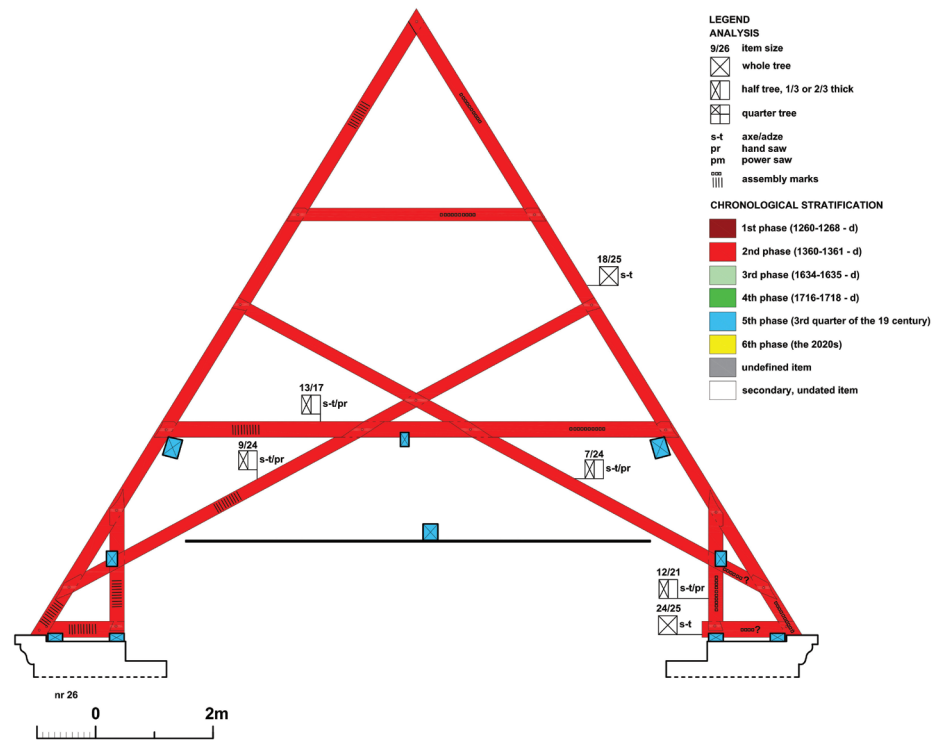
Fig. 2. Kamień Pomorski, cathedral, roof structure above the nave, paired common rafter, no. 26, analysis and stratification (elaborated by U. Schaaf, M. Prarat)

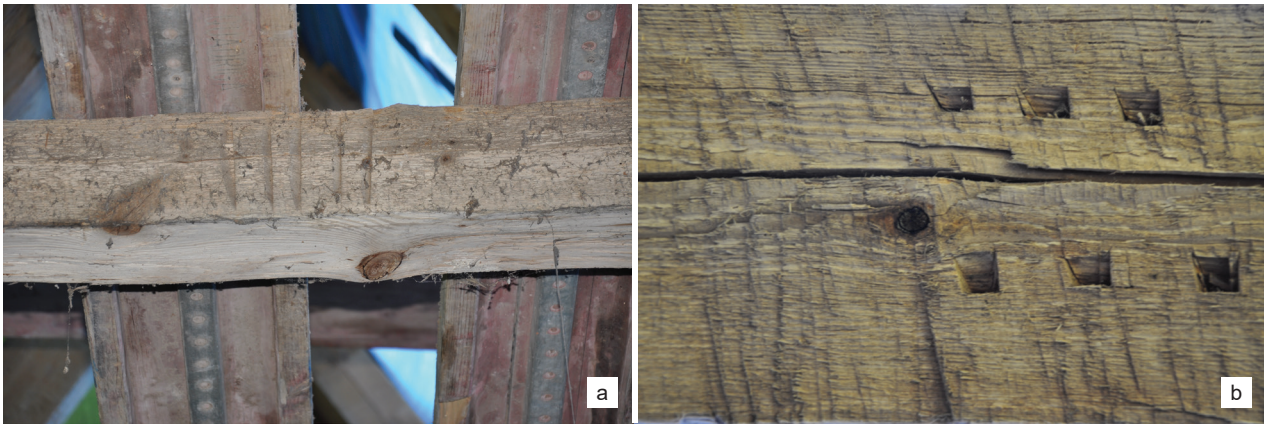
In the following trusses, from 20 to 27, the elements on the southern side were marked with line marks made with an axe or a hand adze (Fig. 3a), and on the northern side, with rectangular marks made with a chisel (Fig. 3b). Theoretically, the marks could grow from three to ten. However, during the assembly, there was probably confusion of the trusses, because the actual numbering in the trusses 20–27 is as follows, from the west to the east: 3, 4, 5, 6, 8, 9, 10, 7. However, this mistake did not create any problems, because all the common rafters, unlike principle rafters, have the same arrangement<sup>3</sup>.

Fig. 3. Kamień Pomorski, cathedral, roof structure above the nave: a) assembly mark in the form of straight lines made with a hand axe, b) assembly mark in the form of rectangular cuts made with a chisel, building material processed from the side of timber framing with a hand saw (photo by U. Schaaf, M. Prarat)

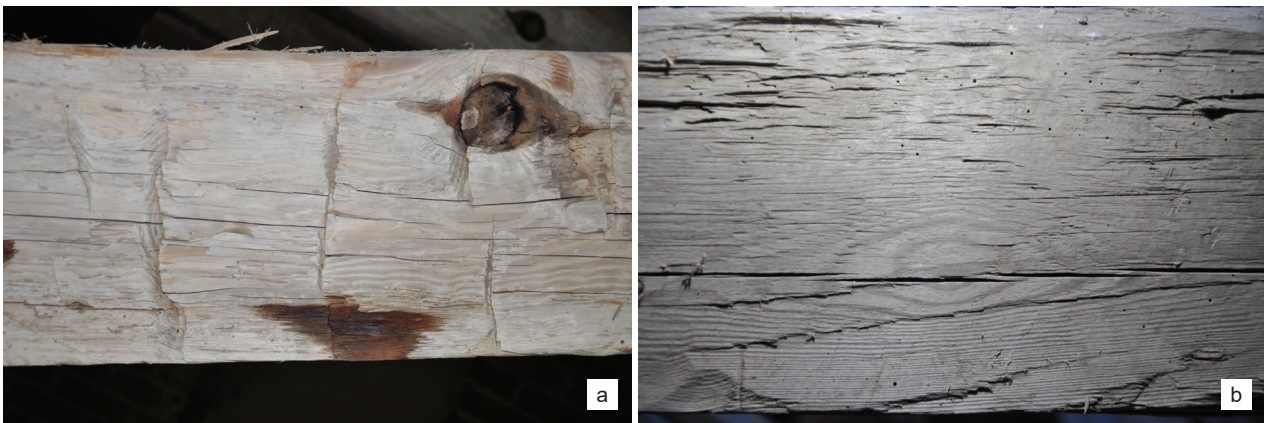
Fig. 4. Kamień Pomorski, cathedral, roof structure above the nave: a) initial processing of wooden building material made with an axe, b) smoothing of pre-processed wooden building material made with an adze (photo by U. Schaaf, M. Prarat)

An axe was used for the pre-treatment of the building material, with some traces in the form of “V” shaped cross-sections transverse to the direction of the fibres (Fig. 4a). Then the building material was smoothed with a carpenter’s adze, which left on the surface typical long and slightly rounded cuts running almost parallel to the fibres (Fig. 4b). Some of the elements processed in this way, called whole trees, were divided into smaller ones by dividing them with a hand saw. This process is evidenced by slightly oblique notches running unevenly across the

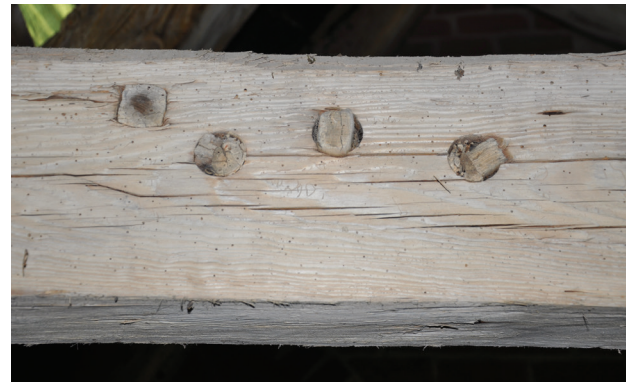
In some structural elements, two round holes, about 3 cm in diameter, with remnants of withes and wedges have been observed (Fig. 5). This proves that at least some of the structural elements were transported by rafts from the felling site in or around the forest to the site near the construction site. These rafts must have been built each time from several branch-stripped logs, connected to each other by a pole placed over them in a transverse direction, and attached to each log with a withe and secured with two wedges. The greater number of holes with remnants of withes and wedges suggest that the raft was repaired or rebuilt during transport. These traces also prove that the logs were floated first, and then the building material was made of them.

Fig. 5. Kamień Pomorski, cathedral, roof truss over the nave, building material with traces of float in the form of round holes with the remains of wedges and withes (elaborated by U. Schaaf, M. Prarat)

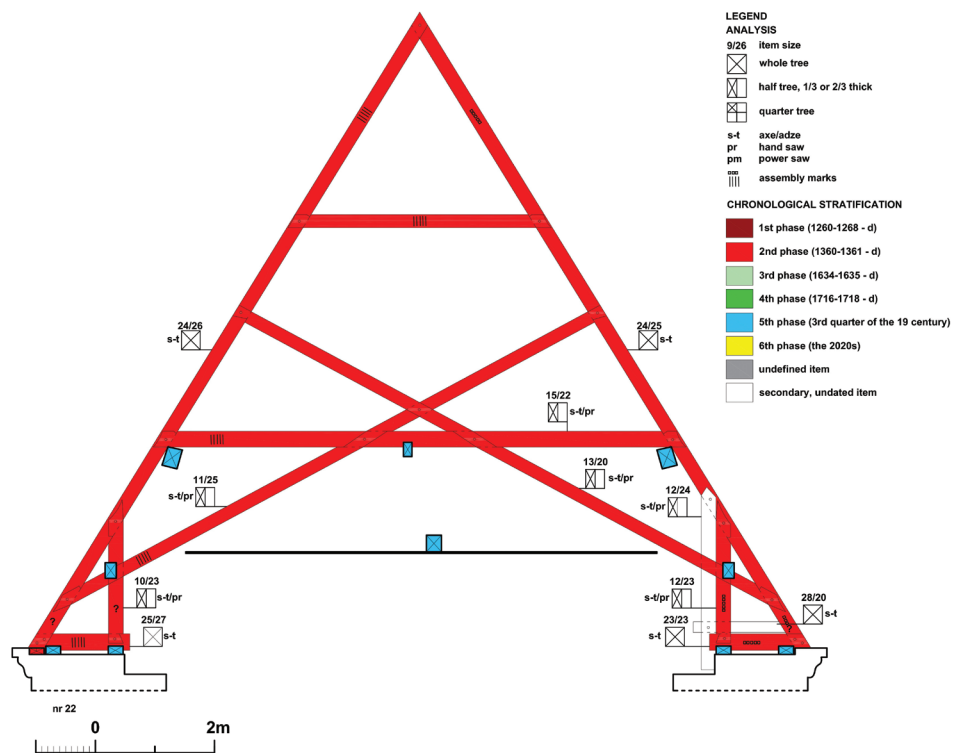
In truss 22 (Fig. 6) on the southern side, the down brace zone was re-strengthened by introducing an additional sole piece placed on the primary sole piece and an additional down brace adjacent to the primary brace. These elements are connected with each other and with the original structure using pegged lap joints of various shapes. These are traditionally processed with an axe, adze, and handsaw in the case of a brace, but have no carpentry assembly marks.

Fig. 6. Kamień Pomorski, cathedral, roof structure above the nave, paired common rafter, no. 22, analysis and stratification (elaborated by U. Schaaf, M. Prarat)

denced, inter alia, by their connection edge-to-edge with the tie beams and sole pieces, and by their processing with a power saw. In addition to the reinforcement of the down brace zone on the northern side in truss 22 (cf. Fig. 6), replacement of individual elements or their fragments in trusses 19–20 (cf. Figs. 7, 8), and with a partial replacement of the wall plates, iron elements were introduced into the entire roof structure (Figs. 9a, b), now a bit rusty, both to protect the wooden structure against parting and to strengthen wooden connections. The treatment and joints used suggest that the changes described here occurred later, after the strengthening of the foot zone in truss 22.

The architectural research has shown that in truss 22, an additional sole piece and an additional down brace were built into the northern side. These elements have not yet been dated.

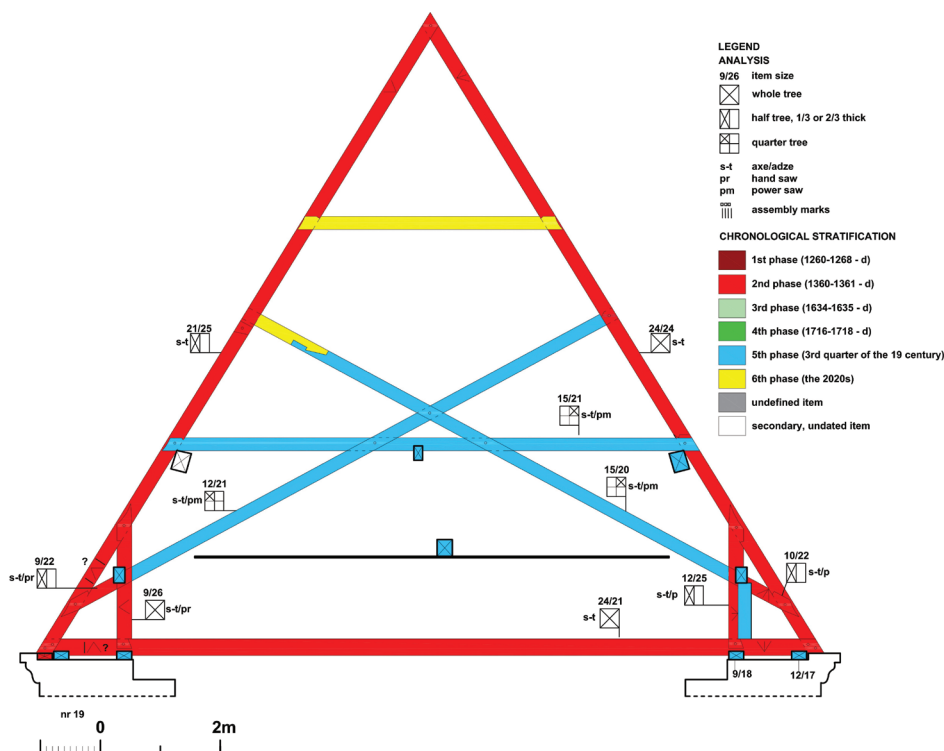
Fig. 7. Kamień Pomorski, cathedral, roof structure above the nave, paired common rafter, no. 19, analysis and stratification (elaborated by U. Schaaf, M. Prarat)

The secondary origin of the lower collar beam and intersecting passing braces (except for their lower ends) in truss 19 (Fig. 7) is evidenced, inter alia, by their treatment with a power saw on two sides, the lack of carpentry assembly marks on them and straight lap joints as carpentry joints. The passing braces were also connected to the rafters not from the timber framing side, but from the rear

In one of the passing braces in truss 19 (cf. Fig. 7) the upper end was replaced, as evidenced by its processing with a modern power saw on all sides and a scarf joint, which connects both parts of the brace. The same treatment is applied to the upper collar in truss 19, the lower part of the northern rafter and one of the intersecting passing braces in truss 20. Among other things, this treatment and the lack of assembly marks and signs of weathering make it possible to combine the assembly of these elements with the repair that has been ongoing since the end of the last decade.

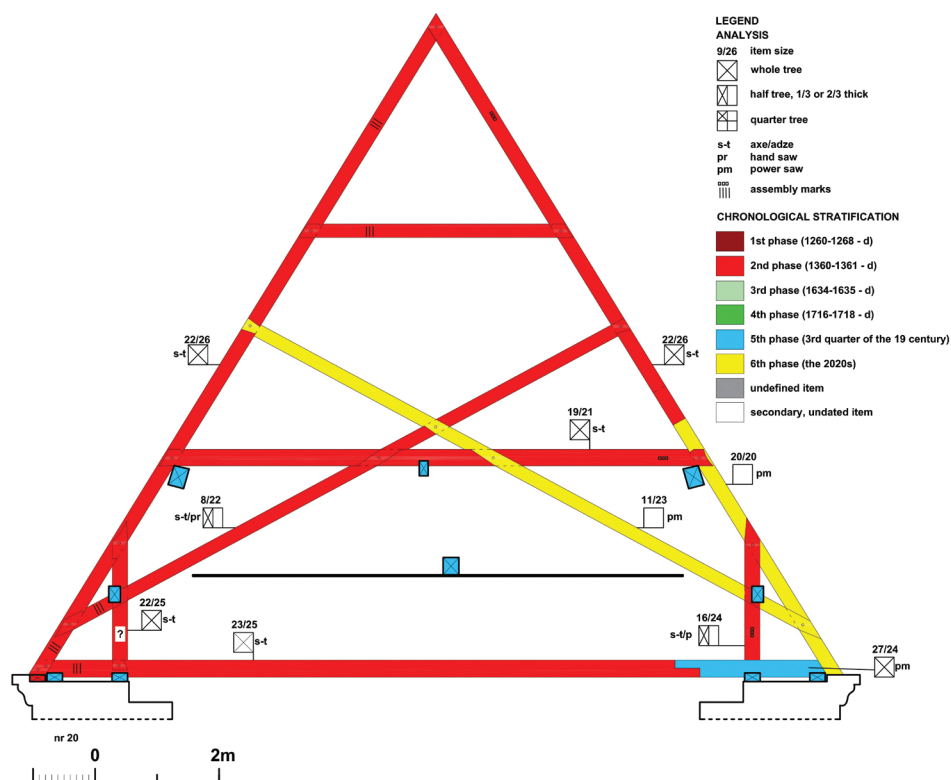
Fig. 8. Kamień Pomorski, cathedral, roof structure above the aisle, paired common rafter, no. 20, analysis and stratification (elaborated by U. Schaaf, M. Prarat)

side. The tie beam in truss 20 (Fig. 8) consists of two parts connected to each other by a straight lap joint, secured with a screw vertically, and iron flat bars attached to the side and also connected with screws. The short part on the north side was machined with a power saw, which allows its classification as secondary. In many fragments, the wall plates are also of a secondary nature. This is evi-

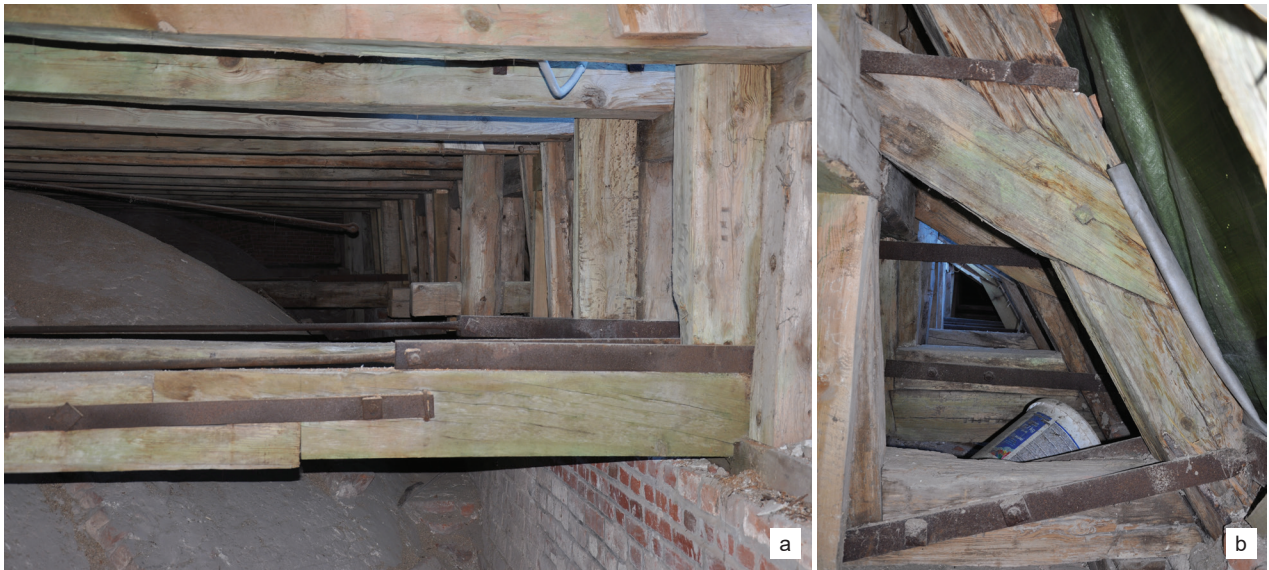
Fig. 9. Kamień Pomorski, cathedral, roof structure above the nave:  
 a) reinforcement of the connection of two parts of the tie beam (principal rafter truss 20) with a flat bar, securing the principal rafter trusses with tensile-resistant anchors (19–20) above the principal rafter truss beam,  
 b) connecting the sole piece with the rafter using two flat bars, joining the (secondary) upper plate with the passing brace and rafter using a flat bar (photo by U. Schaaf, M. Prarat)

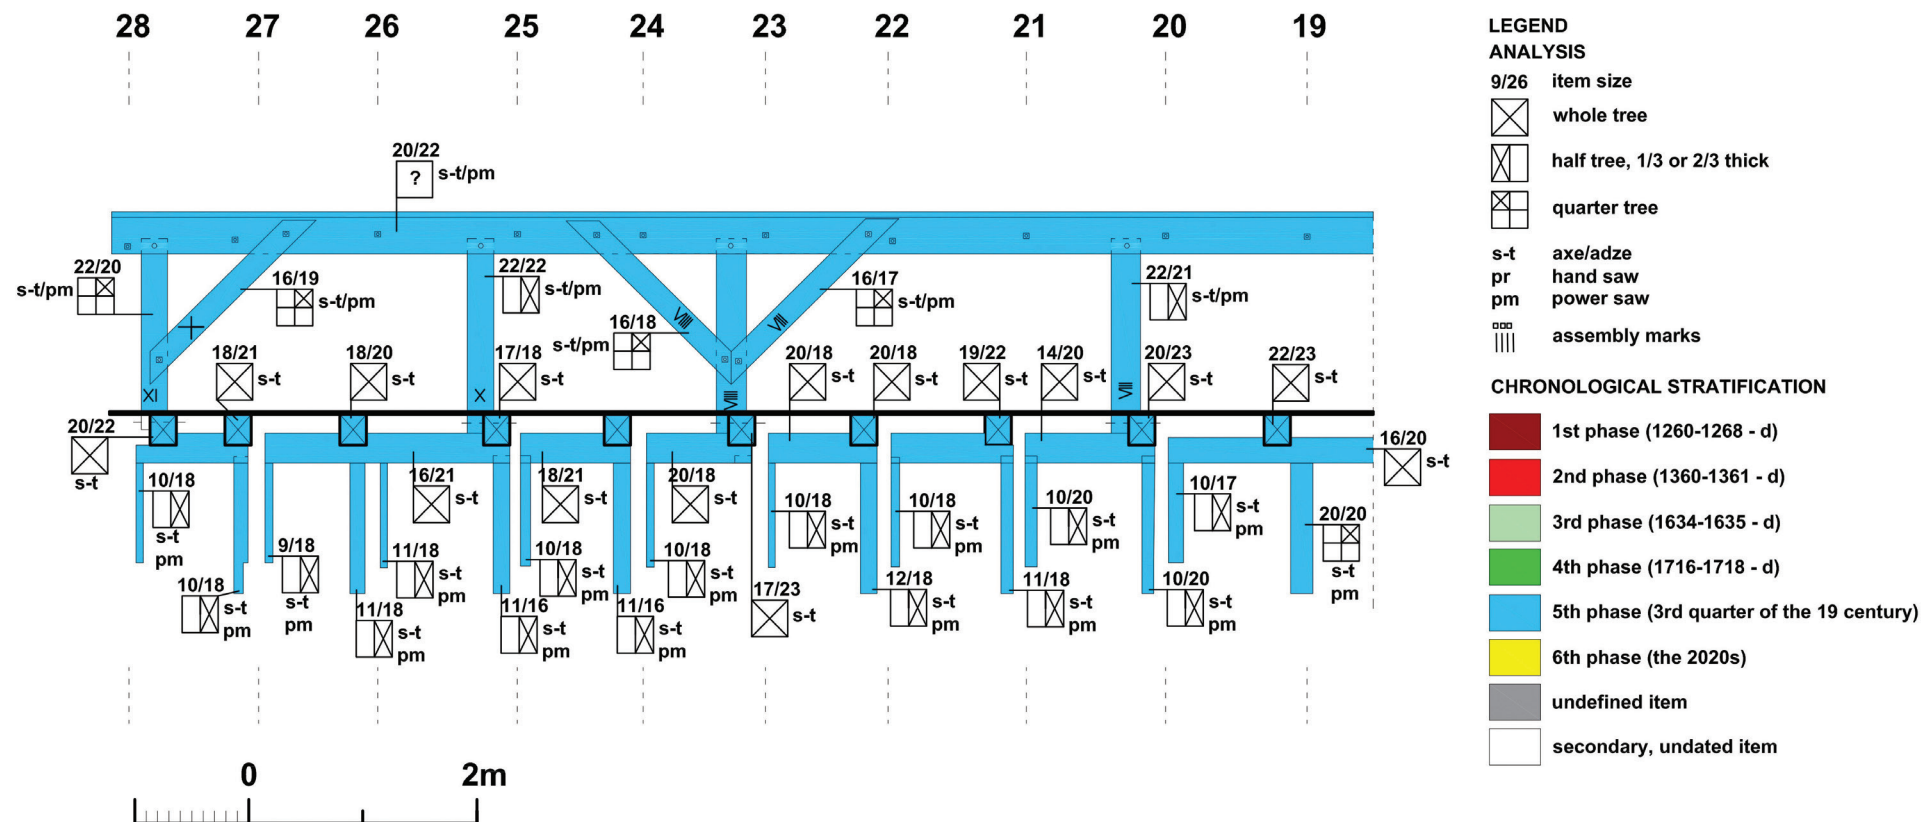
Secondary *frames of the inclined queen post structure* stand on the entablature and support the lower collars of the original roof structure at the connection to the rafters. Each frame consists of posts, oblique, but not parallel to the rafters, an upper plate, and up braces, which stiffen the frame in the longitudinal direction at every other post. The roof strengthening is devoid of a straining beam in the transverse direction, and therefore, the upper plates and the primary rafters were fastened with screws with square heads and nuts. The posts are joined at the lower end with beams using a straight lap joint without a mortise, and at the upper end with wall plates using pegged tenon joints. The straight lap joint was also used to connect the braces with the posts and upper plates. The lap joint on both ends

Fig. 10. Kamień Pomorski, cathedral, roof structure above the nave, eastern part, secondary entablature with a frame of the inclined queen post structure, analysis and stratification (elaborated by U. Schaaf, M. Prarat)

of the brace goes into the mortise, but is not in one plane with the posts or the upper plate. Each time it is only secured with a screw. Also, in the case of frames with an inclined queen post structure, auxiliary lines were drawn with a pencil for making the joints. The studs and upper plate were made of building materials with a cross-section of about 20/22 cm. They were treated on one or both sides with an axe and an adze, and on the other sides with a power saw. The entire southern frame of the queen post structure is marked from west to east with carpentry assembly marks in the form of Roman numerals. The posts within the examined eastern fragment have marks from VII to XI, while the braces from VII to X. This means that the posts and braces were counted separately. The northern frame of the queen post structure is marked essentially in the same way. Marking was made first with a pencil using Arabic numerals, and then with a chisel using Roman numerals. This marking is a logical continuation of the system of assembly marks used in the western parts of the roof structure and proves the homogeneous nature of both secondary roof strengthening frames.

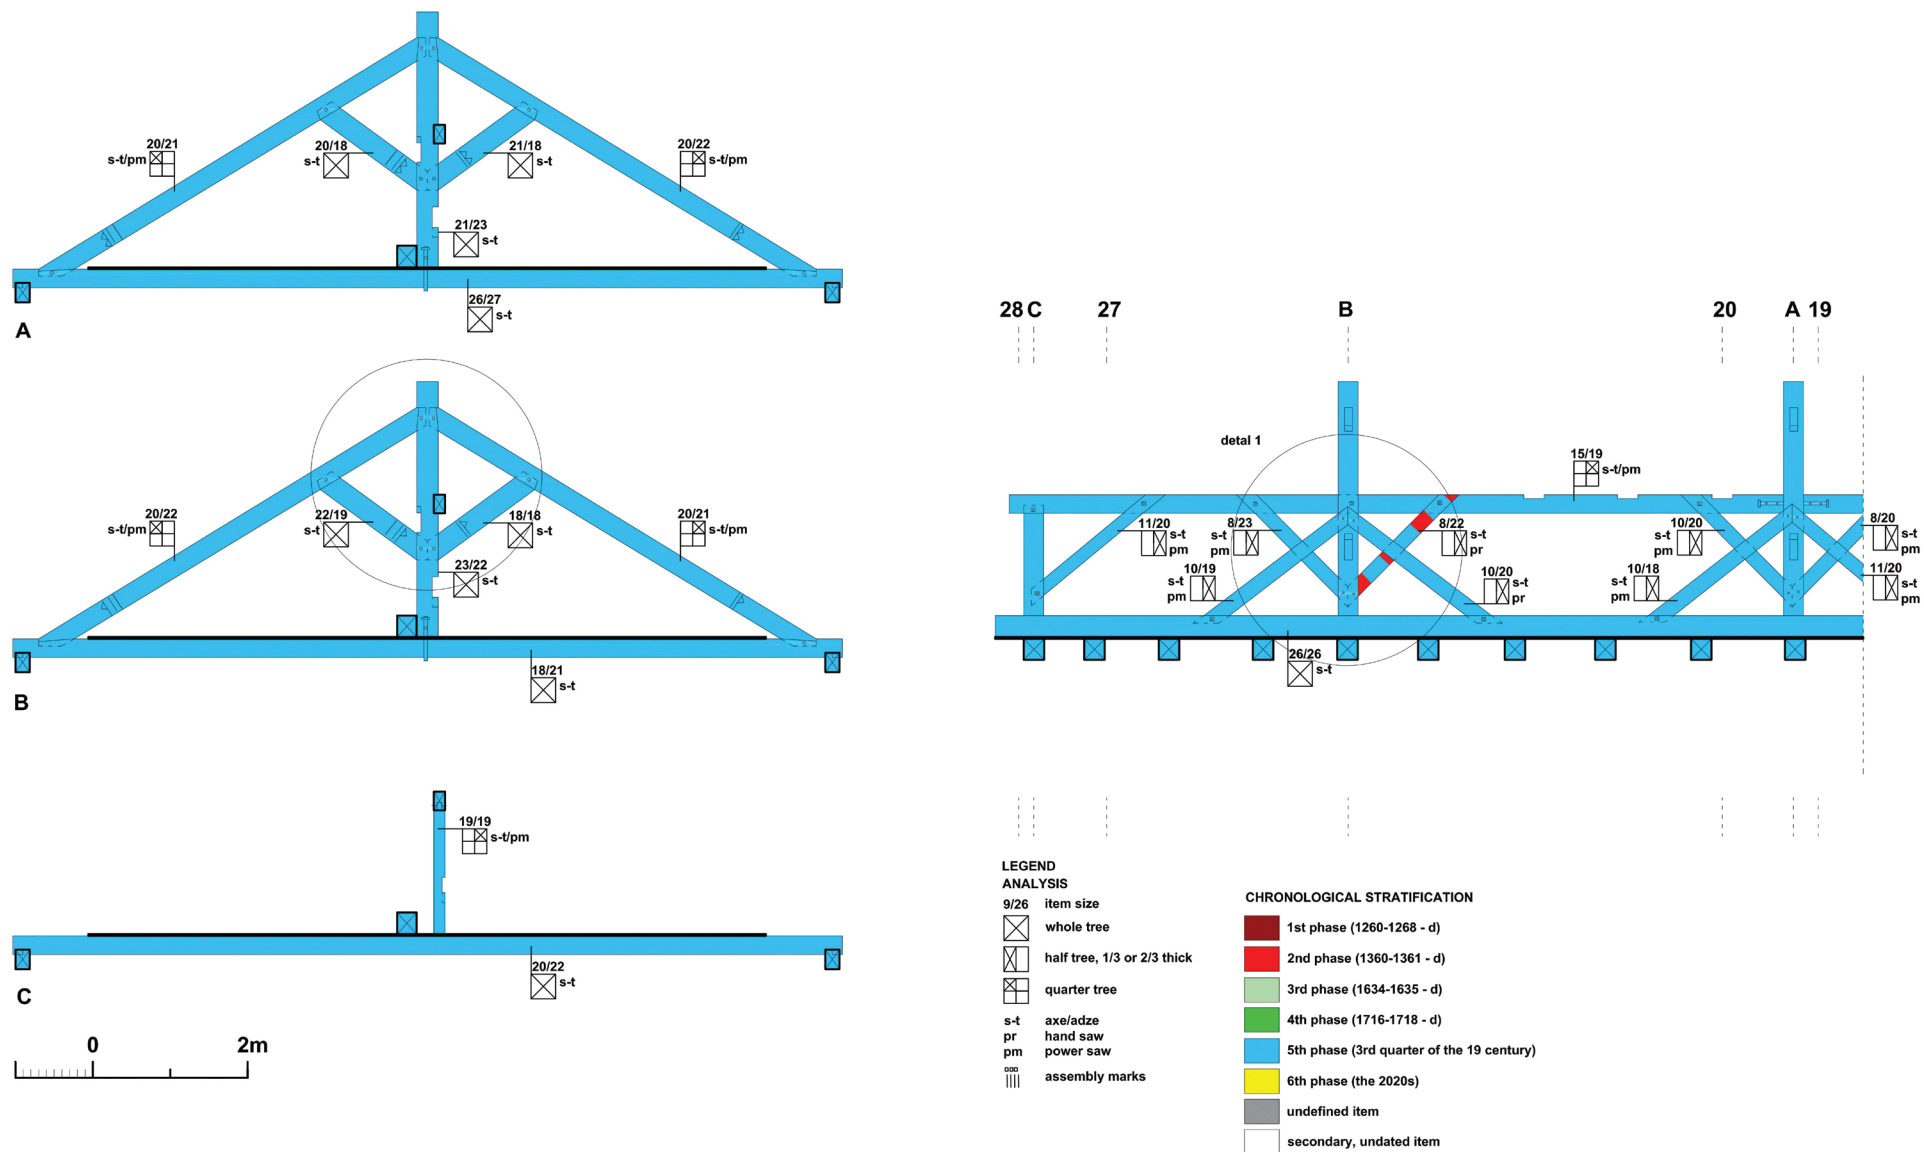
The secondary *king post structure* (Fig. 11) consists of three trusses and a longitudinal frame. Two full trusses (A-B) each consist of a king post and two long braces supporting it, a tie beam acting as a tension tie and two short braces connecting the king post with long braces. The third truss (C) is not a king-post truss, as it consists of only a tie beam and a stud standing on it. The longitudinal frame consists of king posts, an upstand binder from which an entablature is suspended above the vault, a spandrel beam, and stiffening braces. The upstand binder is situated next to the king post on the northern side. The spandrel beam on the southern side enters only 2–4 cm into the mortise made in the king post. In trusses A and B, the long braces connect to the beam and the king post by a pegged tenon with a notch. A pegged tenon joint was used to connect the braces with the king post. The beams were suspended from the king post by means of a flat bar (stirrup) fastened with screws. Moreover, this flat bar is bent at both ends and additionally fastened with small cramps. The same straight lap joints are used in the longitudinal frame as in the case of the queen post structure. They are secured with either screws or nails. The individual parts of the spandrel beams are connected to each other by a scarf joint. This connection was additionally reinforced with a nailed flat bar, and with bent ends secured with small cramps. The auxiliary lines needed to make the joints were made with a pencil. The system of carpentry assembly marks basically consists in marking structural elements in the trusses from east to west with triangular marks adjacent to thin lines – one triangle in truss B, two triangles in truss A. Both sides of the symmetry axis are additionally distinguished by line marks – one on the southern side, two on the northern side. This system of marking the king post structure is continued further on the west side and proves the simultaneous introduction of this structure in the entire roof structure above the nave. In the trusses, king and queen posts (only king posts) (about 23 × 22 cm) and braces (about 21 × 19 cm) were made from the whole tree processed with an axe and an adze, and passing braces (about 20 × 22 cm) were made of a quarter tree,

Fig. 11. Kamień Pomorski, cathedral, roof structure above the nave, eastern part, secondary entablature with a king post structure, analysis and stratification (elaborated by U. Schaaf, M. Prarat)

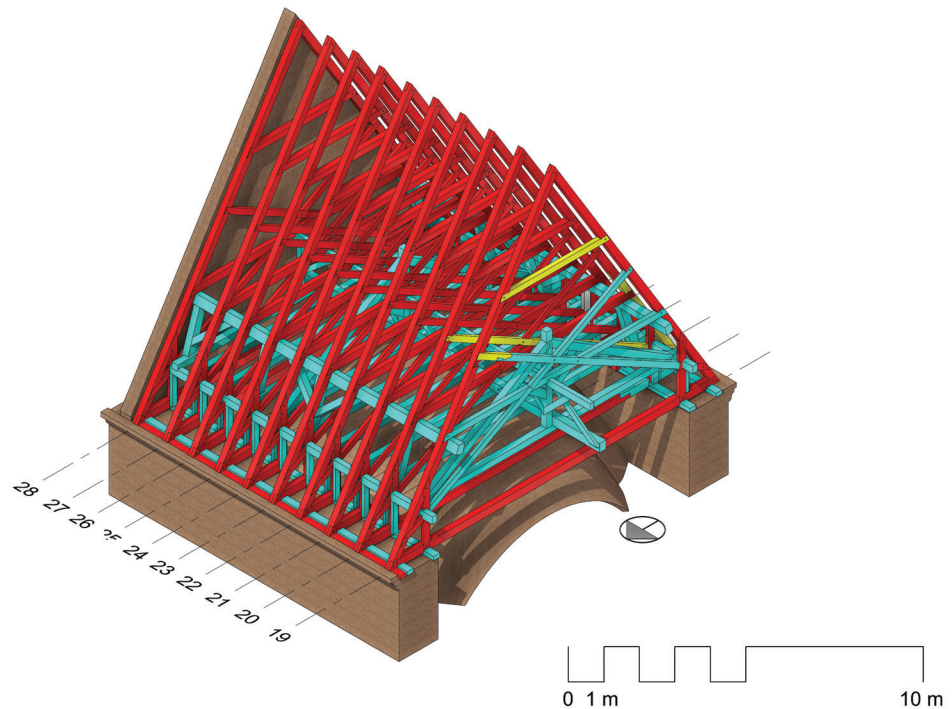
As a result of the analysis of the existing material substance, literature review, and dendrochronological research, it was possible to distinguish three construction phases: the period of construction of the roof structure and the period of two repairs, as described below. Not all items could be dated; they are listed at the end of the stratification (Fig. 12).

Fig. 12. Kamień Pomorski, cathedral, roof structure above the nave, trusses 19–28, stratification (elaborated by U. Schaaf, M. Prarat, drawing by M. Kumorowicz-Brzeska)

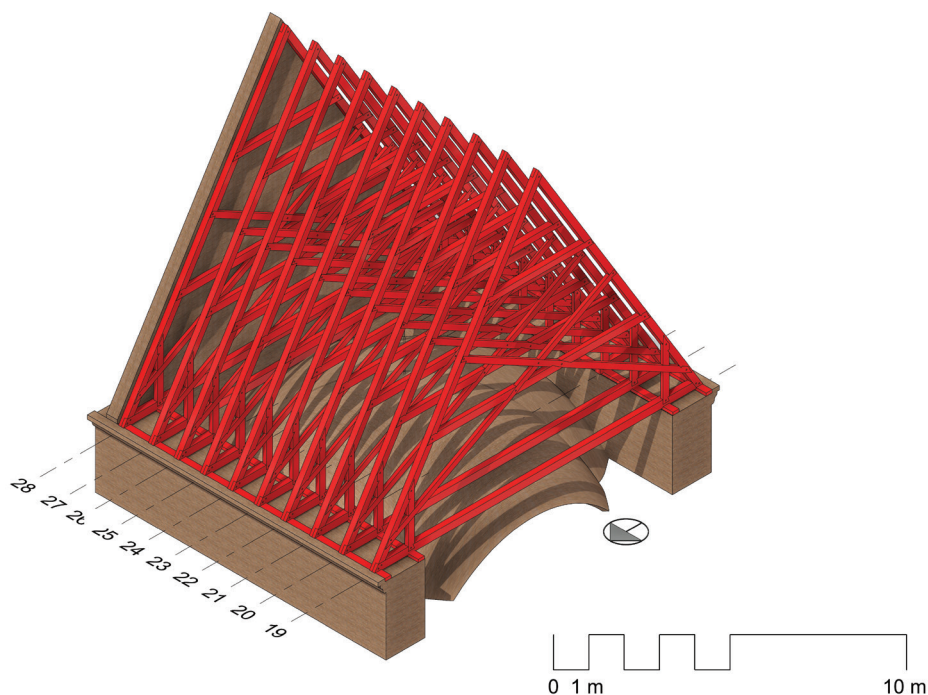
The architectural research has made it possible to reconstruct the original roof structure over the nave of the cathedral in Kamień (Fig. 13). The reconstruction shows

that the structure is a collar beam one with two collars and intersecting long passing braces stretched in each truss between the rafters, and with tie beams only above the inter-span reinforcing arches (19–20, 27–28). In the remaining trusses there are only sole pieces, because the rise of the vault apex reaches into the roof structure. The angle of inclination of the rafters is 58°. The only stiffening in the longitudinal direction is wind braces running diagonally under the rafters. In the connection of individual structural elements of the roof structure lap joints of various forms dominate; coggled joints were used only in the case of connecting the tie beams and the sole pieces with the wall plates. According to the dendrochronological research, this roof structure was created in the 1360s.

Fig. 13. Kamień Pomorski, cathedral, roof truss of the nave, trusses 19–28, reconstruction of the original cross-braced collar beam
