Jerzy Potyrała*

Buildings from the 18th and 19th century on the main rampart of Prussia Fort in Nysa

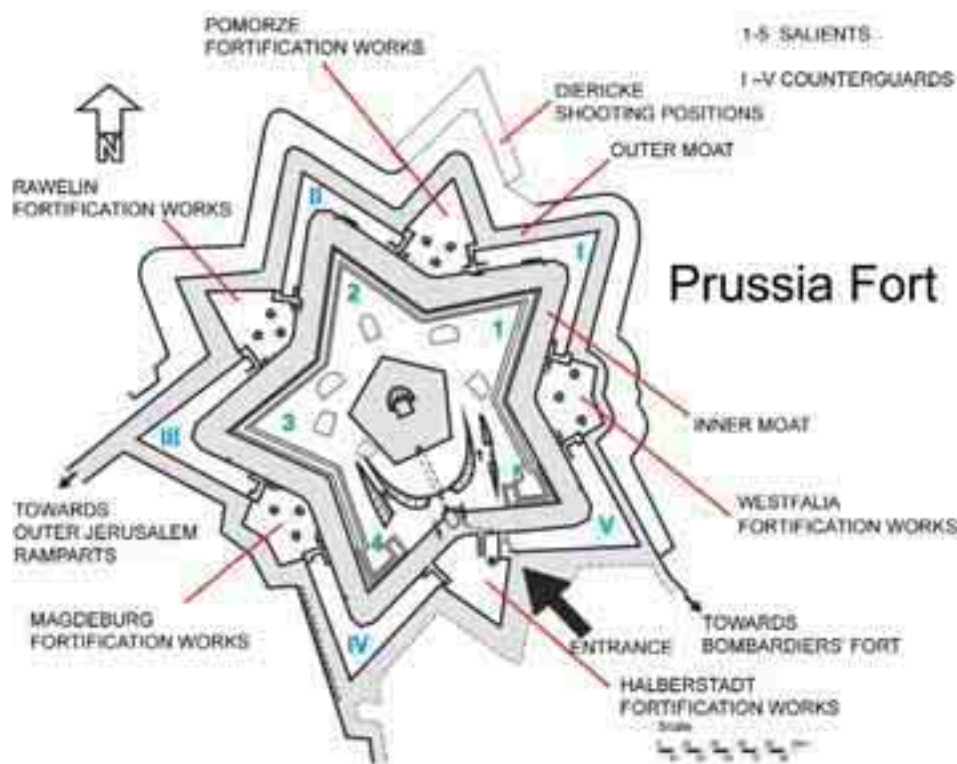
Fig. 3. Elements of Prussia Fort

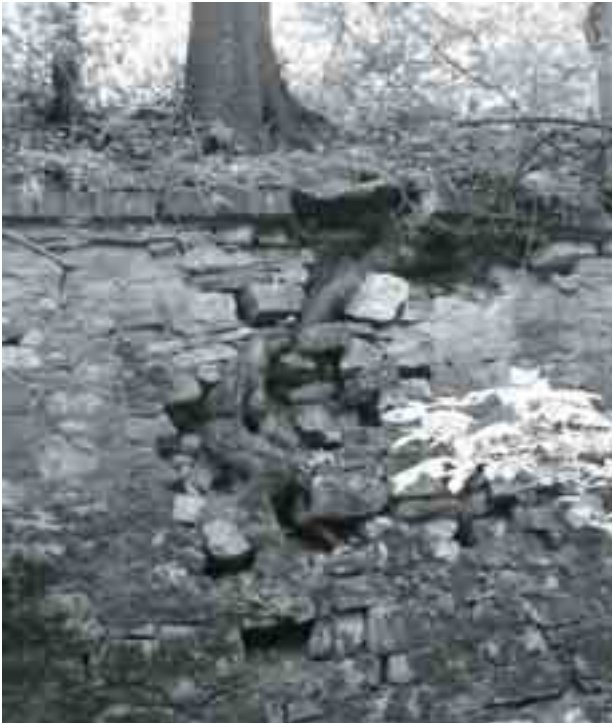
In this area, there are also trees whose root systems endanger the wall structure. The following trees should be removed in the first place: 1) maple-tree sycamore (*Acer pseudoplatanus*); 2) durmast trees (*Quercus robur*); 3) wide-leaved linden (*Tilia platyphyllos*); 4) maple-tree (*Acer plantanoides*); 5) wide-leaved linden (*Tilia platyphyllos*); 6) verrucated birch (*Betula pendula*); 7) maple-tree (*Acer plantanoides*); 8) ash-tree (*Fraxinus exelsior*); 9–12) wide-leaved linden (*Tilia platyphyllos*).

Fig. 17. Destructive influence of plants on the construction structure
(photo: J. Potyrała)

order to make the defensive system more legible, it is necessary to remove self-sown plants and new roots up to 30 cm in circumference and the reduction of bushes so that they form just few smaller complexes between shelters. The planned process of cutting down big trees should be limited to those ones which destroy the structure of the wall and obscure the view axes (of fortification works and towards the direction of Fort II). The trees situated on the edges of salients shall emphasize their landscape dominants (similarly to the experiences of Srebrna Góra Stronghold). On the maidsan it is possible to use specially shaped decorative plants as garrison greenery. Such gradual removal of the plants which cover the fort will not influence rapidly the environment conditions and the system of ground water and at the same time it will enable a better exposition of the object. It is necessary to reconstruct the earth ramparts following the repair of anti-damp insulation of the building structures and, finally, to turf the scarps again.
