Dalia Klajumienė*
Ewa Świącka**

The Wall Painting in the Franciscan Church of St. John the Baptist in Holszany: History and Conservation Works

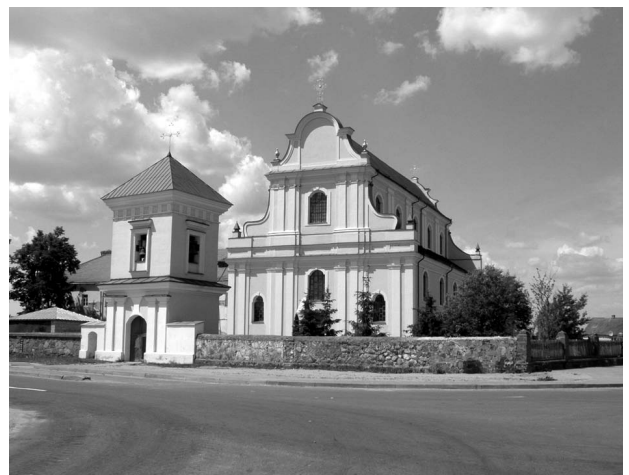
Fig. 1. Church in Holszany (photo by B. Wójtowicz, 2007)

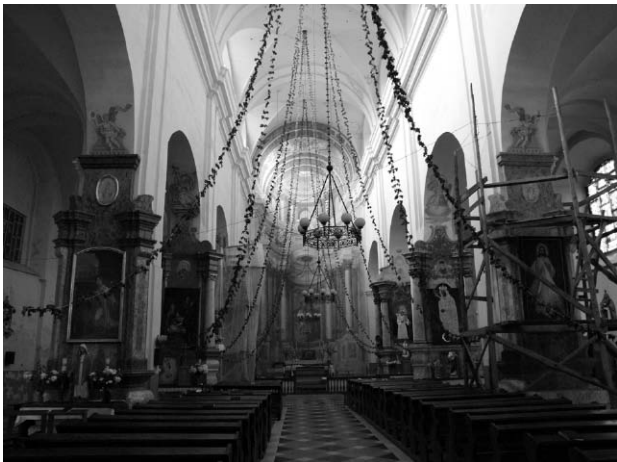
Fig. 2. Holszany interior of the church with side altars
(photo: J. Szczepańska, 2008)

the rich interior of the Church of St. John the Baptist and Evangelist was only marble side altars decorated with polychrome and monumental, two-stage composition: illusory painting taking up the whole wall of the presbytery with centrally located scene of Jesus's baptism in Jordan with the figure of St. John the Evangelist where the stages meet. It can be only assumed that this illusory composition of exceptional beauty and monument character was not recognized by the workers of local workshops as the altar decoration and that is why it was not destroyed (Fig. 2).

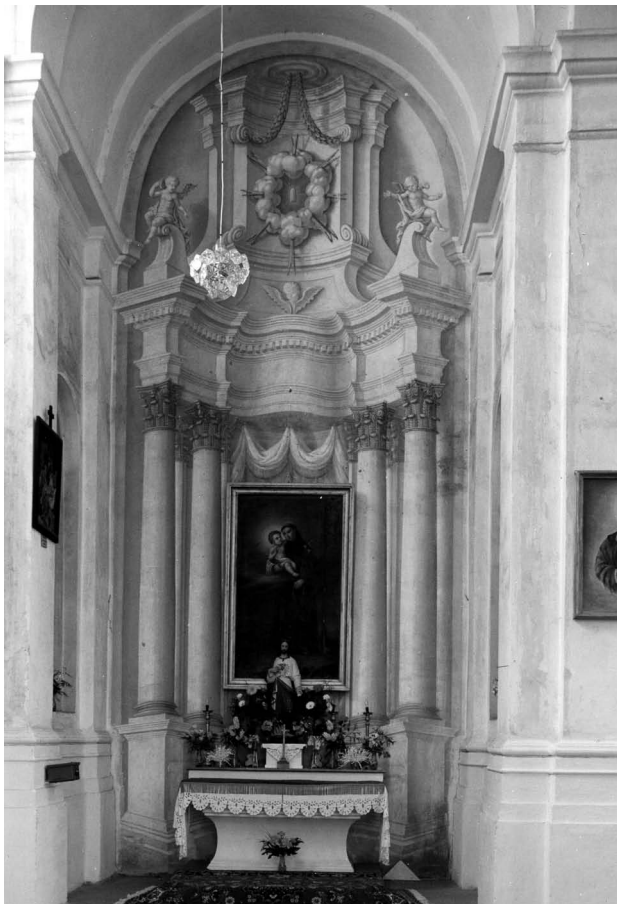
Fig. 3. Side altar of St. Anthony in the church of Friars Minor
in Budslaw (photo: G. Trimakas, 1997)

In respect of professional painting workmanship, the main altar in the Franciscan Church in Holszany ranks among those created at that time in late Baroque style and early neoclassical altars in such churches on the territory of today’s Belarus as the Church of Friars Minor in Budslaw (Fig. 3, 4) or former monastic Church of the Basilians in Liady (Fig. 5). The chronicle written by Friars Minor from Budslaw in the years 1769–1782 states that in the years 1778–1782 their church was decorated with a group of nine painted altars

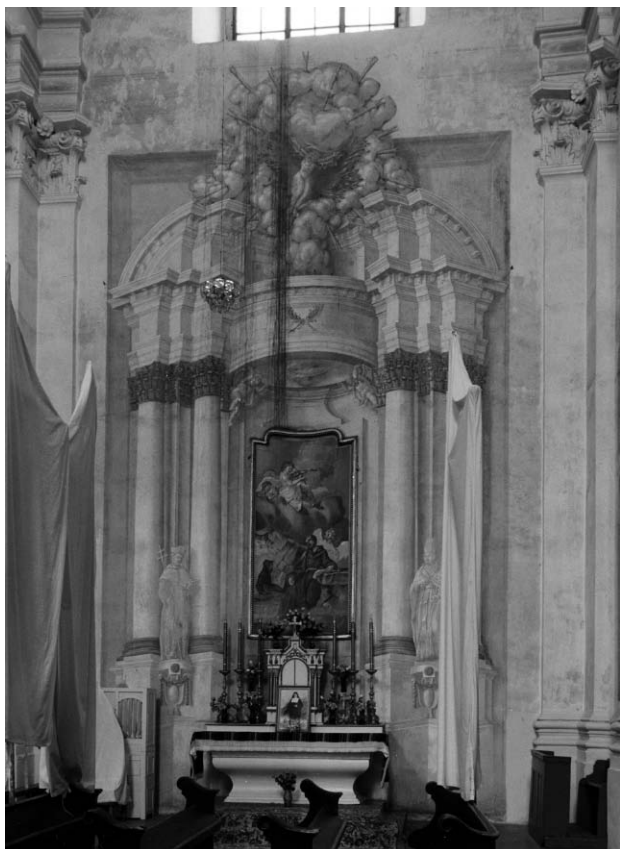
Fig. 4. Side altar of St. Francis in the church of Friars Minor in Budslaw (photo: G. Trimakas, 1997)

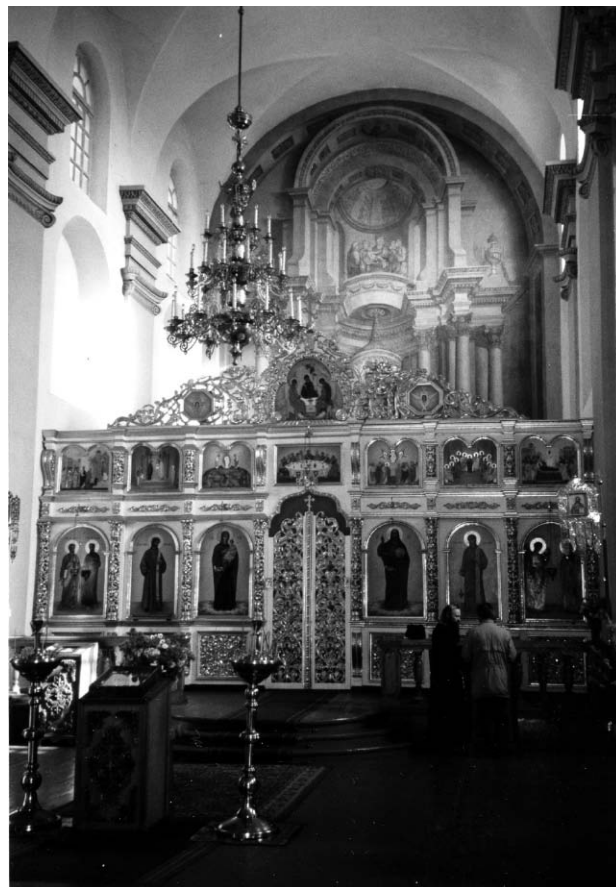
Fig. 5. Interior of the monastic orthodox church of the Basilians (currently eastern orthodox), Liady. Behind the iconostasis on the sanctuary wall, the upper section of painted altar. (photo: D. Klajumienė, 2000)

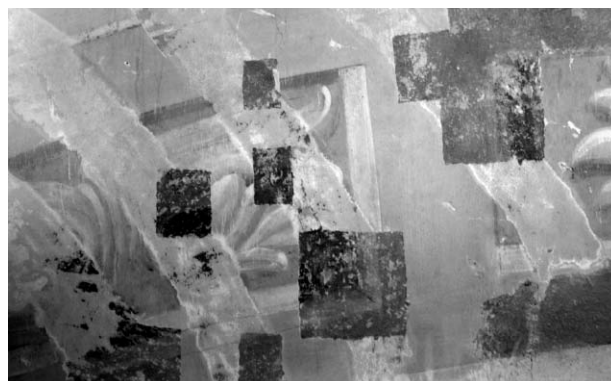
Fig. 6. Holszany; uncovered patches of the original painting in its uppermost section (photo: P. Lisowski, 2006)

the overpaint was removed it was possible to repair the chipped plaster. Anyway, the surface was uniform and the number of lacunae which needed puttying was really small. There were a few longer and shorter cracks in the wall but the plasters were not extensively chipped or incoherent. The main task was the removal of overpaint.

Most coats of the overpaint could be removed dry with the use of stiff brushes. Over the years, inside the interior which was exposed to a lot of moisture and differences in temperature, the binding agent of the overpaint disintegrated. The original layers of fresco remained in a very good condition and in many places, after they were uncovered and cleaned, they did not need any additional procedures. The best proof of their mechanical strength is the fact that the original painting was first uncovered during putting out fire inside. After a coat of overpaint was removed, some traces of earlier repairs of damaged fresco were uncovered. The lacunae in the upper section of the painting were significant. The middle section above the dome was almost completely whitewashed and then covered with a thin filler of a very hard fine grain mortar. The coat was white but its texture was similar to a smooth cement filler. The uppermost section of the wall, in the place where it meets the vault, some quite large patches of original painted decoration in the form of golden panels in a gray and green arch were found. It was very difficult to remove the layer of hard filler to expose the original fragments (Fig. 6). The outline of the overpaint coat did not match the original at all. In order not to lose the original outline of the composition, in case it is seriously damaged, it was uncovered by removing small strips by grinding off the hard mortar and applying the architectural composition on its surface; only after it was sure that the original was preserved to the sufficient degree guaranteeing reconstruction were the next fragments further cleaned with the use of scalpels¹³.

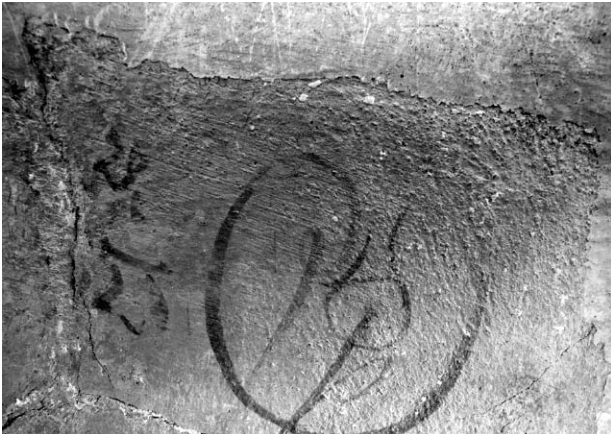
Fig. 7. Holszany, original signs with a pink cloud in the background pose an interesting riddle for researchers. It is possible that it is a form of signature and date (?) (photo: P. Lisowski, 2006)

Fortunately, the original division of the panels, the window with the sky, and a small fragment of an angel's arm remained, which enabled the determination of its scale. Right next to it, a sign was discovered which could be a kind of signature and some writing which could be a date – unfortunately, it was partly damaged by a crack in the wall (Fig. 7). Underneath the pope's tiara and St. Peter's keys, which were painted twice, in the last and earlier coats, there is an original cartouche for the coat of arms whose field was removed with the use of a sharp tool before overpaint was applied (Fig. 8). Unfortunately, at present the existing documents do not provide sufficient information to determine the moments when those changes were made. Maybe the earlier overpaintings were made during the complete refurbishment referred to above which was conducted at the turn of the 19th and the 20th centuries [21]. The last overpainting should be connected with the renovation conducted in 1927 [19].

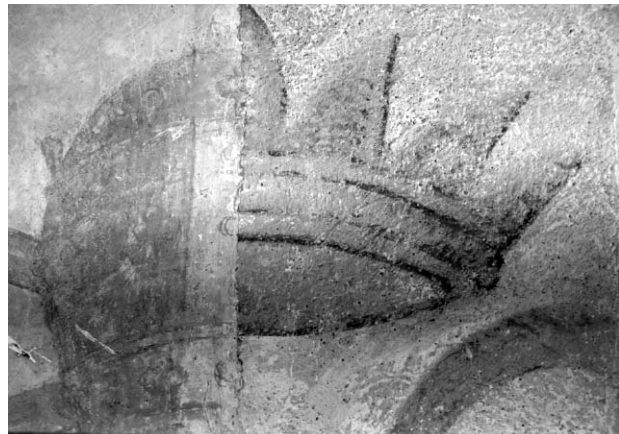
Fig. 8. Holszany, originally a crown was painted under the cartouche and then a pope's tiara and keys of St. Peter appeared in two successive layers (photo: P. Lisowski, 2006)

severely damaged¹⁴. There were more fillings like that. The same mortar was used to fill the cracks in the uppermost sections of original fragments of the decorations. Today, it is difficult to say to what extent the last paint coat repeated the original composition which did not survive but a rather primitive outline of angels and simple architectural forms seem to indicate that their painters had to create them anew.

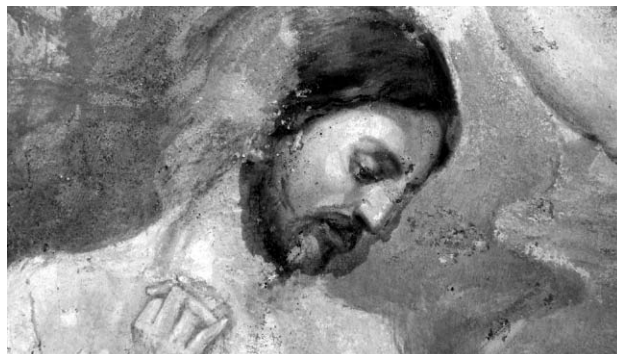
Fig. 9. Holszany, wet fragment of the painting shows the way tonality was modeled (photo: E. Świąćka, 2007)

technique. Thick, oil overpainting maybe is not the first layer of paint applied on the original painting. The next overpainting, which is visible now, consists of two phases: masterly painted figures – probably in technique of lean tempera which lost some of its binding properties and only after its surface is slightly wet can the high level of tonality of the painting be fully appreciated (Fig. 9). It is difficult to say if the painter did not finish the painting or the sections of its background disintegrated, but surely the mechanically painted landscape elements and the waves of Jordan were not painted by the same hand. However, the composition of the scene is too big for the original “gilded” frame and it was extended to cover the columns. The conservation of the altar painting is a very complex problem for conservators. A lot of observations must be made in various kinds of light as well as many places must be uncovered and chemical tests must be conducted. It is unlikely that the original composition can be recovered because oil overpaint resulted in a deep penetration of the plaster layer with a greasy, blackened binder (a number of runs visible on the frame). These works will have to be performed in the future to select the best solution. It seems that the exposure

of a rather primitive oil overpainting which has survived under the current painting next to it would benefit the illusory altar currently restored to its original form. Maybe only a delicate correction of the visible overpainting will be the best solution.

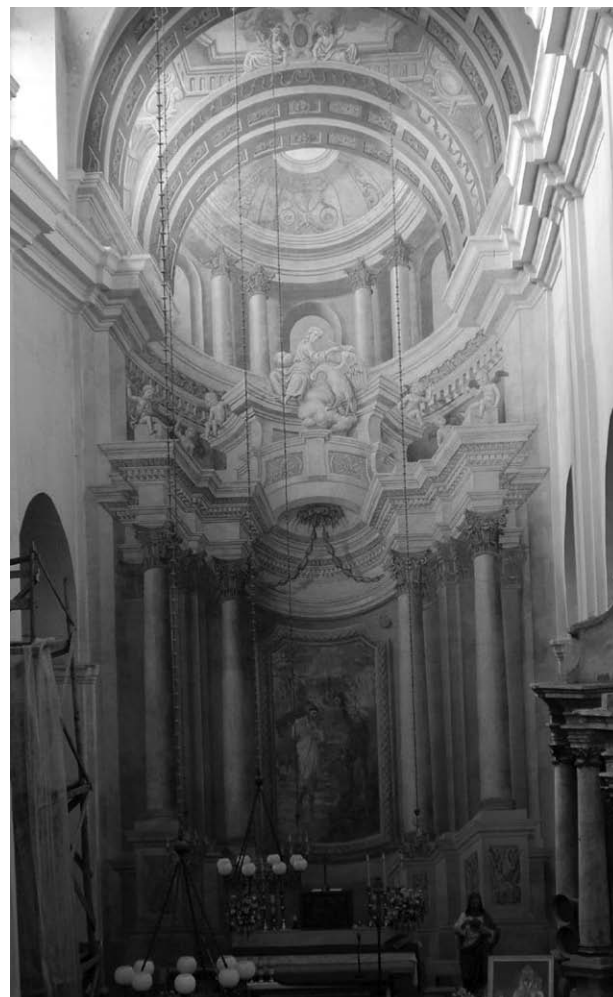
Fig. 10. Holszany, painting after conservation (photo: E. Świąćka, 2007)

soned, putties cured, and the wall dried, artistic works began and they included filling the lacunae in the painted coat, paint dotting and reconstruction¹⁵. After a detailed analysis of the situation, gouache technique was applied to paint dots. As original paintings are resistant to water, the fillings could be easily removed if necessary. Due to the great amount of work as well as limited time the paint dots imitate fillings without distinct optical variations.

Large lacunae were relatively easy to fill in the composition outline as it is symmetrical. In the case of larger lacunae the outline was corrected on digital photography printouts. It was, however, difficult to maintain the right balance in *chiaroscuro*. The scaffold blocking the view of large sections of the decoration prevented viewing the whole composition from a distance, which was needed to keep the chromatic balance.

The reconstruction of the upper section of the composition was based exclusively on last overpainting. The architectural divisions were maintained according to the drawings made on hard mortar which was left. The colors of architecture were slightly corrected; the secondary, bright blue sky was not retained in all clearings. The figures of angels were painted correctly anew on the basis of the original ones which survived in the uppermost section and an angel which did not survive, by left edge of the composition. Lacunae filled and the central scene with St. John the Evangelist was corrected. After many years of overpainting, the original architectural composition was restored.
