Stanisław Kowalski*
Czesław Lasota**
Andrzej Legendziewicz***

The Late-Gothic Town Hall in Zielona Góra and Its Remodelings in the 16th and 17th Centuries

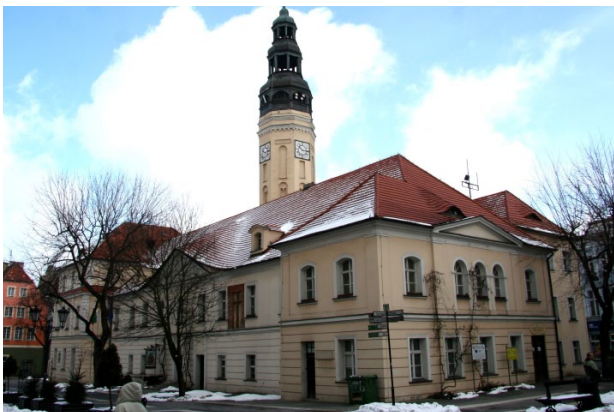
Fig. 1. View of the town hall from the south-west (photo: A. Legendziewicz)
Il. 1. Widok ratusza od południowego zachodu (fot. A. Legendziewicz)

The town hall in Zielona Góra is located in the middle of the elongated market square (Fig. 3, 4) Its present shape is defined by of a few buildings of different sizes erected at different times; it has a dominant tower topped by a neoclassical spire and its elevations indicate its Gothic origin. The town hall has three wings of which the middle single-storied one, whose façade features neoclassical decorations, is its oldest and main part (Fig. 1, 2)

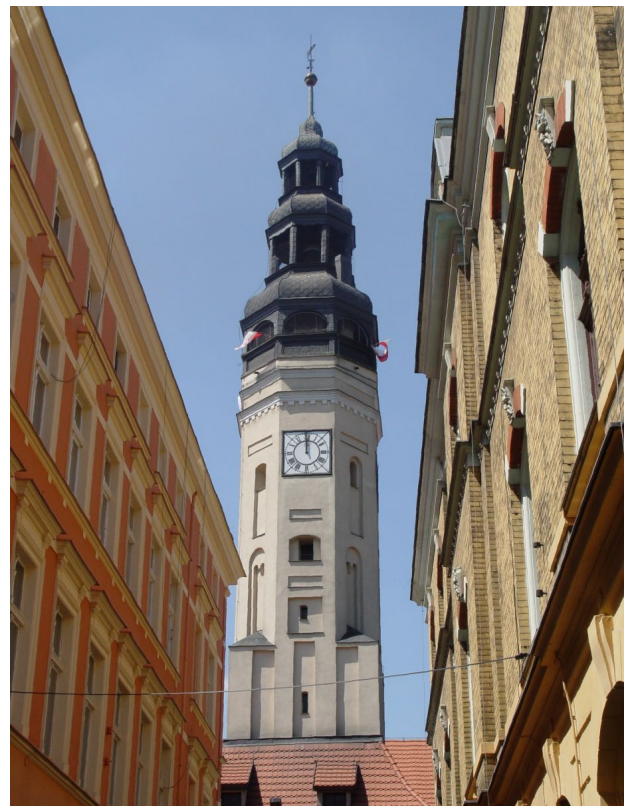
Fig. 2. View of the town hall from the south-west (photo: A. Legendziewicz)
Il. 2. Widok wieży ratusza od wschodu (fot. A. Legendziewicz)

same level as on the ground floor of the town hall, was about 5 m. First of the stages covered with a ceiling was 4.1 m high, whereas the last of them, and the lowest, was 3.4 m high. The ingress of light into the quadrangular part of the tower was allowed through windows built in the north and the east walls. The jambs of the window openings were slightly splayed. The elevations of the quadrangular part of the tower had different articulations, which was demonstrated by the revealed sections of the east and the north elevations, accessible from the attic of the building surrounding it. In the case of the east elevation, two levels of blanks with segmental arches were detected, lower one with three blanks and upper one with one much bigger blank, with walled-up window clearance, located on axis. Above it there is a blank which was walled up still during construction of the tower (Fig. 11) One level with two blanks in the examined part of the north elevation does not correspond to the vertical layout of the ones detected in the east elevation. The octagonal part of the tower with 1 m thick walls and rectangular window openings was placed with the whole circumference on the walls of the quadrangle. It had two stages divided by a ceiling supported on stone corbels. Four windows were located in the walls of the 5.2 m high lower stage, one in the north and one in the south wall and two, one above the other, in the east wall. The upper stage, with openings in all walls, was covered with a ceiling whose beams were fused into the walls. The windows located in all of its walls indicate that it was the last stage of the tower designed for observation of the area. The original division of the interior of the octagonal part of the tower corresponds to two levels of elongated blanks with pointed arches in elevations. The ones located on lower level have recesses topped by two arcades springing from a corbel (Fig. 2)

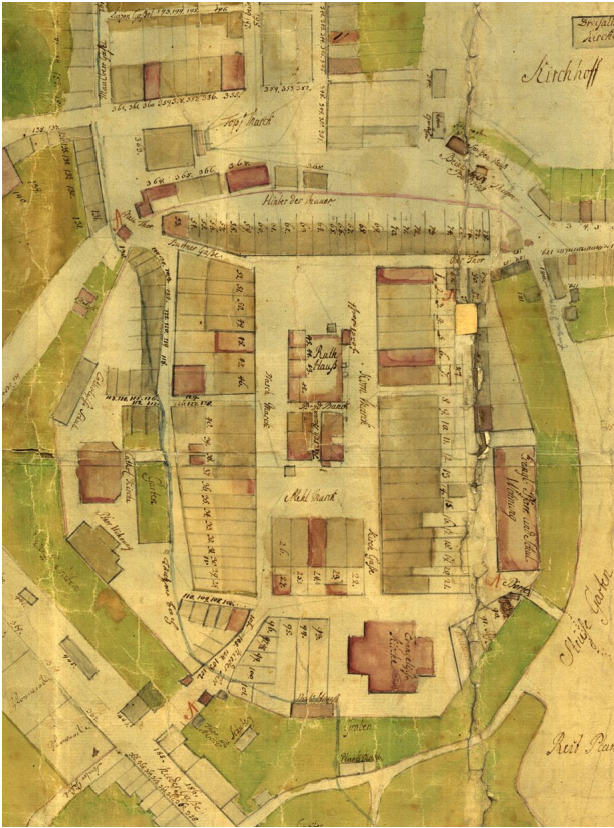
Fig. 3. Fragment of Büttner's plan from 1784 (original in the Museum of Ziemia Lubuska in Zielona Góra, file MZL-H-ZG-223)

Il. 3. Fragment planu Büttnera z 1784 r. (oryginał w Muzeum Ziemi Lubuskiej w Zielonej Górze, sygn. MZL-H-ZG-22)

house, with the ground floor for commercial purposes and residential upper floor [6, pp. 13–166]. Sources with layouts and view of the block in the middle of the market square in Zielona Góra show the commercial section from the final years of its existence. The plans made in 1784 and 1840 (Fig. 3, 4) show that it consisted of three complexes of buildings divided by passages, including the town hall on the south with four burgher's houses adjoining it from the east. The buildings on the north side were divided by a north-south passage. A later plan also shows that when it was made the buildings on the south side were already fully owned by the town and there was a guardhouse adjoining the town hall from the south. The drawings from the 19th century show the west side, probably a nicer one, of the block in the middle of the market square with three buildings in the form of townhouses adjoining the town hall with a neoclassical façade from the north [3, p. 70, 71]. The emergence of the capitalist economy in Silesia at the beginning of the 19th century eliminated the commercial operations controlled by the city authorities on the basis of legal norms which derived from the medieval times from the buildings in the middle of the market square. In 1857, the north part of the block of buildings in the middle of the market square in Zielona Góra was demolished except for the townhouse adjoining the town hall from the west which the city bought from a burgher in 1827 and located the City Treasury there. The

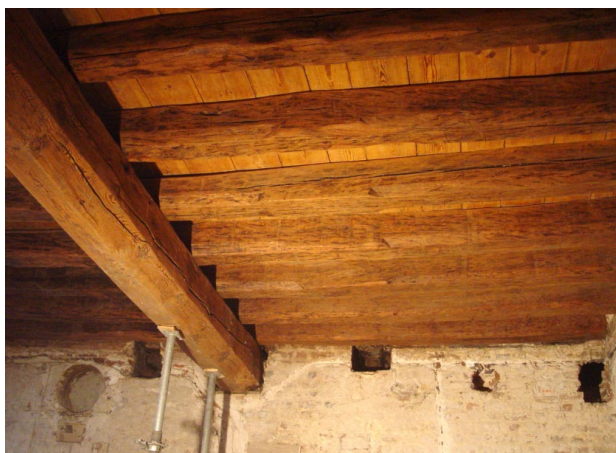
Fig. 6. Ceiling from the 15th century in the south-west room wing of the town hall (photo: A. Legendziewicz)

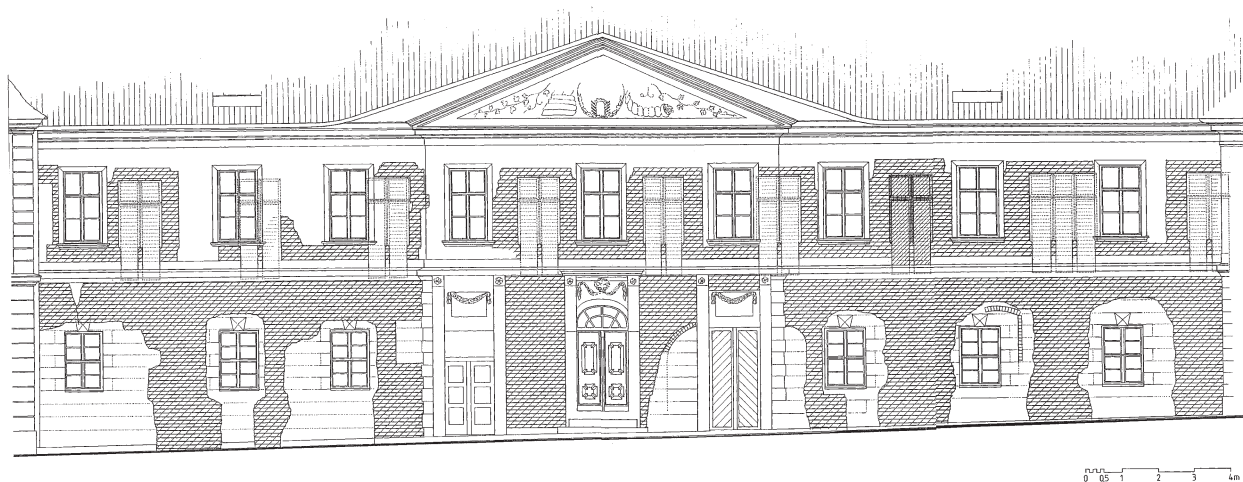
Fig. 9. The west elevation of middle wing of the town hall with the wall from the 15th century (marked) (by J. Burnita, S. Kowalski)
