## *Chronology of transformations in Grodno Castle from the 13<sup>th</sup> to the mid-16<sup>th</sup> century*

### *Introduction*

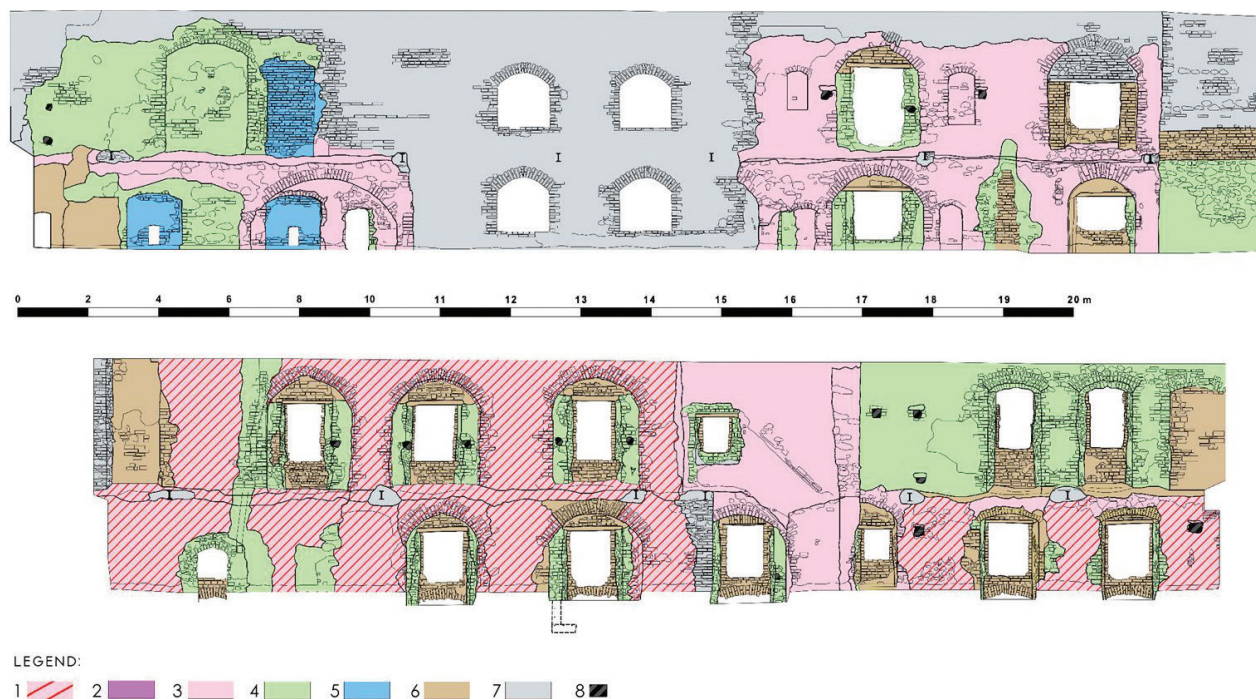
Fig. 3. Grodno Castle.

Stratifications of the walls of the southern wing at the level of the 3<sup>rd</sup> and 4<sup>th</sup> storeys:

- 1 – wall face from about 1300, remodeled in around 1500, 2 – wall from about 1350, 3 – wall from about 1500, 4 – wall from about 1550–1600, 5 – wall from the end of the 18<sup>th</sup> or the 1<sup>st</sup> half of the 19<sup>th</sup> century, 6 – wall from the 2<sup>nd</sup> half of the 19<sup>th</sup> and 20<sup>th</sup> centuries, 7 – wall from the 21<sup>st</sup> century, 8 – negative of the wooden beam  
(elaborated by M. Chorowska, R. Biel)

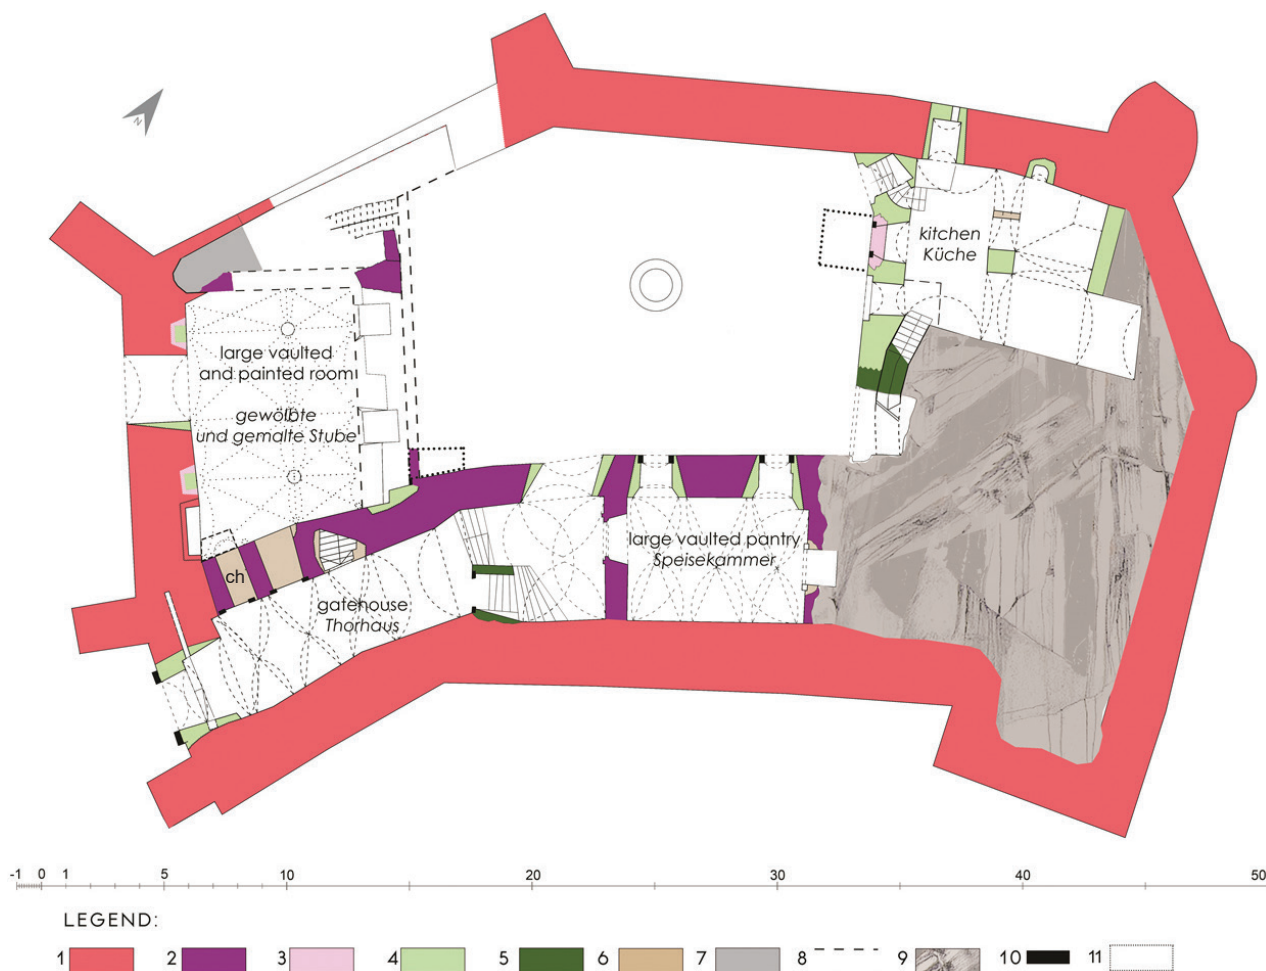
Fig. 4. Grodno Castle.

Chronological stratification of the walls of the upper castle on the ground floor level:

- 1 – in about 1300, 2 – in about 1350, 3 – in about 1500, 4 – the years 1550–1600, 5 – the years 1600–1700, 6 – years 1789–1850, 7 – years 1850–2010, 8 – reconstructed walls, 9 – rock, 10 – stonework, 11 – archaeological surveys, ch – chimney, kitchen chimney, furnace cavity; names of the rooms according to the urbarium from 1595 (elaborated by M. Chorowska, A. Gryglewska, A. Kubicka)

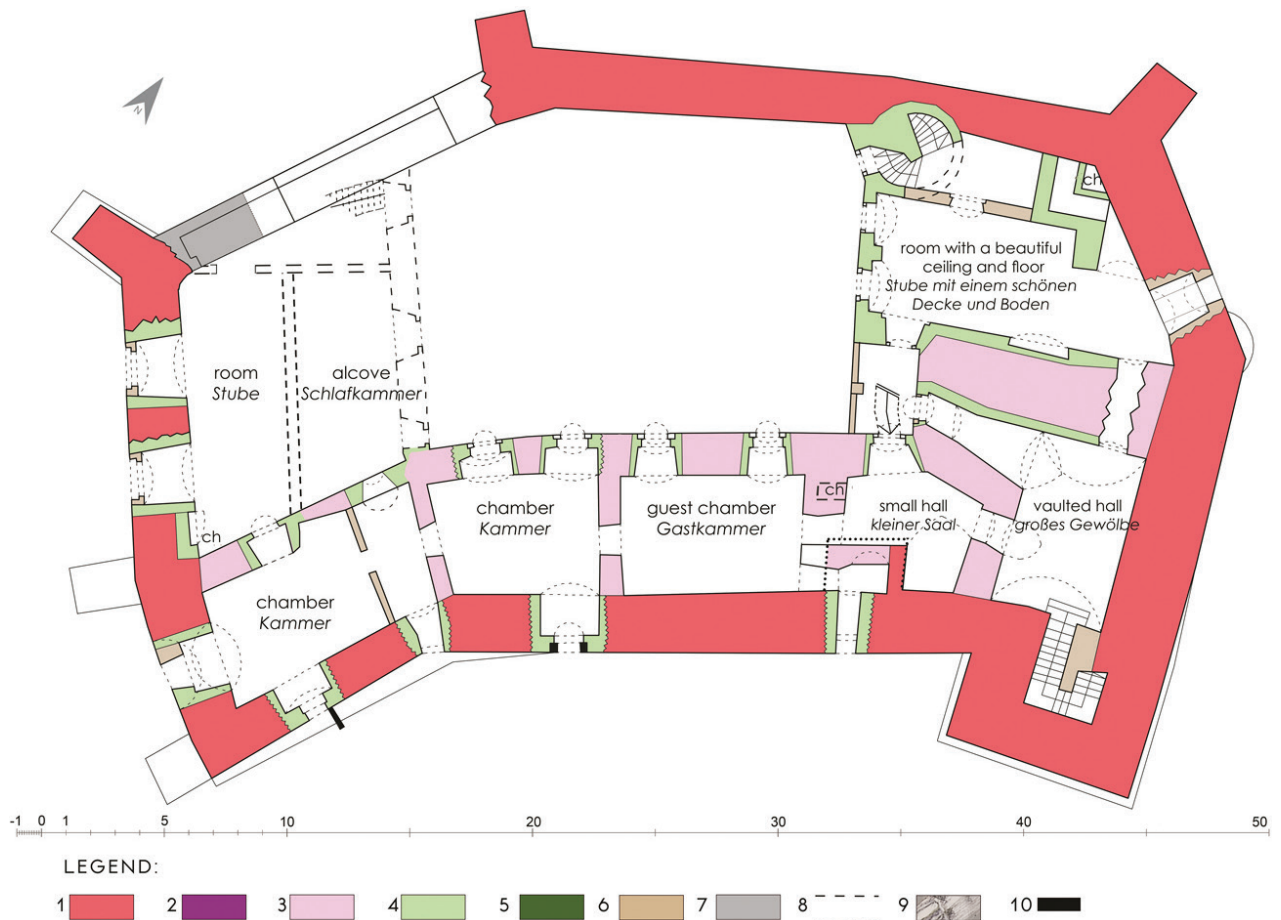
Fig. 5. Grodno Castle.

Chronological stratification of the walls of the upper castle on the 1<sup>st</sup> floor level:

1 – in about 1300, 2 – in about 1350, 3 – in about 1500, 4 – the years 1550–1600, 5 – the years 1600–1700, 6 – years 1789–1850, 7 – years 1850–2010, 8 – reconstructed walls, 9 – rock, 10 – stonework,

ch – chimney, kitchen chimney, furnace cavity; names of the rooms according to the urbanium from 1595

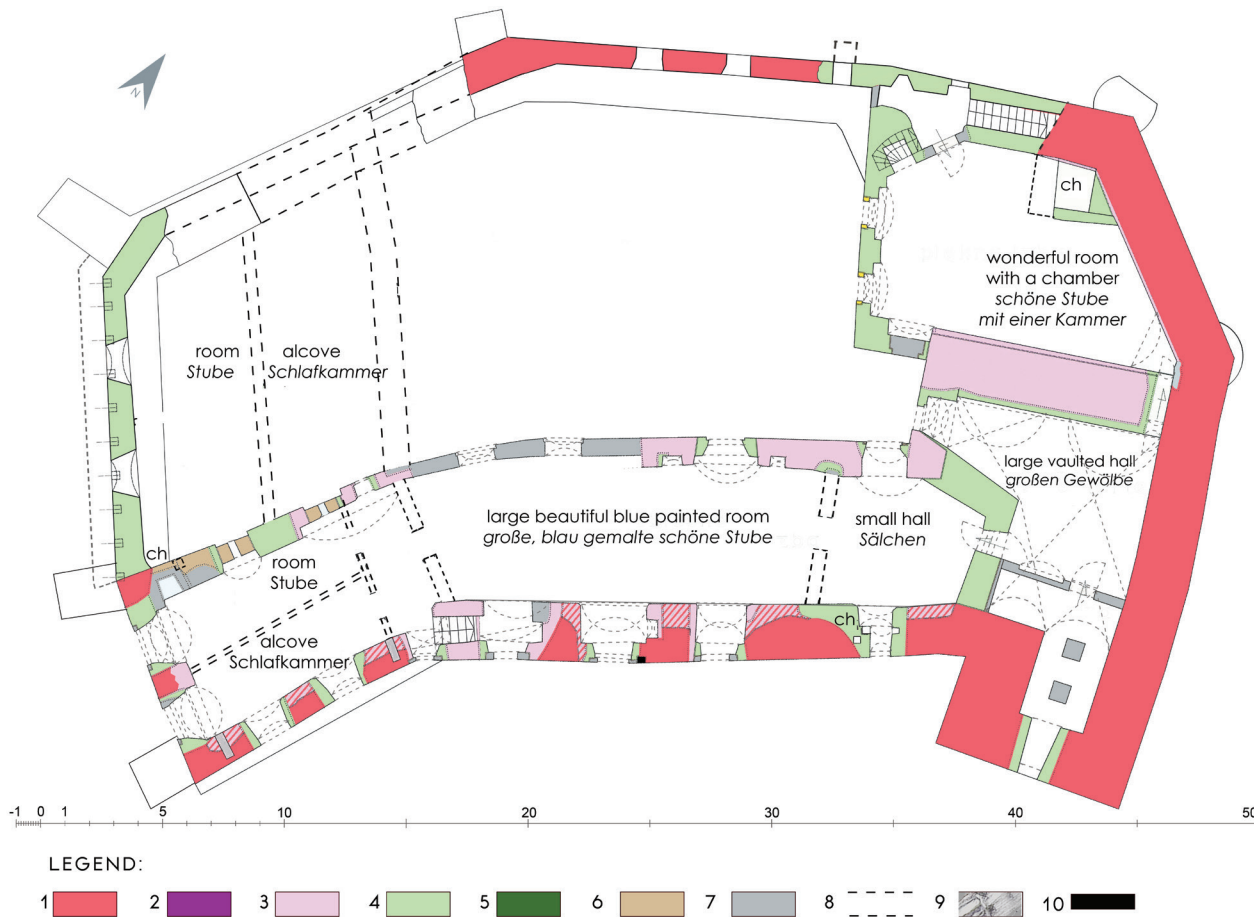
Fig. 6. Grodno Castle.

Chronological stratification of the walls of the upper castle on the 2<sup>nd</sup> floor level:  
 1 – in about 1300, 2 – in about 1350, 3 – in about 1500, 4 – the years 1550–1600,  
 5 – the years 1600–1700, 6 – years 1789–1850, 7 – years 1850–2010,

8 – reconstructed walls, 9 – rock, 10 – stonework,  
 ch – chimney, kitchen chimney, furnace cavity; names of the rooms according to the urbarium from 1595  
 (elaborated by M. Chorowska, A. Gryglewska, A. Kubicka)

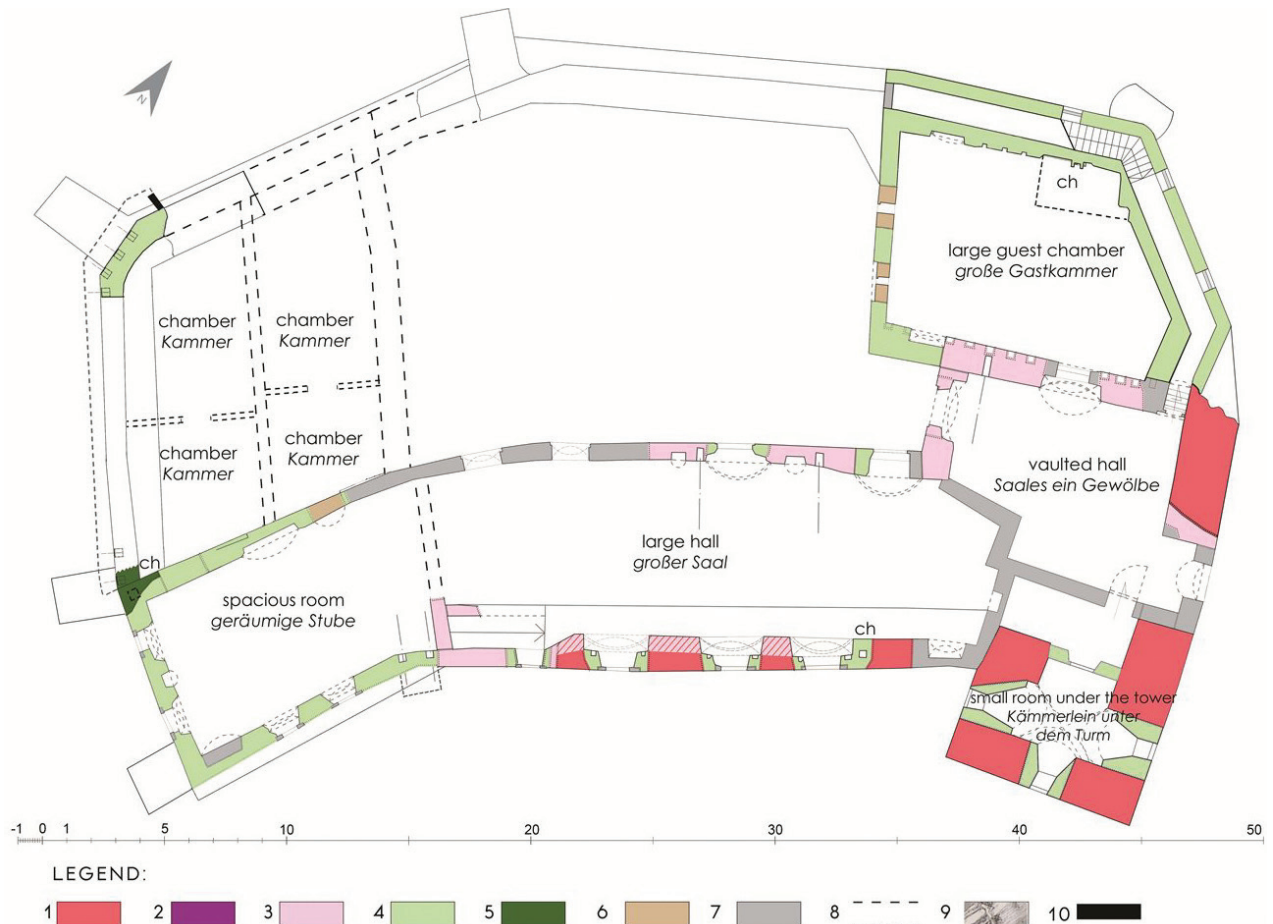
Fig. 7. Grodno Castle.

Chronological stratification of the walls of the upper castle on the 3<sup>rd</sup> floor level:

- 1 – in about 1300, 2 – in about 1350, 3 – in about 1500, 4 – the years 1550–1600, 5 – the years 1600–1700,  
 6 – years 1789–1850, 7 – years 1850–2010, 8 – reconstructed walls, 9 – rock, 10 – stonework,  
 ch – chimney, kitchen chimney, furnace cavity; names of the rooms according to the urbarium from 1595  
 (elaborated by M. Chorowska, A. Gryglewska, A. Kubicka)

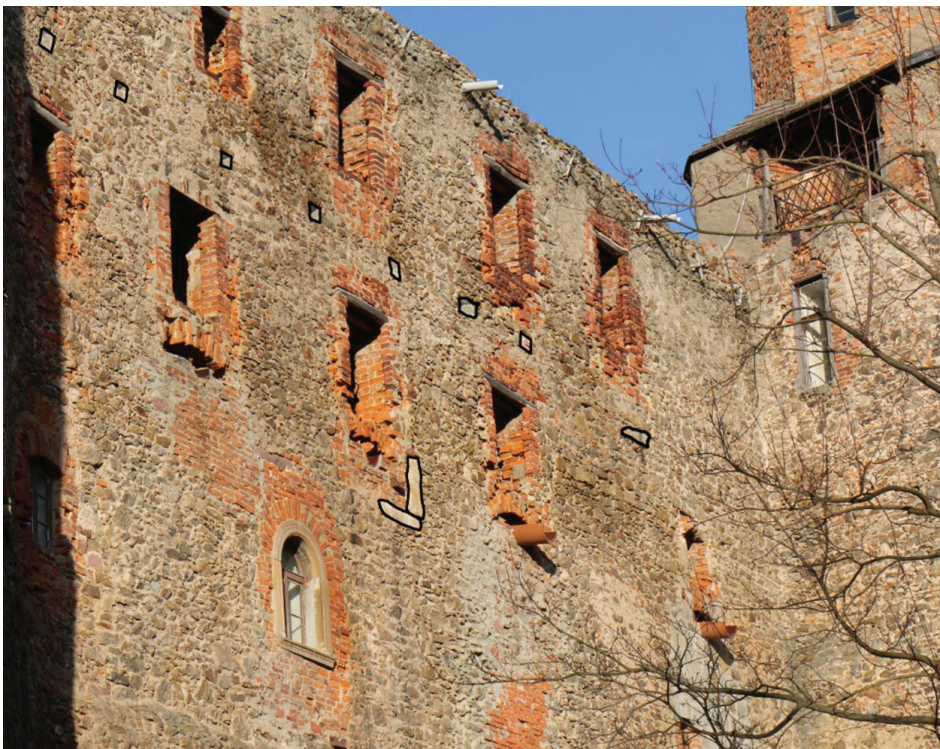
Fig. 8. Grodno Castle. View of the southern curtain of the perimeter wall. Nests of the cantilever beams of hoarding and relics of late gothic window stonework were outlined (photo by M. Chorowska)

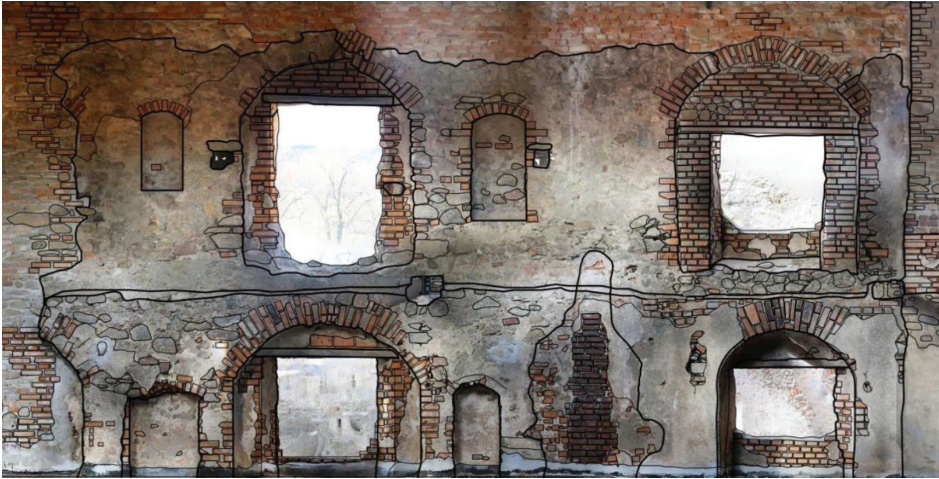
Fig. 13. Grodno Castle. Window openings, niches and nests in the northern wall of the southern wing, photo-scan outlined (elaborated by R. Biel)

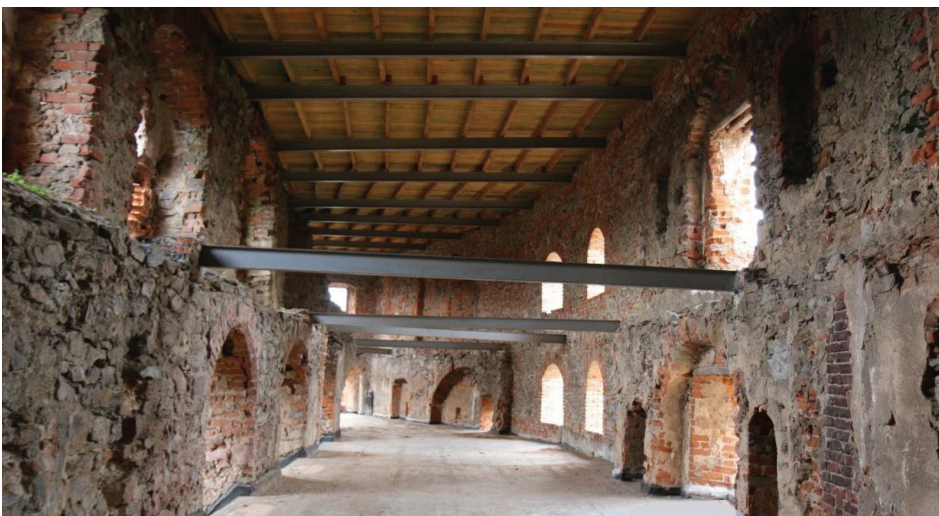
Fig. 14. The interior of the southern wing from the east, during construction works in 2019. To a large extent it corresponds to the lost knight's hall, which, like today, was of two storeys height (photo by M. Chorowska)

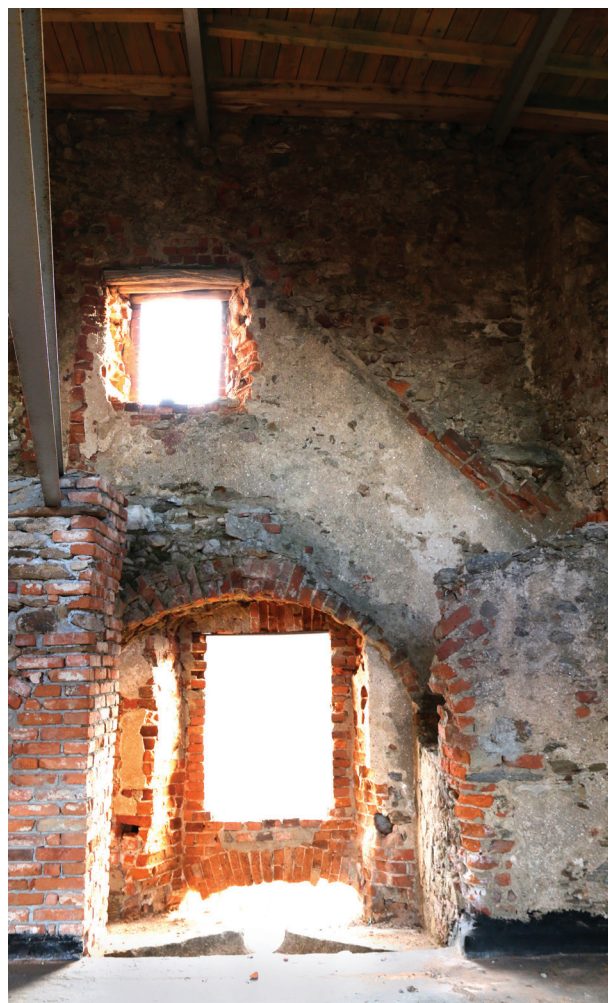
Fig. 15. Grodno Castle. The outline of plaster on the wall shows the flight of stairs leading to the porch (photo by M. Chorowska)

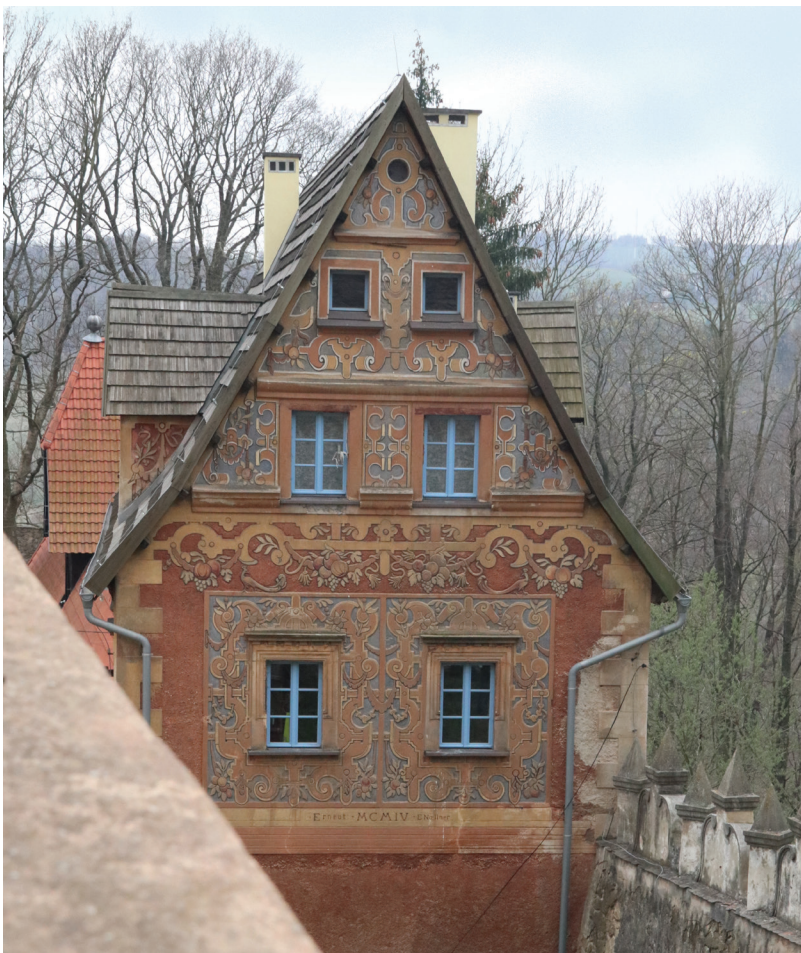
Zagórze Śląskie, Grodno Castle.  
The gate building of the lower castle  
from around 1570.  
View of the gable wall to the south-east  
(photo by A. Gryglewska, 2021)
