Roundel bastion fortifications of Grodno Castle in Zagórze Śląskie

Introduction

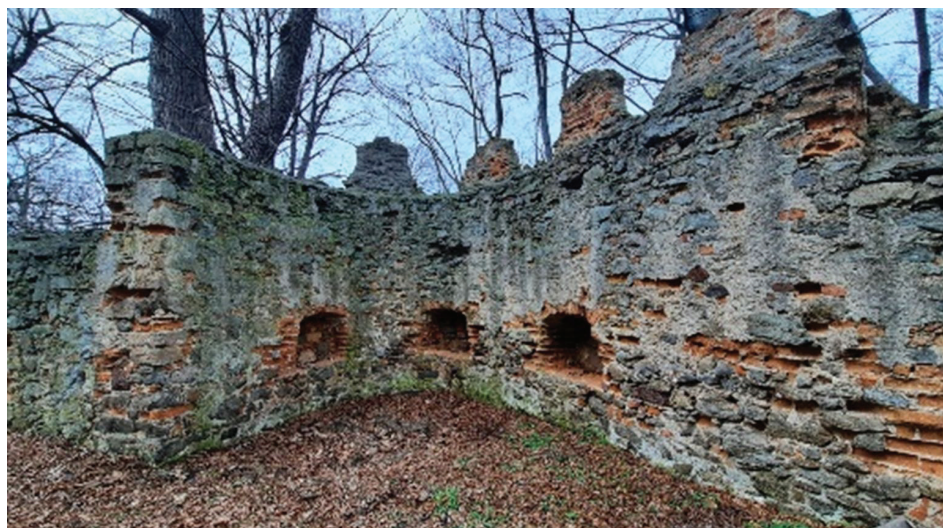
Fig. 5. The interior of roundel bastion No. 3 (photo by A. Chodkowska)

Roundel bastion No. 3 was directed asymmetrically in relation to the adjacent walls. Its eastern arm was slightly longer and smoothly changed into the further part of the defensive perimeter. On the western side, it was perpendicularly connected with the wall. This arrangement

provided defenders with an increased field of observation of the access road to the castle and the space in front of the gate. The shell probably had two utility levels. The first one was accessible from the contemporary ground level and was equipped with three brick key embrasures (Fig. 5). We can assume that there was the lower level due to the second line of embrasures, now bricked up and visible in its external face 2.5 m below the key embrasures. Their longitudinal shape and brick finish, as in the case of other embrasure openings, suggest that the roundel bastion was originally casemated. Its lower level was equipped with arrowslits. The course of vertical transportation between the levels is unknown. Only excavations works could explain it.

The negatives of wooden beams are visible above the embrasures of the upper level. Their location just below the preserved remnant of the Renaissance attic allows us to suppose that they had elements of the roofing structure which protected defenders against unfavorable weather conditions and against gunpowder getting damp⁶. The left internal corner of the roundel bastion was finished with sandstone dimension stones fitted into the stone wall.

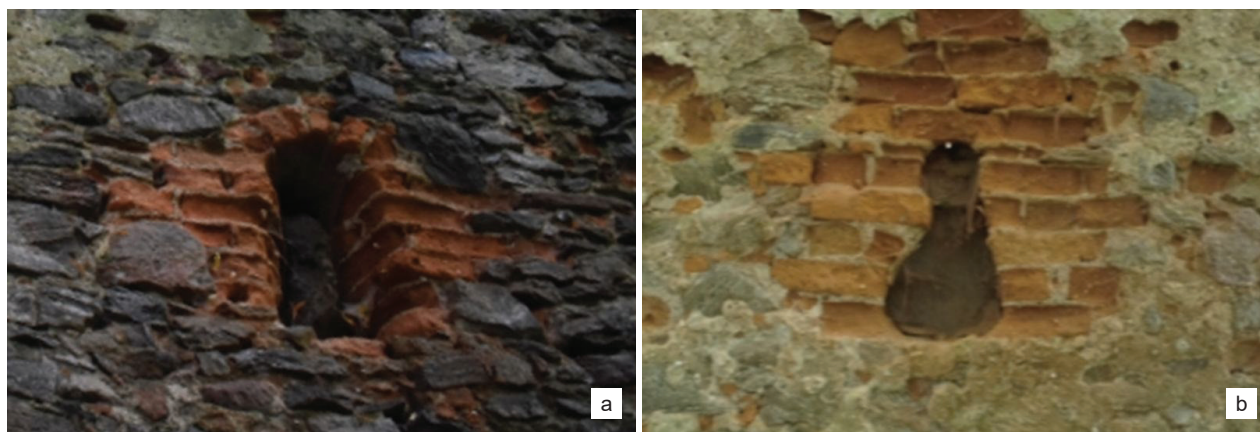
Fig. 7. Types of shooting holes in Grodno Castle: a) slit embrasure in the zwinger, b) keyhole embrasure of roundel bastion No. 3 (photo by A. Chodkowska, M. Bogdała)

Two types of shooting holes can be distinguished in the object, i.e., arrowslits and keyholes (Fig. 7). The first ones were narrow vertical slits splaying towards the interior of the building. These embrasures were very simple in their form – there are no remains of technological facilities which would make it possible to use conveniently, for
