Grodno Castle in the iconography from the 18th and 19th centuries

Introduction

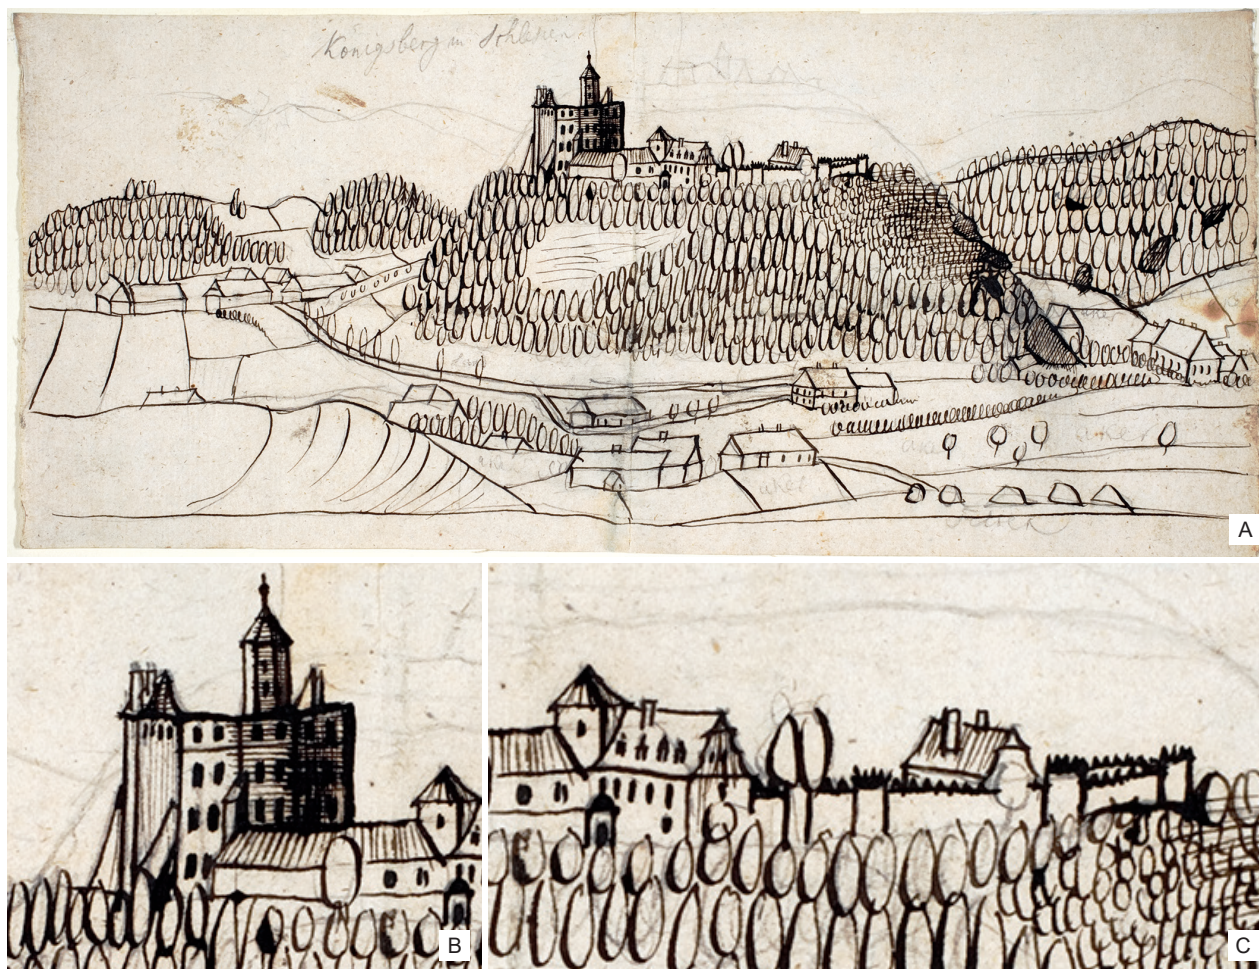
Fig. 1. *Königsberg in Schlesien*. A feather sketch of Grodno Castle at the end of the 18th century.

A. General view.

B. Close-up on the upper castle with two visible gables, i.e. one over the eastern wing, the other over the southern one. From the left, the fully preserved perimeter wall and to the right of it, the façades of the western and southern wings.

At the bottom, in the zwinger area, there is a long stable building.

C. Close-up on the lower castle. From the left: a chapel, a gatehouse and a bakery with a bathhouse.

The lower courtyard is surrounded by a modern wall with roundel bastions

Probably the oldest preserved image of Grodno Castle is a drawing from the resources of the German Herder-Institut für historische Ostmitteleuropaforschung (Fig. 1A), originally from the collection of Albrecht Haselbach (1892–1979), a brewer from Namysłów. It is a feather sketch showing the top of Choina Mountain along with the castle and buildings which were situated at the foot of the mountain. Unfortunately, neither the author nor the date of this sketch are known. The sketch presents the upper and lower castle. The upper castle (Fig. 1B) no longer has a roof, but two preserved gables are marked on it, i.e., one on the southern wing and the other one on the north-eastern wing. Moreover, on the north-eastern wing there are two protruding kitchen chimneys, the remains of which in the form of a broken chimney duct can still be seen up to the third storey of the wing. Interestingly, the sketch shows the perimeter wall which still existed in its entirety with a row of windows at the very top of it, perhaps adjacent to the battle porch from the other side. Since it is already collapsed in subsequent graphics, it suggests that we are dealing with the oldest graphics from the entire iconography of Grodno collected so far. The perspective in which the upper castle was presented is distorted – to the right of the perimeter wall we can see the external wall of the western wing adjacent to it (still existing today) and then two walls of the southern wing. Under the buildings of the upper castle, in the zwinger area, there is a long building or a fragment of the external wall covered with a roof. In the 19th century, it was probably demolished during numerous works carried out at that time. Both Johann G. Büsching [2] and Heinrich Schubert [3] describe these buildings as stables (German: *Stall*). Among the buildings of the lower castle (Fig. 1C), we can easily see the gatehouse, the chapel, and the building which was described

in the urbarium from 1595 as a bakery with a bathhouse. In Büsching's study, on the plan of the castle this place is described as an old bakery (German: *altes Backhaus*), whereas Schubert locates a bathhouse (German: *Badhaus*) here. Moreover, the entire lower courtyard where the above mentioned buildings are situated, is surrounded by an early modern wall with roundel bastions. At the top of the drawing, the sketch title is added by hand in pencil, i.e., *Königsberg in Schlesien*. Perhaps it is a signature written by Haselbach himself, who thus entitled the work in his collection for the sake of clarity.

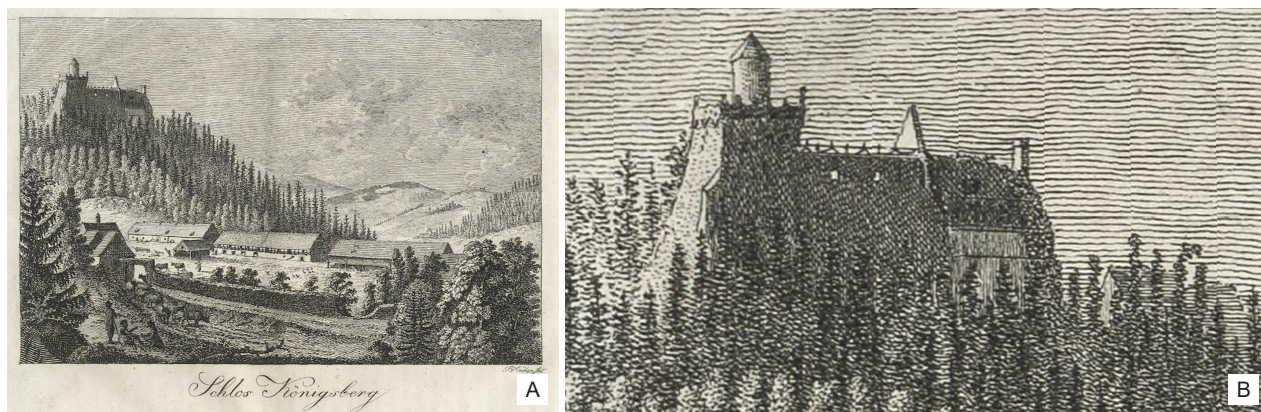
Fig. 2. *Schlos Königsberg*. Etching of Grodno Castle from the end of the 18th century.

A. General view. B. Close-up on the upper castle. We can see the tower, the eastern wing with attics in front of it, and to the right of it, the long southern wing with the preserved gable in the center, attics and the chimney in the corner (drawing by F.G. Endler, source: Śląska Biblioteka Cyfrowa, ref. number 461652 I)

Endler (Fig. 2A). He was one of the most prolific artists at the turn of the 19th century, who immortalized the appearance of the then Silesian villages and towns by means of his works [4]. Endler specialized primarily in capturing landscapes, in which he showed buildings surrounded by idyllic nature and mountain landscapes. It is similar in the case of the etching depicting Grodno Castle. The castle itself – contrary to the title – is not the main motive of the work, but rather it is shown as a component of the mountain scenery suspended over the buildings of the village of Schenkendorf (formerly Mysłęcín, today part of Zagórze Śląskie). Nevertheless, Grodno is depicted quite faithfully. Endler's graphic presents a view of the upper castle

from the northern side (Fig. 2B). It shows the tower, eastern and long southern wings of the upper castle. On the southern wing, we can see a clearly preserved gable as well as a chimney in the western corner of this wing. The most intriguing part is the attic which is marked on the southern wing because it does not appear in other graphics and has not been preserved either. It is difficult to say whether it was the author's over-interpretation or whether the attic was actually in this place. The eastern wing is also surrounded by an attic (preserved to present day) with a delicately marked gable on the right side (presented from the side and slightly higher than the attic itself). The perimeter wall seems to be partially collapsed, however, it still has two little windows which were formerly adjacent to the battle porch. On the right side of the upper castle, the roof of the gatehouse emerges from above the trees. The presented etching by Endler was published in periodical "Vaterländische Blätter zum Nutzen und Vergnügen für das Jahr 1798" in 1798. There was a caption at the bottom of the graphic: *Schlos Königsberg*.

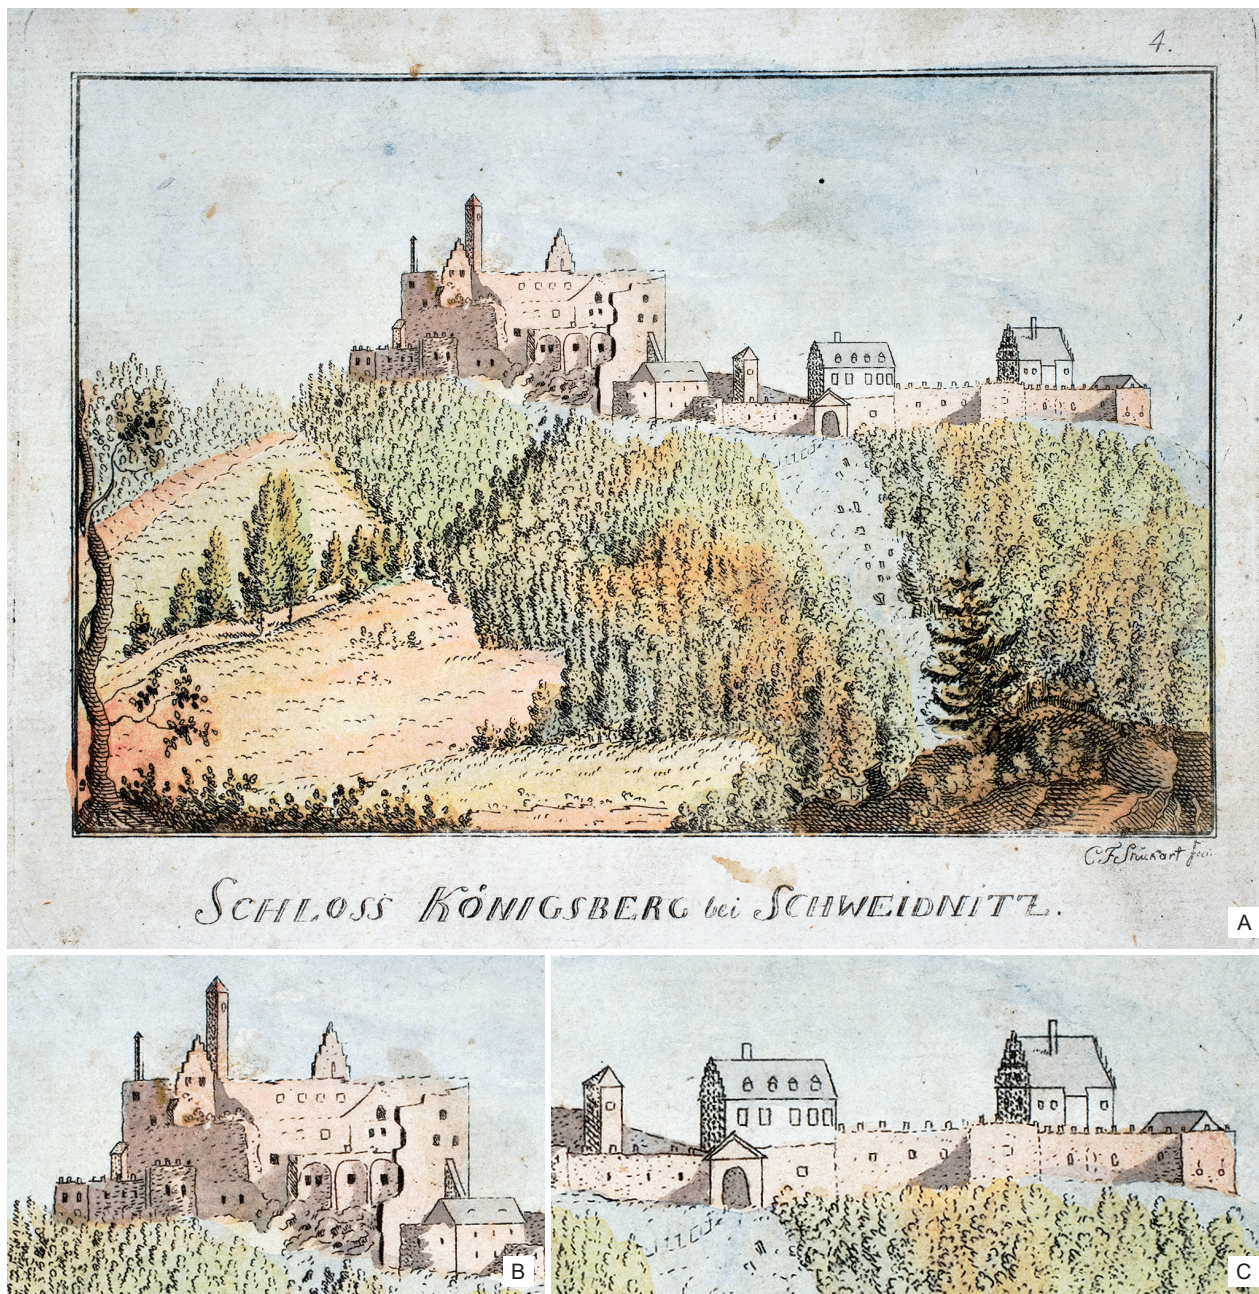
Fig. 3. *Schloss Königsberg bei Schweidnitz*. Etching of Grodno Castle from 1812.

A. General view.

B. Close-up on the upper castle. From the left: eastern and southern wings and the collapsed western wing.

On the southern and eastern wings, two preserved gables are visible.

In the west wing, however, we can see the remains of the vault of the room on the ground floor.

The perimeter wall is collapsed. The modern roundel bastion wall looks incomplete as well.

On the right, in the zwinger area there is a stable building.

C. Close-up on the lower castle. From the left: the chapel, the gatehouse with an entrance portal, the bakery building with the bathhouse.

The lower courtyard is surrounded by the wall with roundel bastions.

At the end, the roof of the old shed rises above the wall

Further iconography of Grodno Castle, which was collected as a result of the query, dates back to the beginnings of the 19th century. Among the early 19th-century graphics of Grodno, the colored etching by Carl Friedrich Stuckart from 1812 is particularly interesting (Fig. 3A). It shows the buildings of the upper and lower castle. It is the first graphic which shows the entire castle in close-up. The etching is rich in details, although as for the proportions of some elements, e.g., the tower, one can have considerable reservations. In the upper castle (Fig. 3B), similarly to the previous graphics, there are two preserved gables on the eastern and southern wings. Additionally, in the eastern wing we can see a chimney duct. The western wing is

collapsed and more similar to the present state, whereas through the collapsed perimeter wall we can see arches which can be identified with the remains of the vault of the room which was formerly situated at the level of the upper courtyard. A novelty is the incomplete early modern roundel bastion wall with which the upper castle was protected from the northern and western sides. Along the roundel bastion wall, on the right, in the zwinger area, we can see the stable building which was also presented in the earlier and oldest graphics. The lower castle (Fig. 3C) does not differ from the older iconography either. Among the buildings, we can distinguish, among other things, the chapel, the gatehouse and the bakery with the bathhouse. The entire lower courtyard is surrounded by the wall with roundel bastions. At the very end, the roof of a low building protrudes above the wall, which Büsching and Schubert describe as an old shed (German: *alter Schuppen*). At the bottom of the graphic the following caption is placed: *SCHLOSS KÖNIGSBERG bei SCHWEIDNITZ*. The etching also comes from the collection of the aforementioned Albrecht Haselbach.

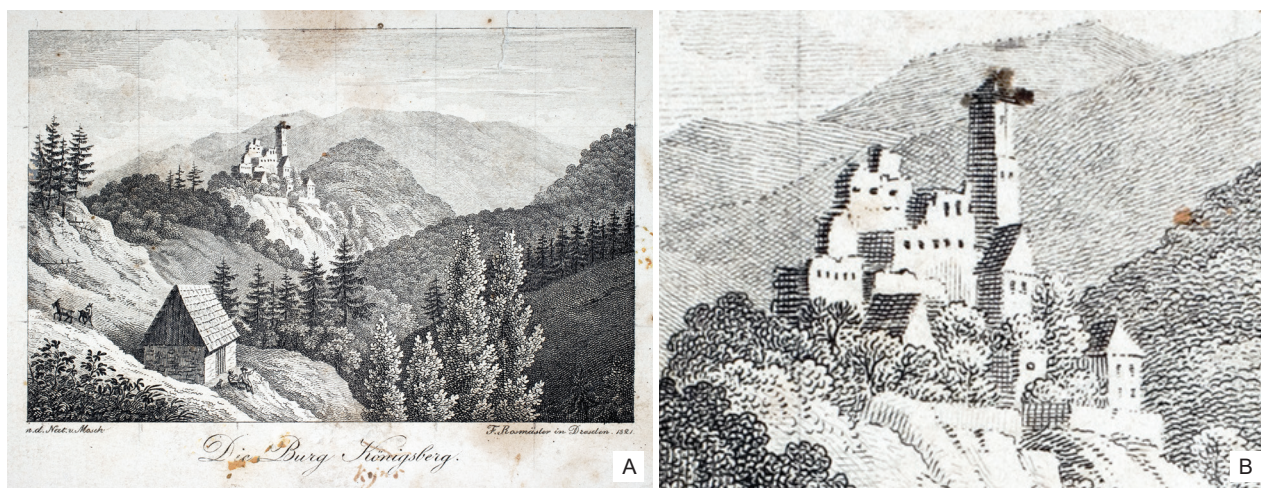
Fig. 4. *Die Burg Königsberg*. The etching of Grodno Castle from 1821.

A. General view. B. Close-up on the castle buildings. From the bottom: the early modern wall with roundel bastions, the bakery building with the bathhouse, the chapel and the ruins of the upper castle with the tower.

Below the upper castle, above the trees, the roof and the gable of the gatehouse protrude above the trees (drawing by C.F. Mosch, published by F. Rossmäßler, source: The Kunstforum Ostdeutsche Galerei in Regensburg, Herder-Institut für historische Ostmitteleuropaforschung, ref. number P 2510)

Another graphic in which Grodno Castle is presented against the background of the mountain landscape is the etching by Carl Friedrich Mosch and Friedrich Rossmäßler (Fig. 4A). The graphic follows the contemporary trend of showing nature. The mountainous landscape is highly exaggerated, fanciful, slightly soaring, and different from its actual appearance. Taking a closer look at the castle itself (Fig. 4B), we can see the previously described buildings, i.e., in the foreground there is an early modern wall with roundel bastions, the bakery building with the bathhouse, the gatehouse, the chapel and the ruins of the upper castle with a tower. At the bottom of the graphic there is the caption: *Die Burg Königsberg*.

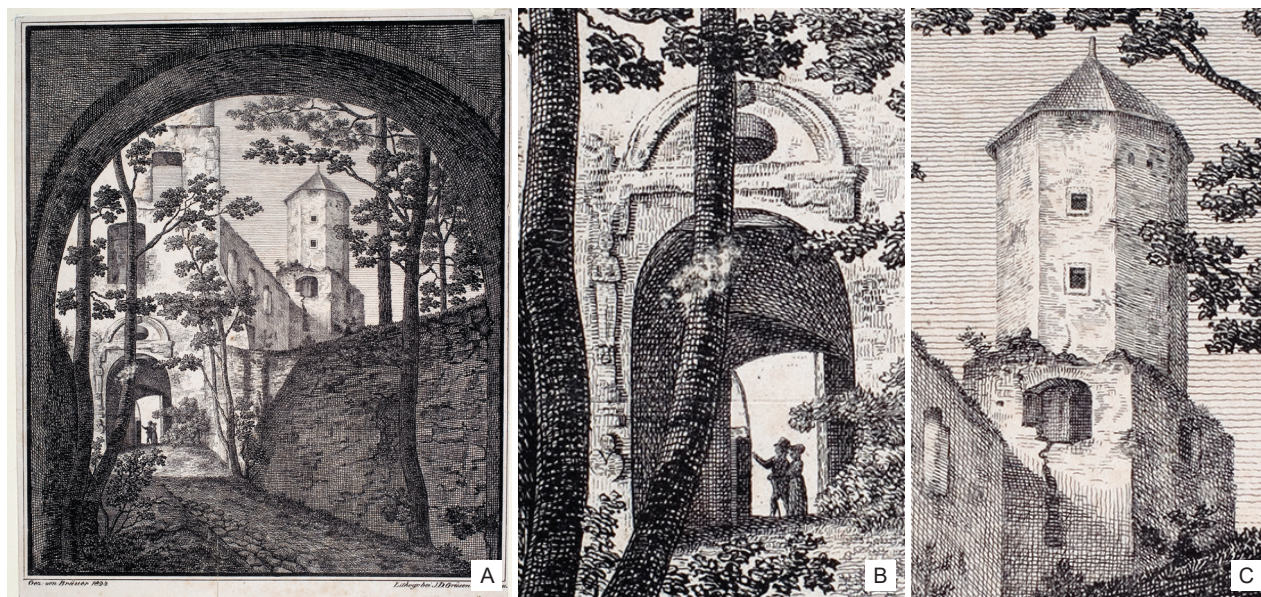
Fig. 5. *Burg Kinsberg in Schlesien*. Lithograph showing the entrance to the upper castle hall from 1824.

A. General view. B. Close-up on the portal leading to the upper castle hall. C. Castle tower
(drawing by K. Bräuer, published by J.D. Grüson, source: The Kunstforum Ostdeutsche Galerie in Regensburg, Herder-Institut für historische Ostmitteleuropaforschung, ref. number P 2740)

copula (still visible in a lithograph from 1824) in favor of the viewing platform. This proves the fact that the castle was slowly adapted to tourist purposes. Similarly, from the side of Silesian Valley, the castle is shown in the well-known lithography by Ludwig Eduard Lütke from around 1850 (Fig. 6).

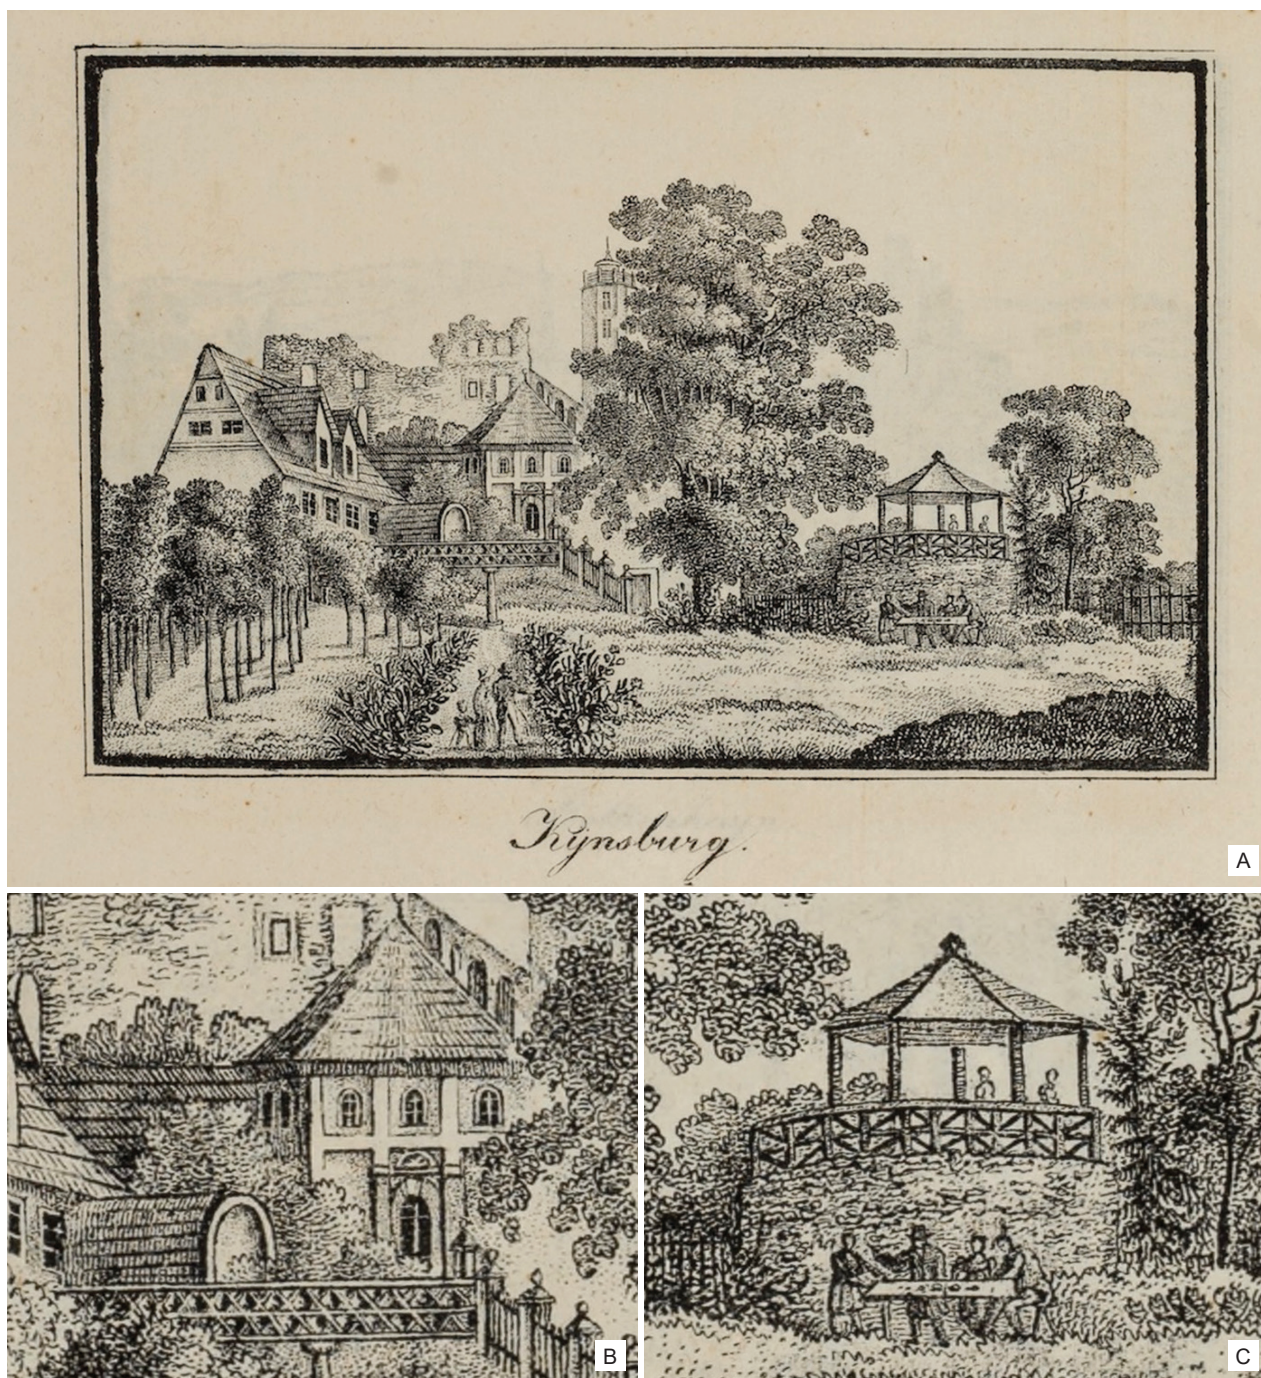
Fig. 7. Kjnsburg. Grodno Castle presented from the side of the lower courtyard. A. General view.

B. The castle chapel still in the baroque style. Below there is an outline of the Renaissance portal. On the left, there is a bridge entrance to the gatehouse through the porch which no longer exists. C. Eastern roundel bastion which was adapted to a scenic viewpoint (drawing C.T. Mattis, source: Śląska Biblioteka Cyfrowa, ref. number 410172)

In the 19th century a rapid development of tourism took place in the Sudetes. Grodno Castle became one of the most popular tourist attractions in the region. It was eagerly visited by patients residing in nearby spas. In 1860, Grodno appears as one of the attractions in the illustrated guide to Szczawno-Zdrój [5], where there is a lithograph by Carl Theodor Mattis showing the castle from the side of the lower courtyard (Fig. 7A). At the bottom of the lithograph there is the caption: *Kjynsburg*. The graphic itself was probably made by Mattis much earlier because it still presents the castle chapel in the baroque form (Fig. 7B). Attention should be paid to the progressive changes taking place within the castle buildings, whose purpose was to adapt the monument to the needs of tourists. Typical farm buildings disappeared from the lower courtyard and zwinger and purely tourist structures appeared. The bakery (bathhouse) was dismantled. One of the roundel bastions (eastern) was built over with a gazebo and adapted as a scenic viewpoint (Fig. 7C). A platform secured with railings appeared on the viewing tower. During the next decades of the 19th century, further changes, which were immortalized in subsequent 19th-century lithographs, took place in the lower courtyard. One of them is a graphic by Ferdinand Koska which was published in the years 1848–1856 (Fig. 8A). We can see the castle from the scenic viewpoint in the lower courtyard. The lush gardens which were previously established by Büsching attract attention. In the background, we see the castle chapel remodeled in the neo-Gothic style (Fig. 8B). At the top of the lithograph the following inscription can be found: *Schlesisches Album*, at the bottom: *Burg Kjynau*.

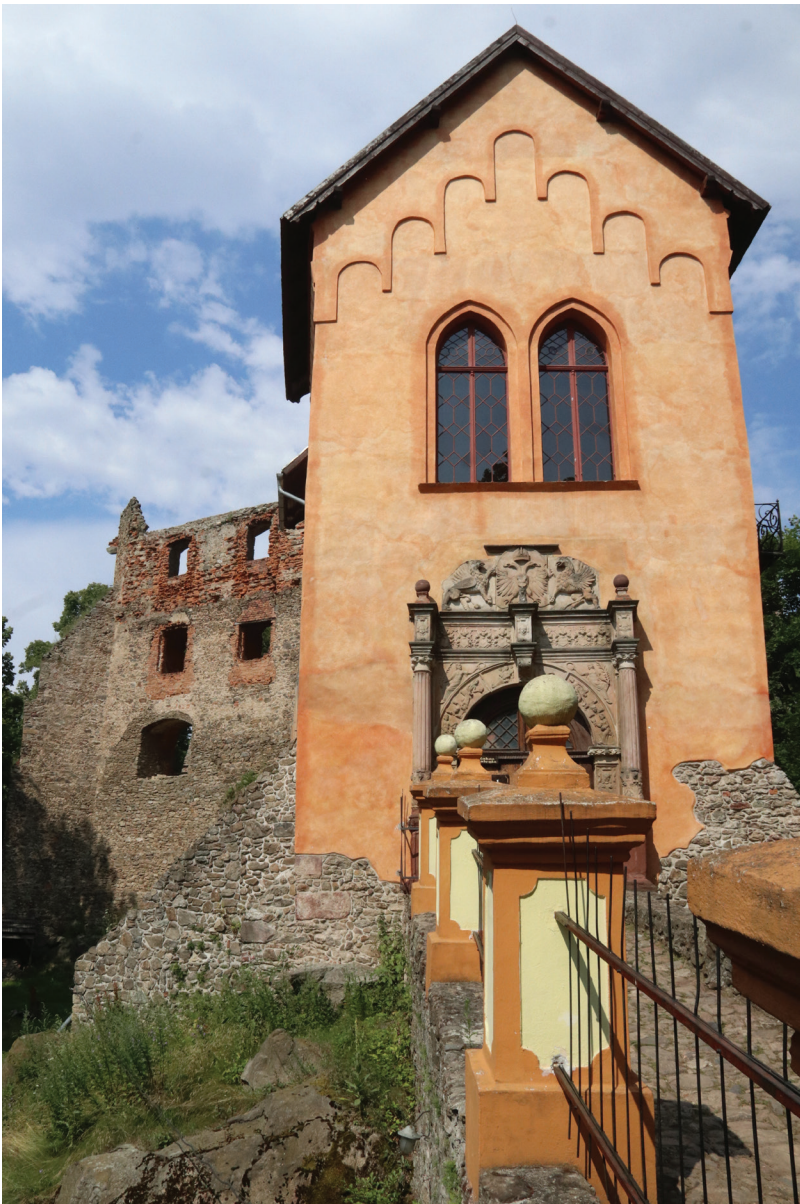
Zagórze Śląskie, Grodno Castle.
Foregate of the upper castle
after the neo-Gothic reconstruction
in the mid-19th century.
View from the south-west
(photo by A. Gryglewska, 2021)
Zagórze Śląskie, zamek Grodno.
Przedbramie górnego zamku
po neogotyckiej przebudowie
w połowie XIX w.
Widok od południowego zachodu
(fot. A. Gryglewska, 2021)
