# CONDITIONS OF PROPER INTERACTION OF LOW-PRESSURE INJECTION PILES (LIP) WITH STRUCTURE AND SOIL, CARRYING CAPACITY OF PILE ANCHORAGE IN FOUNDATION

HENRYK PACHLA

*Key words:* low-pressure injection piles, pile anchorage in foundation, contact surface, foundation design

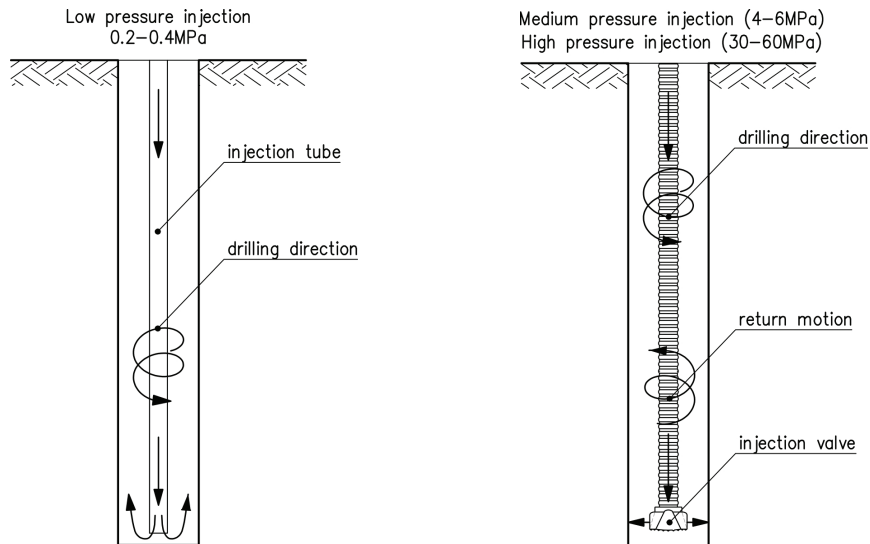
Fig. 1a. Diagram of low pressure injection Fig. 1b. Diagram of medium and high pressure injection

Low-pressure injection piles are classified into the group of piles in which the building material is grout pumped under pressure to the borehole. Injection piles are drilled piles of diameters not exceeding 25 cm. 15 to 20 cm diameter piles are formed most often. Cement grout is a widely applied type of grout, which is pumped under pressure of several atmospheres to the bottom of the borehole at the same direction of drilling (Fig. 1a). Injection piles are also formed under pressure perpendicular to the drilling direction (Fig. 1b). This group of piles includes medium-pressure piles formed under pressure of several dozen atmospheres (e.g., Titan piles) and high-pressure piles formed under pressure of several hundred atmospheres. Depending on pressure magnitude the diameters of these piles (columns) can be very large. Due to torsional grouting (return motion upward) the pile is partly or fully a mixture of grout and soil. The term “micropile”,

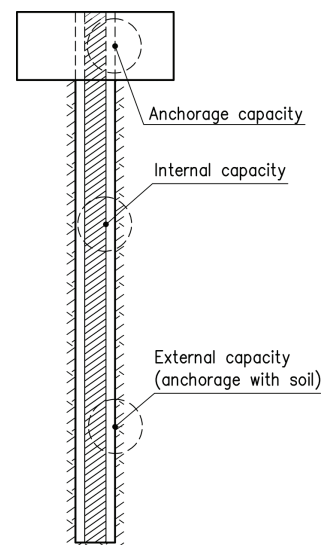
Fig. 2. Foundation-pile-soil connection surface

The ability to transfer loads to soil by foundation-pile-soil structure is determined by the interaction between these three elements (Fig. 2). For low-injection piles each of these elements is made of different material. The amount of load which can be applied is determined by the interaction of these elements. First, it is the interaction between foundation and pile, often called pile anchorage. In this case the bonding between the material of which the foundation is made and the grout which forms the pile.

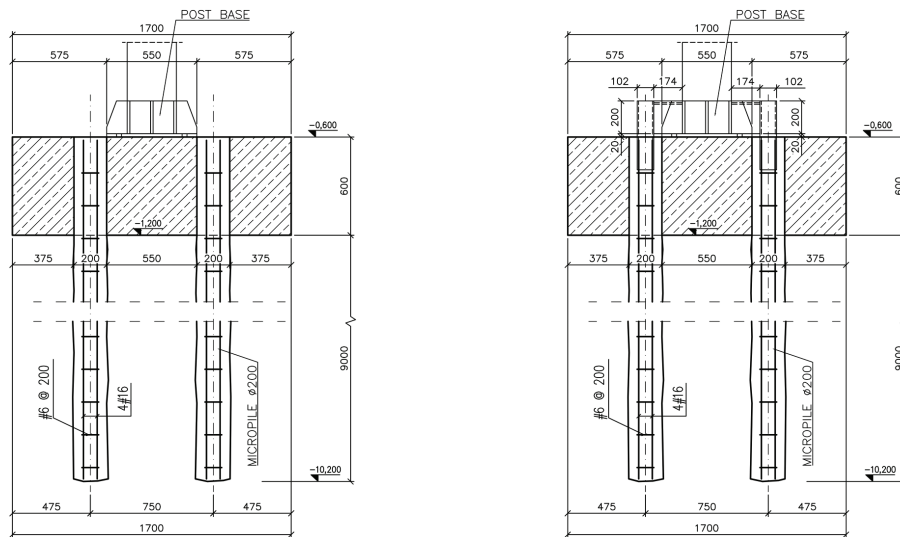
Fig. 3a. Alternative pile anchorage in foundation Fig. 3b. Pile anchorage in post through steel construction [6]

The first tests were conducted in 2011 [2] in order to verify the effectiveness of such a connection used alternatively to strengthen the foundations of the IKEA store in Cracow (Fig. 3a). Fig. 3b shows the original project – the pile was anchored directly in the column.

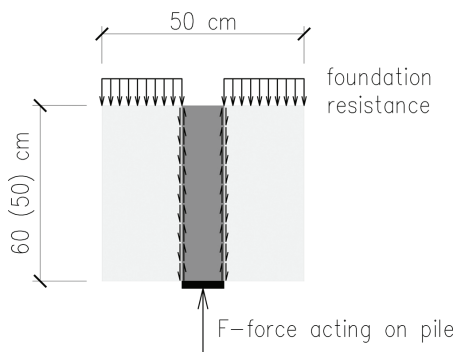
Fig. 4. Loading of specimens

As in previous experiments the loading scheme was adopted as shown in Fig. 4. Load was applied until pile-foundation adhesion loss. Apart from the measurement of load and displacement (axial displacement of jack piston) measurements were taken of displacements at fixed bases as shown in the schematic diagram below (Fig. 5).

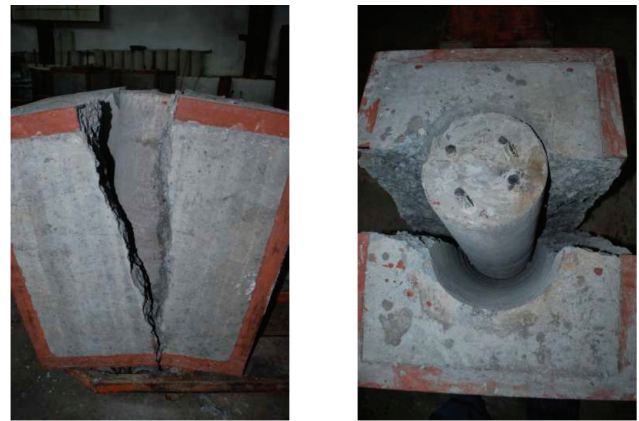
Photo 2. Form of specimens failure

The form of damage was the same in all seventy specimens. In Photo 1, cracking of a specimen and pile dislocation are shown after the load reached the value which caused pulling the pile out of specimen. Photo 2 presents the form of damage after the reinforcement is

split. The adhesion on the contact surface is totally lost. The separated pile rests loose in the specimen hole. In none of the specimens was the pile failure observed. The growth of positive transverse strains in the pile pushed into the specimen causes a positive strain state in the concrete part of the specimen. After the positive strain in concrete reaches the limit value, failure of test-piece modelled foundation is observed.

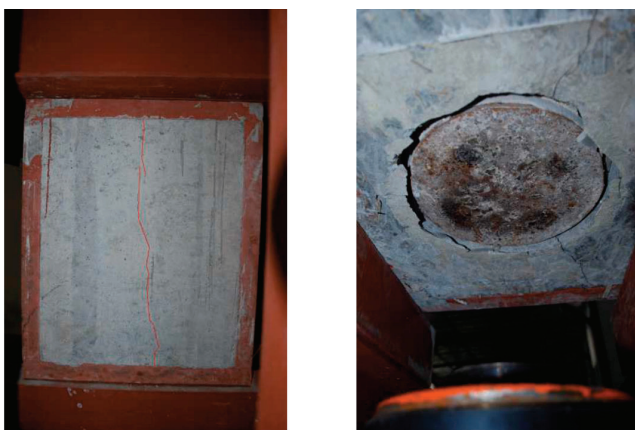
Photo 1. Specimen cracking and pulling the pile out of specimen

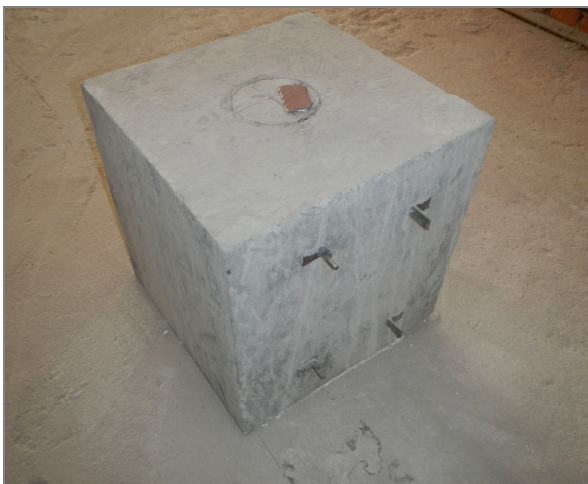
Photo 3. Specimen modelling foundation made of concrete

concrete class C12/15 which was delivered from a concrete plant. In both concrete and masonry specimens, after curing 150 mm-diameter holes were drilled (Photos 3, 4). Piles of this diameter are commonly used to strengthen the foundation, hence this hole diameter was selected. In drilled holes, piles were formed. Inside the holes piles reinforced with four bars 14 mm in diameter were installed. Round plain steel stirrups 6 mm in diameter were spaced every 20 cm. The piles were made from cement grout of w/c ratio of 0.5, on the base of cement CEM II/B-M(V-LL)32,5 R, from Rudniki cement factory.

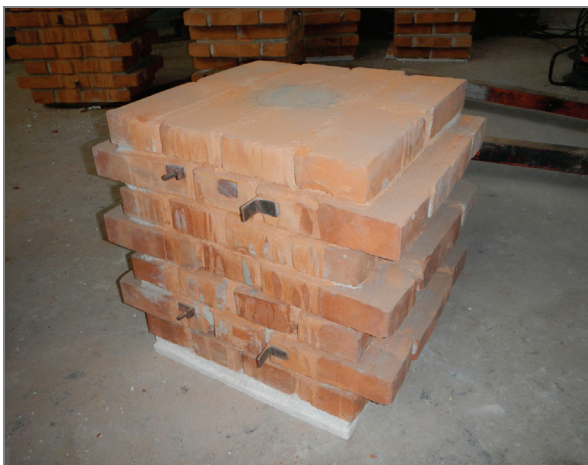
Photo 4. Specimen modelling foundation made from brick

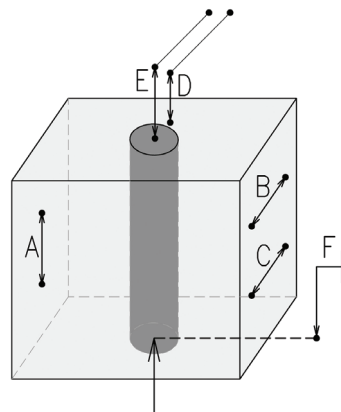
Fig. 5. Location of displacement sensors

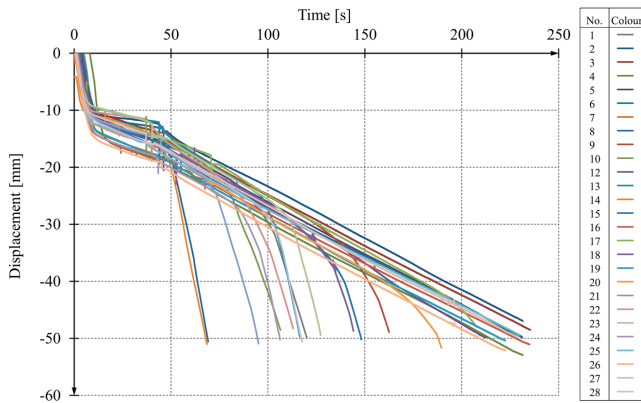
Fig. 6a. Changes of displacements of pile heads in selected concrete specimens

Failure propagation process, and in consequence macrocracks and failure of elements made of brittle materials such as concrete, brick, mortar and grout are highly dependent on the loading application program. In the tests, loads were applied using hydraulic jacks with a given initial velocity of the piston. Different resistances of specimens and characteristics of hydraulic jacks used in experiments accounted for the displacements of the pile head. The displacements of pile heads measured during the tests on individual concrete specimens are shown in Fig. 6a. Figure 6b illustrates real displacements of piles heads for five selected specimens modelling brick foundation.

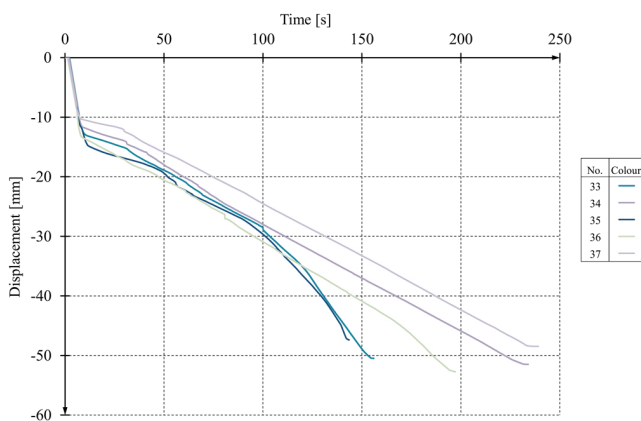
Fig. 6b. Changes of displacements of piles heads in brick specimens

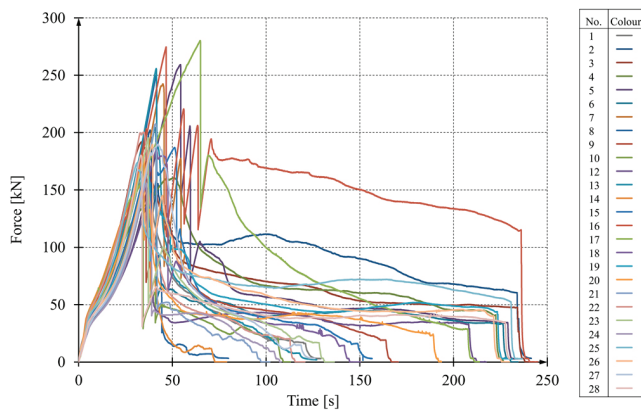
Fig. 7. Changes of load transferred by pile-concrete specimen anchorage

Such displacements of pile heads were accompanied by time variable loads controlled by the resistance on the pile-foundation contact surface. For concrete specimens this relationship is shown in Fig. 7 and for brick specimens in Fig. 8. The same nature of the process is clearly seen.

The obtained results indicate that at the initial stage of load application linear and similar to each other increments of load occur in all specimens. The first microcracks in the contact area, accompanied by acoustic effects, are followed by a decrease of load increment rate. The curves diverge and a scatter of results increases. The field of microcracks intensifies and spreads over an increasing large space. Diver-

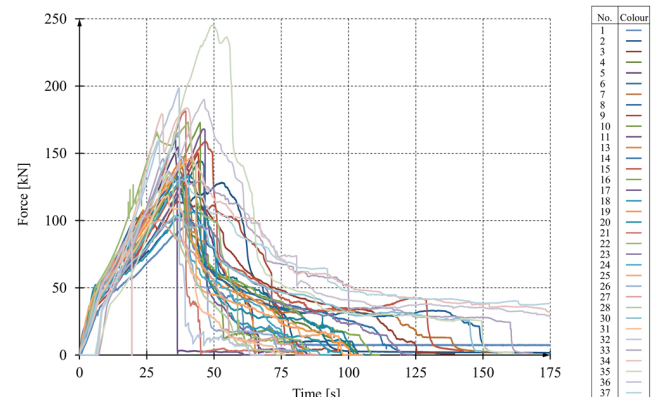
Fig. 8. Changes of load transferred by pile-brick specimen anchorage

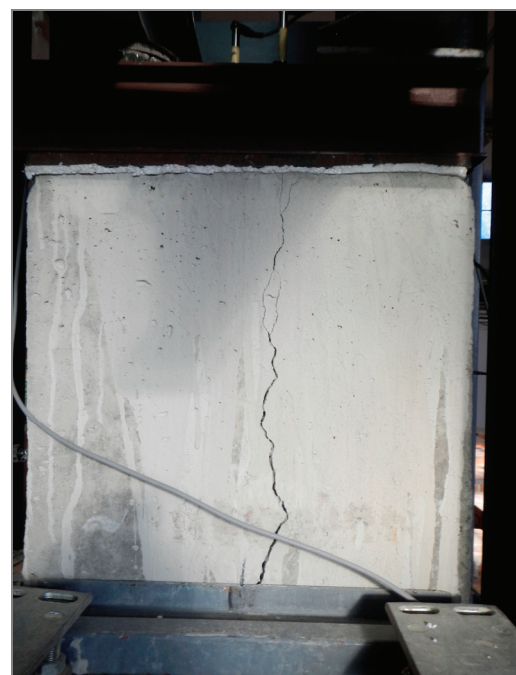
Photo 5. Macrocracks at final stage of force application observed in foundation specimen made of concrete

The final effect is the formation of macrocracks and fractures observed on the external surfaces of specimens (Photos 5, 6). The load that can be transferred by the contact surface begins to drop violently. At this stage the scatter of the test results is the highest. This state is basically affected by non-uniform propagation of microdamage. Both microcracks propagation rate and their distribution in the area tested are different in particular specimens. Deformation process on the contact surface is illustrated in Figs. 9, 10 in which simultaneous distribution of force together with pile and foundation displace-

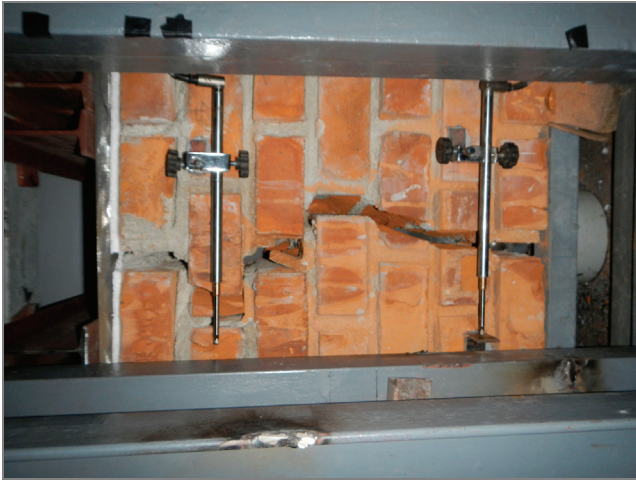
Photo 6. Macrocracks at final stage of force application observed in foundation specimen made of bricks

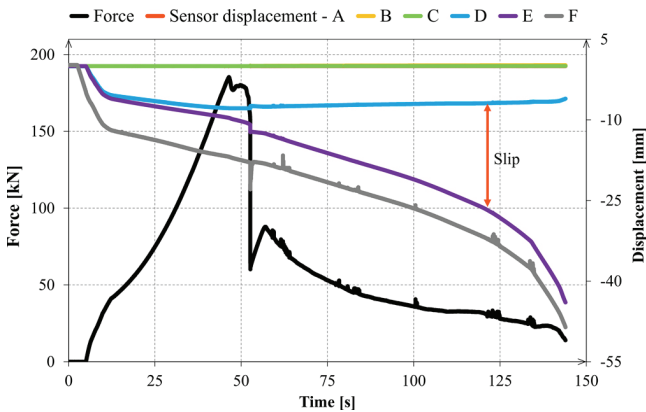
Fig. 9. Changes of displacements in a selected concrete specimen

ments on the contact surface are shown for selected concrete and brick specimens. At the initial stage the displacement of loaded pile head (curve F in Fig. 9) increases faster than the displacement of its free end (curve E). The pile is shortened and as a result its diameter enlarges. The damage process of the connection begins and the difference between the displacements of the pile free end (curve E) and corresponding surface of the specimen modelling foundation (curve D) widens. This difference indicates a slip on the contact surface of the two materials, i.e., concrete and grout of the pile in Fig 9 and masonry wall and grout in Fig. 10. As the slip increases, pile relaxation is observed and the difference between the values on curves E and F decreases.

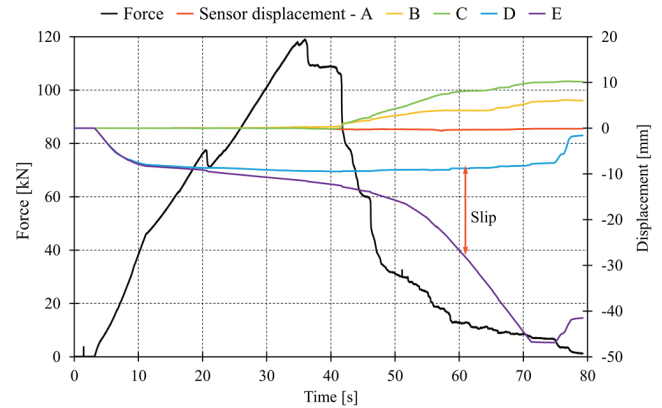
Fig. 10. Changes of displacements in a selected brick specimen

The further from the contact surface the smaller the deformation of specimens. The sensors fixed on specimens external surfaces did not detect any important changes. Only the sensors through whose base passed the surface destroying specimens indicated

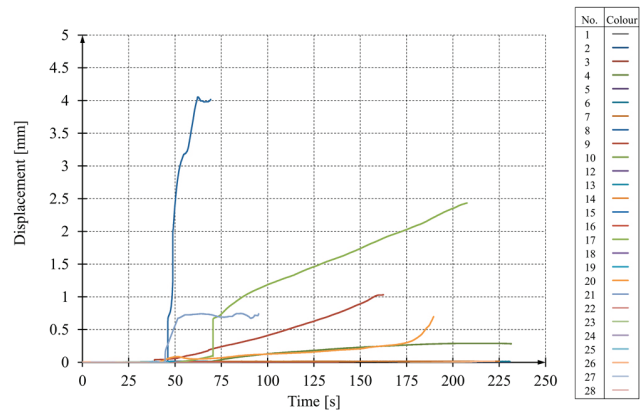
Fig. 11a. Changes of displacements measured on base B (Fig. 5)

a rapid increase of displacement values. In Figs. 11a and 11b, changes of displacements of concrete specimens are compared, when the crack damaging a sample was located in the sensor base. The form of failure for all specimens remained the same. The foundation part cracked and the pile was pulled out of the specimen. Photo 7 illustrates the results for concrete foundation, Photo 8 the results for masonry foundation.

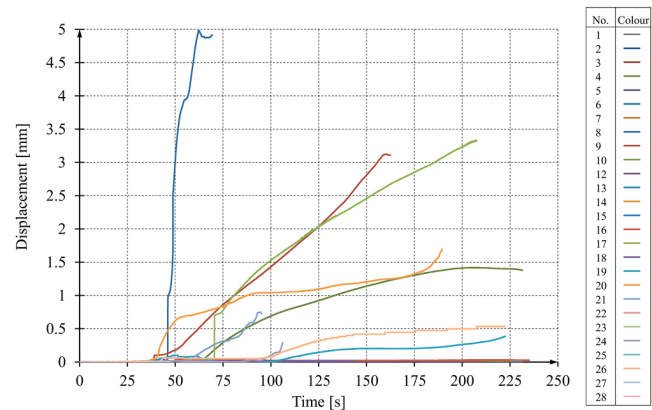
Fig. 11b. Changes of displacements measured on base C (Fig. 5)

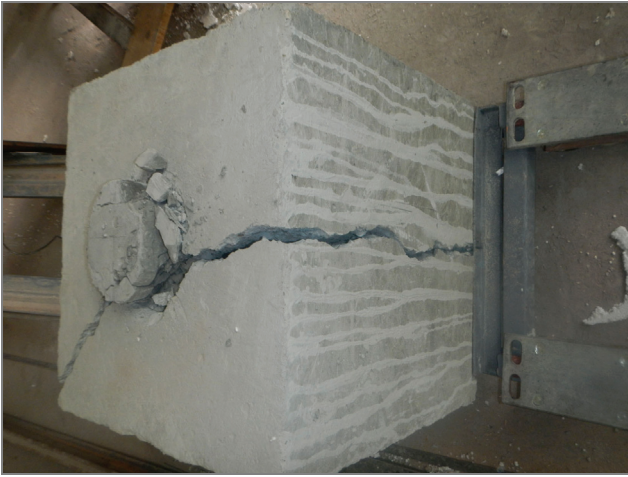
Photo 7. Form of concrete specimens failure

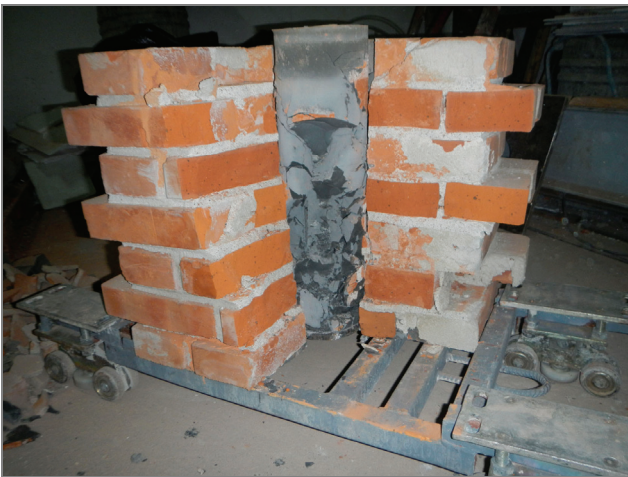
Photo 8. Form of brick specimens failure

intact (Photo 9). In masonry foundations horizontal cracks form, overlapping the periodic structure of brick layers and mortar (Photo 8). This effect is a result of different adherence and deformability of bricks and mortar pre-bonded with the pile.

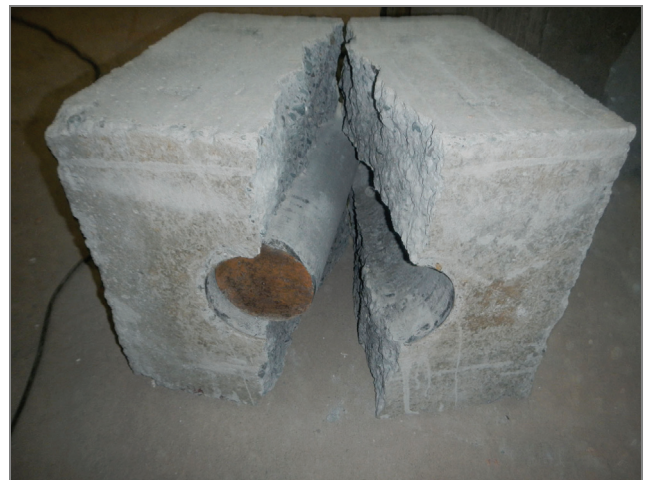
Photo 9. Pile after concrete specimen failure

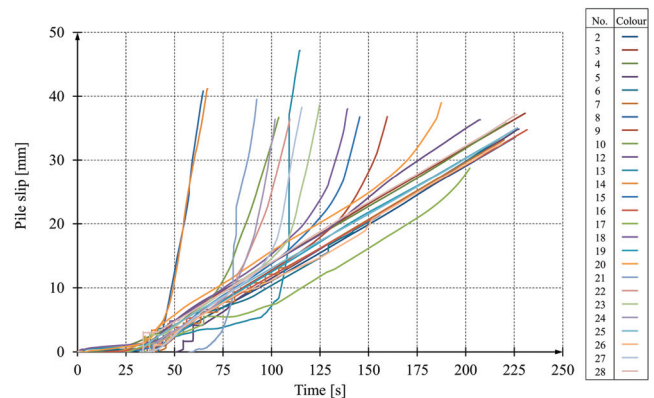
Fig. 12. Pile slip during loading of concrete specimen

The difference between longitudinal displacement of a pile free end and the corresponding surface of the foundation part is a measure of the total slip on the pile-foundation contact surface. The slip values result from the difference between the readings of sensors E and D. In Fig. 12, changes of the slip taken in particular load tests have been listed for all the concrete specimens tested. The slip changes for masonry specimens are shown in Fig. 13.

At the initial stage, a minor linear change in the slip was observed, which was followed by quite a rapid slip increment, although the change practically remained linear. At the unstable stage the process was non-linear. The slip increment rate increased exponentially, to end this stage by pile being pushed out of the foundation.

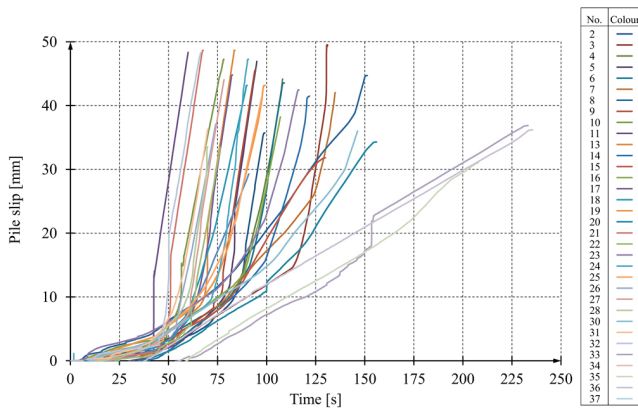
Fig. 13. Pile slip during loading of masonry specimens

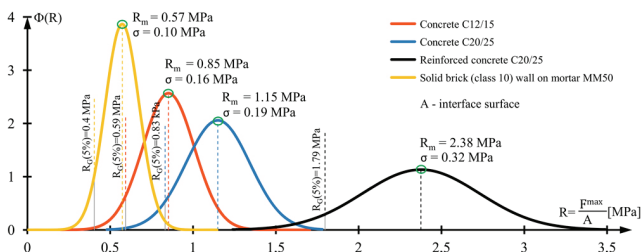
Fig. 14. Probability distribution of strength of connection between pile and the part modelling various types of foundations

In Fig. 14, probability distribution of the pile-foundation connection strength in all specimens tested is presented ( $R$ ). The summary of the results provides parameters basic from the engineering point of view: mean values, guaranteed at 5% and standard deviation.

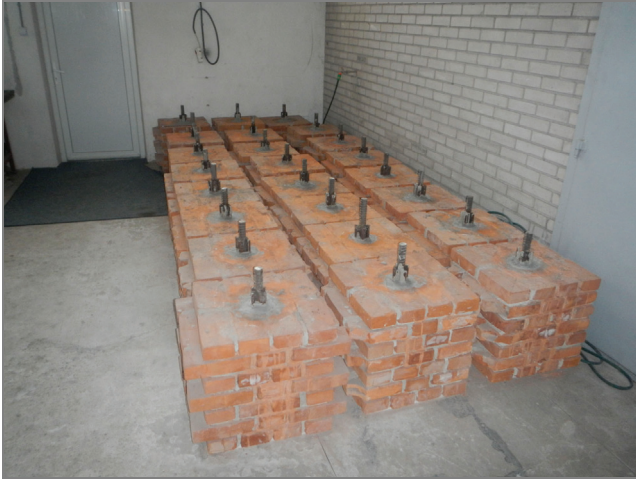
Photo 10. Test specimens modelling brick foundations

In both masonry and concrete specimens after the curing period holes were drilled through foundation using a 150 mm diameter core. In the holes piles identical as in the case of pushing the pile into the foundations were installed but tips of SAS system thread bars were welded between the rebars to execute a force pulling out the pile (Photos 10, 11).

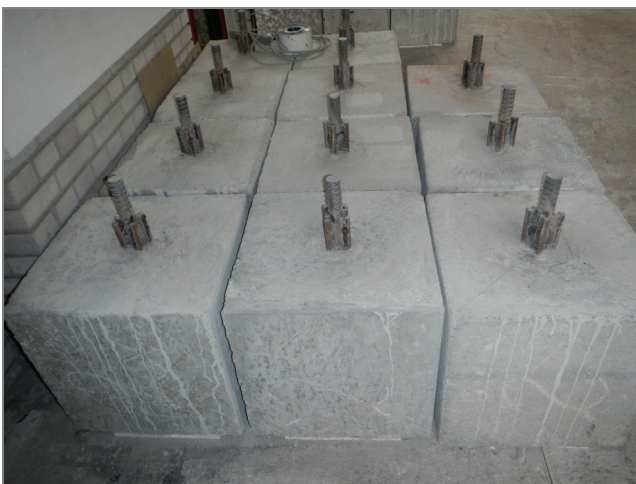
Photo 11. Test specimens modelling concrete foundations

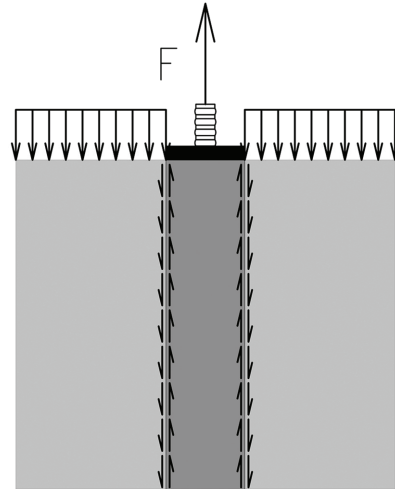
Fig. 15. Force application to specimens

The load was applied as shown in the diagram in Fig. 15. The load application continued until the loss of cohesion between the pile and the part modelling the foundation.

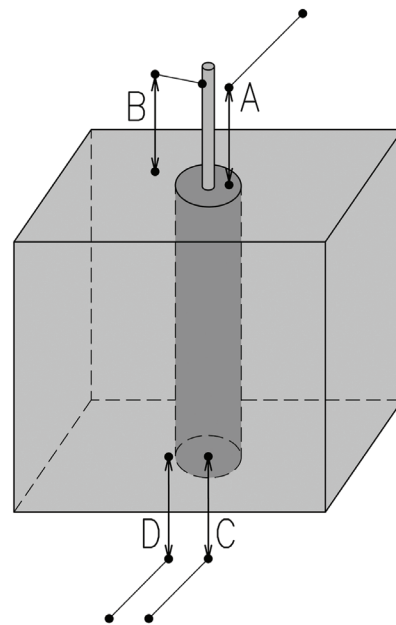
Fig. 16. Location of displacement sensors

Independent of measuring the magnitude of force and pile displacement (axial displacement of jack piston) measurements were taken of the displacements at fixed points as shown in Fig. 16.

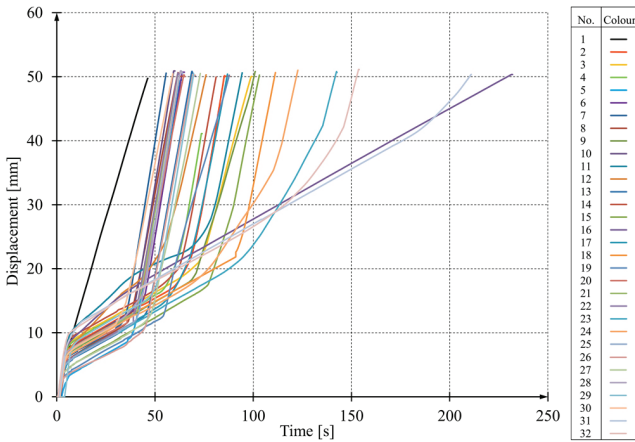
Fig. 17a. Pile head displacement change in masonry specimens

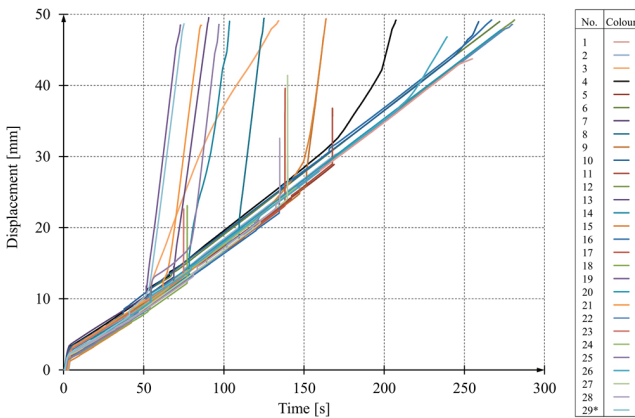
Fig. 17b. Pile head displacements change in concrete specimens

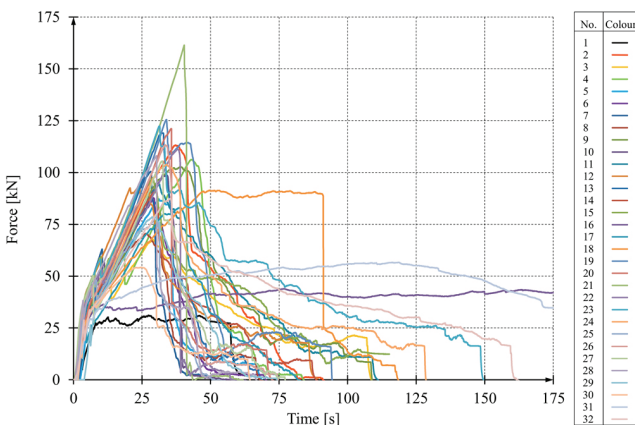
Fig. 18a. Force transferred by pile-masonry foundation anchorage over time

tance on the pile-foundation contact surface. For specimens made of brick this relationship is presented in Fig. 18a and for concrete specimens in Fig. 18b.

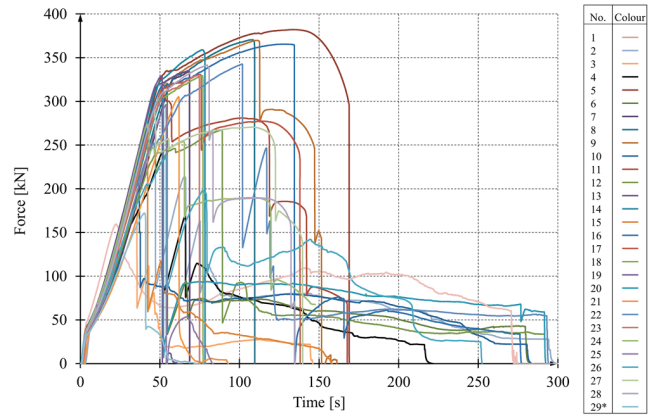
Fig. 18b. Force transferred by pile-concrete foundation anchorage connection over time

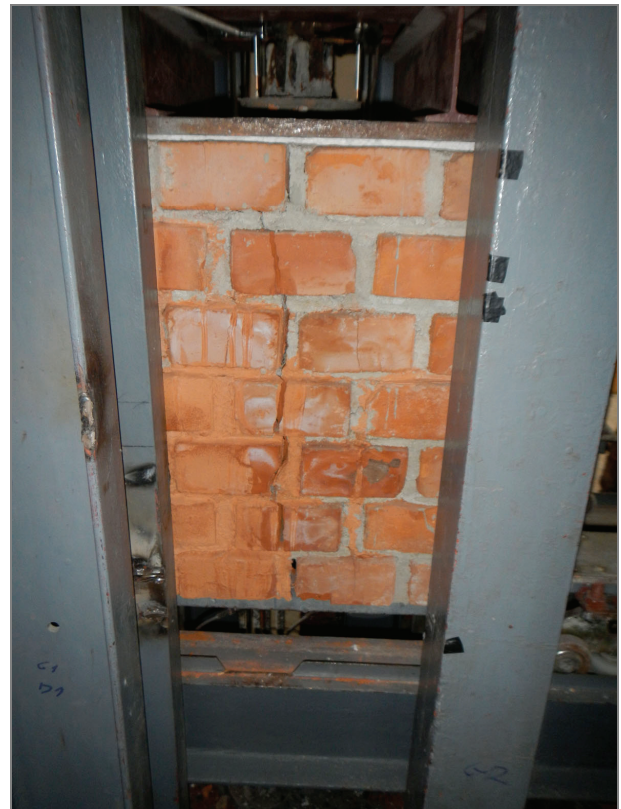
Photo 12a. Final fracture of brick foundation specimen

The final effect is the formation of macrocracks and fractures on the external surfaces of specimens (Photos 12a, 13). The force that can be transferred by the contact surface decreases rapidly and scatter of the test results is the highest. Similarly, this effect is accounted for by the non-uniform microdamage propagation, different intensity of microcracks development and their distribution in the area tested.

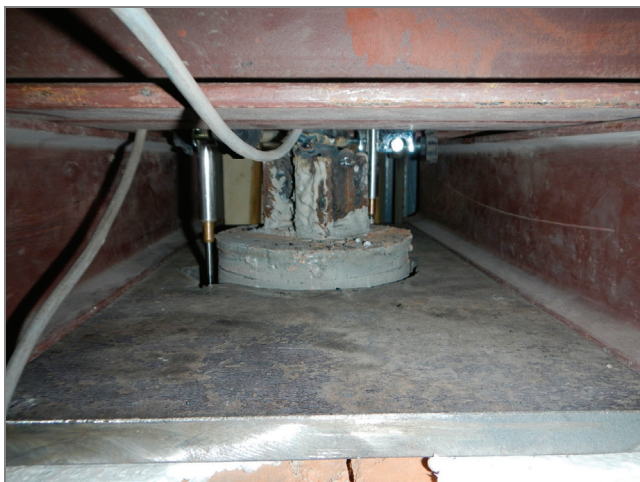
Photo 12b. Displacement of pile head in brick foundation specimen

surface increases and, as a result, the pile slides out of the part of the specimen modelling the foundation (Photos 12b, 13).

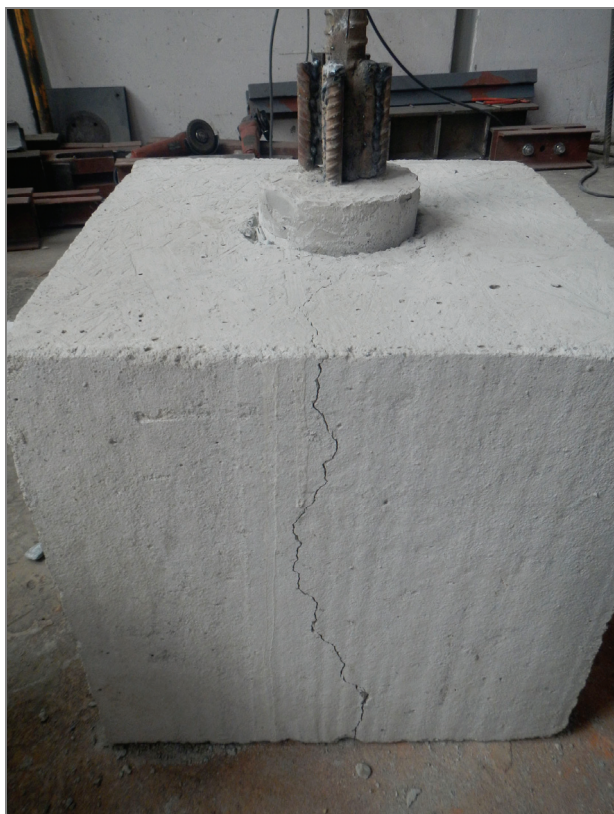
Photo 13. Concrete foundation specimen after the test

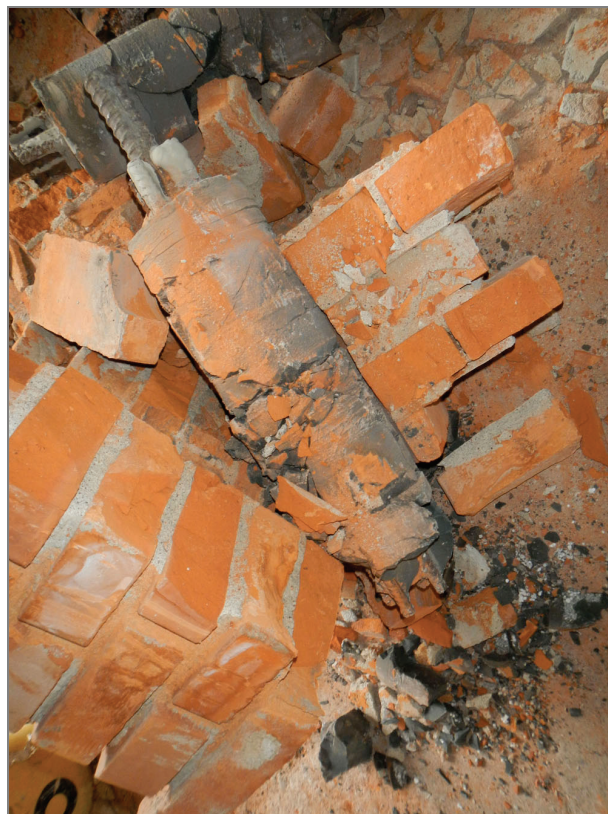
Photo 14. Damaged masonry foundation specimen

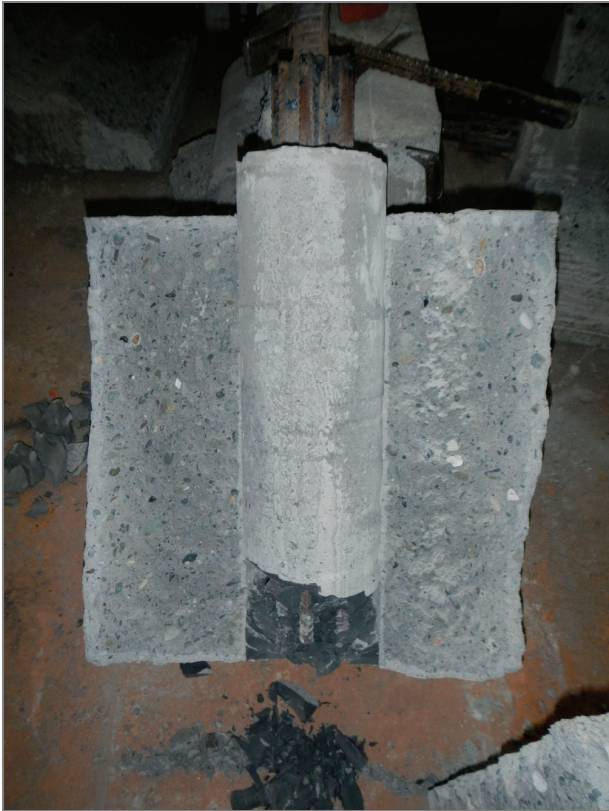
Photo 15. Damaged concrete foundation specimen

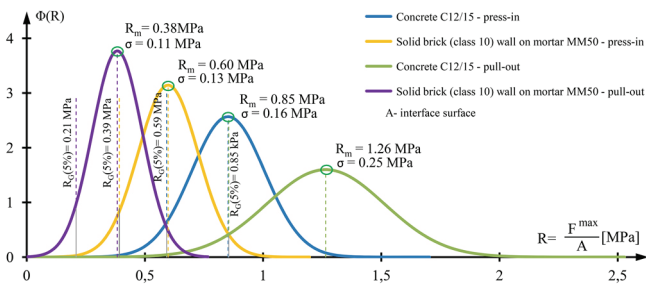
Fig. 19. Probability distribution of strength of pile-foundation connection for specimens tested

Considering the fact that the obtained results are random events, the statistical parameters were determined for respective mechanical values. Normal distribution was again adopted as a basis. In Fig. 19, the probability distributions of the strength of the pile-foundation connection in pullout and push-in tests are compared for concrete and masonry foundations.

Similar as before the following notation has been adopted:  $F_{max}$  is a maximum force obtained in experiment,  $R_m$  and  $R_G(5\%)$  are the mean and guaranteed values, respectively, at 5% strength of connection,  $\sigma$  is standard deviation,  $A$  is a contact surface

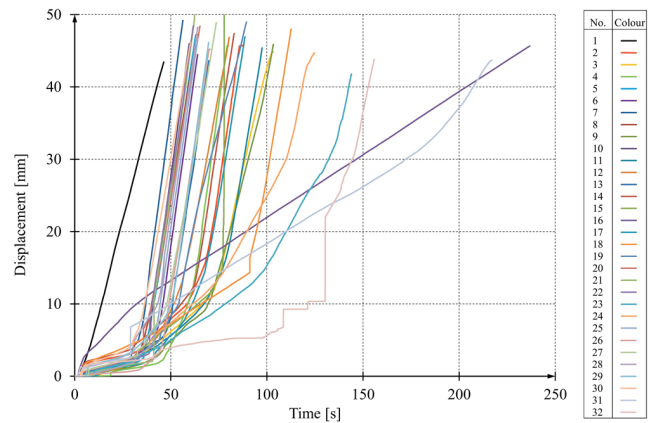
Fig. 20a. Slip on load application plane in masonry specimens

The slip is the most intensive on the surface on which the load is applied. The slip process on the pile free end is significantly slower and starts later.

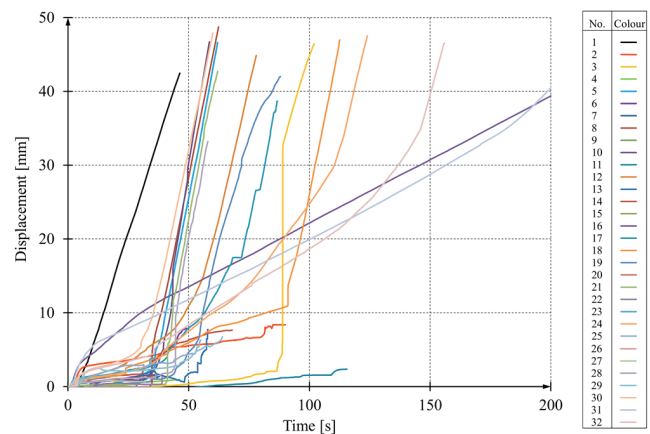
Fig. 20b. Slip on pile free end in masonry specimens

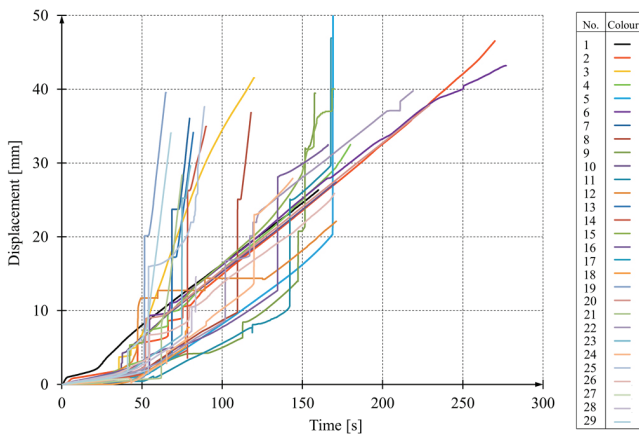
Fig. 21a. Pile slip on load application plane in concrete specimens over time

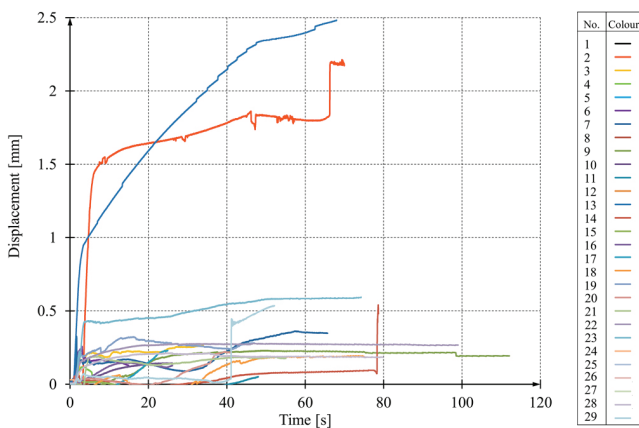
Fig. 21b. Slip in pile free end plane in concrete specimens

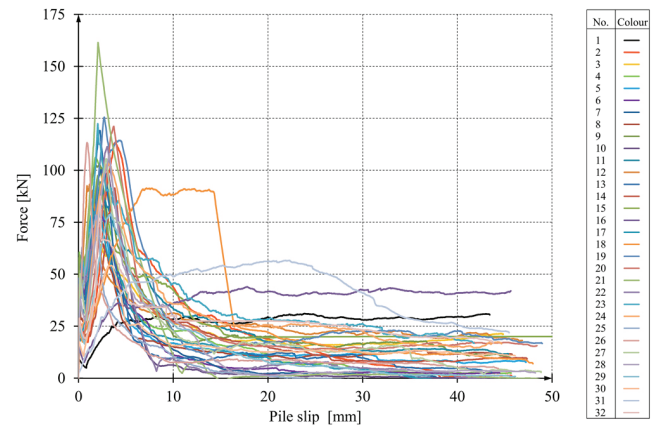
Fig. 22a. Relationships between loads applied to pile and slip on the contact surface for brick specimens

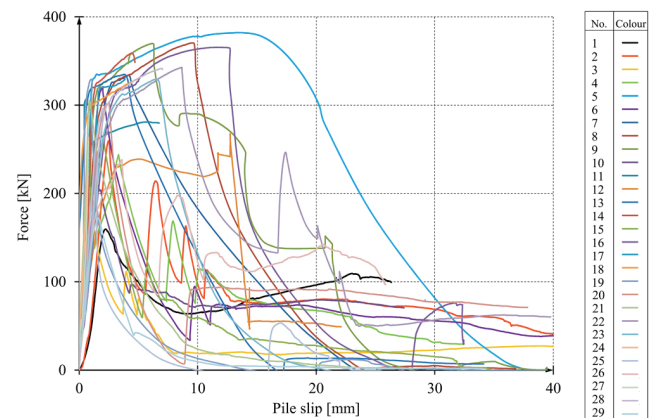
Fig. 22b. Relationships between forces applied to pile and slip on a contact surface in concrete specimens

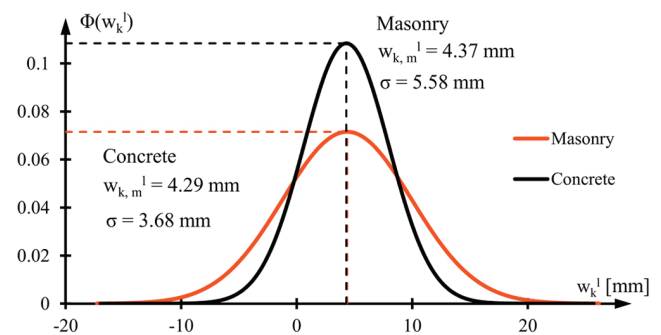
Fig. 23. Probability distribution of limit slip for specimens tested

Such adopted value of limit slip is a random value. Figure 23 illustrates normal distribution of probability density function for specimens modelling masonry and concrete foundations.  $w_{k,m}^l$  is an mean value and  $\sigma$  is standard deviation.
