MAŁGORZATA KUTYŁOWSKA*, HALINA HOTŁOŚ*

HISTORY, STRUCTURE AND DETERIORATION OF SEWERAGE SYSTEM IN WROCŁAW

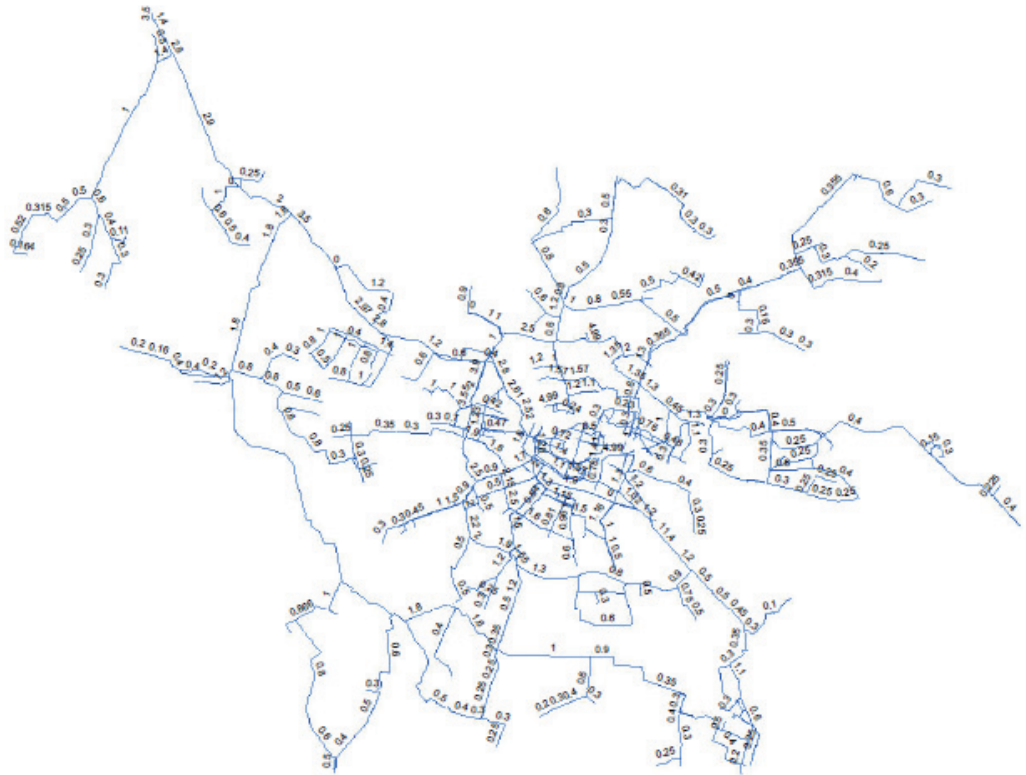
The framework of sewers is shown in the Fig. 1. The architecture of the network is complicated and widespread. Each city district has dense network of sewers, but in downtown, what is obvious, compaction is the highest.

Fig. 1. The framework of sewerage system in Wrocław [12]
