LANDSLIDE GEOHAZARD MONITORING, EARLY WARNING AND STABILIZATION CONTROL METHODS

ZBIGNIEW BEDNARCZYK

Institute of Opencast Mining, "Poltegor-Institute", Wrocław, e-mail: zbigniew.bednarczyk@igo.wroc.pl

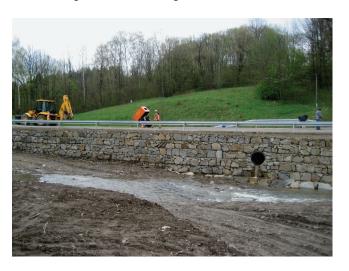
Fig. 13. Stabilization works at Sekowa landslide

age system, which has a total length of 300 m, took the rainwater away from the landslide area into the river through a new culvert under the road (Figs. 12, 13). However during stabilization, after intense rainfalls mass movement activation of up to 60 mm was observed. After remediation works, the size of the observed movement will hopefully be reduced to +/- 5 mm within a five years' period. The values of the groundwater pore pressure which were equal to 45 kPa before the stabilization works reduced to approximately 30 kPa. The depth of the groundwater level was reduced from 1.3–1.8 m to 2–2.2 m. The conclusions from the monitoring measurements and the control of stabilization are shown in Table 1.

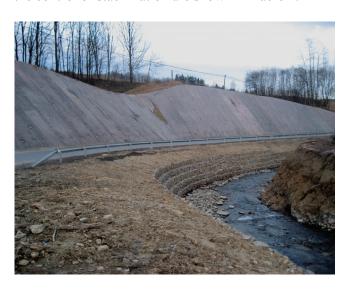
Fig. 14. Landslide in Szymbark after partial stabilization

For landslide in Szymbark, several concepts of stabilization or temporary protection were considered due to the large size of the area and the risks posed (Fig. 14). The remediation implemented allowed for the partial stabilization of the landslide head. For this purpose the anchors of up to 20 m in length were installed in the bedrock. Anchors and high tensile Geobrugg wire mesh supported the landslide head part. Partial stabilization works also included a gabion retaining wall along the Bystrzanka River. The surface and internal drainage system (horizontal drains and drainage wells), and two new culverts under public
