Research Article

Concrete surface evaluation based on the reflected TLS laser beam's intensity image classification

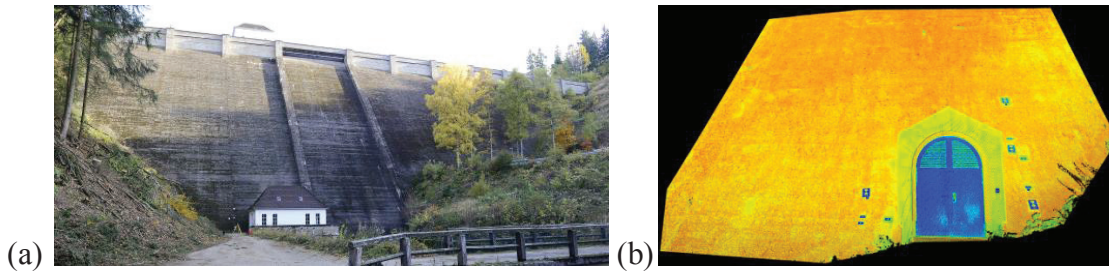
Figure 1: Ecker Dam. (a) Photograph of the structure and (b) results of laser scanning with Leica C10 of downstream surface – station 501 (image of intensity).

The test object is concrete-gravity water dam Ecker Dam (figure 1), located in the Harz Mountains (Germany). The concrete dam on the Ecker River went into service in 1942. The dam consists of 13 contraction joints 15.7-m wide and one spillway that is 31-m wide. The maximum height of the section is 65 m, and the maximum height of the reservoir in the area of overflow sections is 57 m. Experimental measurements of Ecker Dam were performed in the autumn of 2013 using Z+F Imager 5006h scanner as well as a Leica ScanStation C10 instrument.

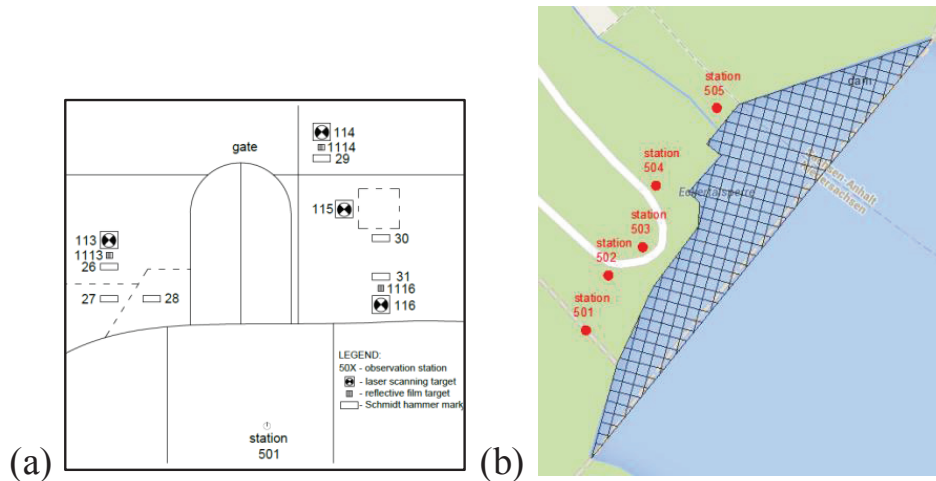
Figure 2: Ecker Dam: (a) example of survey markers/planar targets/signs distribution (station 501) and (b) survey position locations.

The presented analysis use traditional tacheometric techniques in order to combine different types of measurements into one corresponding coordinate system. Three groups of signs were applied for marking points on the edge of the dam section: reflective foil, black and white planar targets for coordination of various scanning sessions and charts marking designated reference fields, the material characteristics of which were assessed using Schmidt hammer (Fig. 2a).

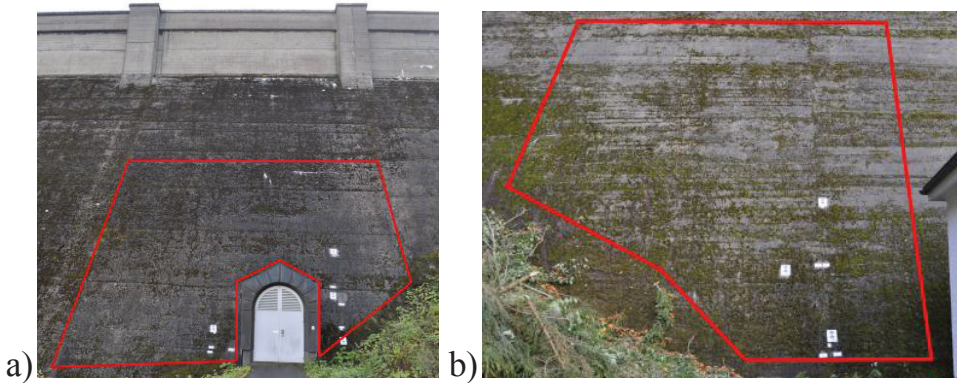
Figure 3: Selected fragments of Ecker Dam surface: (a) east section (station 501) and (b) west section (station 505).

For this study, two fragments of surface were selected: west section – surfaces around the entrance door into the inspection gallery (station 501; Fig. 4a) and surface of full east section – in proximity of power plant, with no visible concrete infill observed on surface of this section (station 505; Fig. 3b). Owing to article length restriction, only the analyses for the west section are presented in this paper (Fig. 3a).

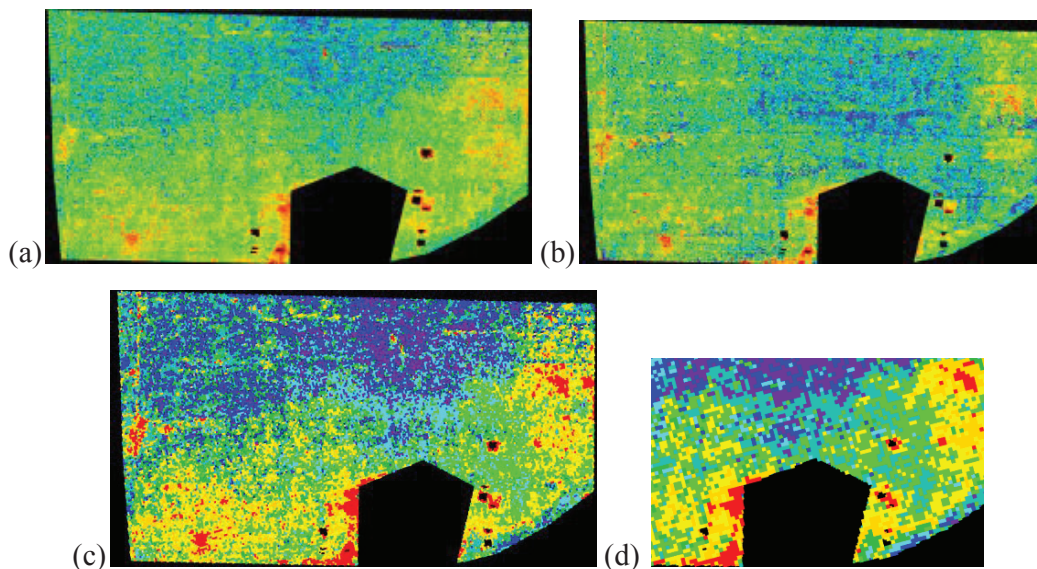
Figure 4: Results of unsupervised classification of intensity value using ISODATA algorithm, Ecker Dam, station 501: (a) Scanner Leica C10, pixel 5 mm × 5 mm; (b) scanner Z+F 5006 h, pixel 5 mm × 5 mm; (c) integrated data, pixel 5 cm × 5 cm; (d) integrated data, pixel 10 cm × 10 cm (fragment) clearly visible/legible separate surface areas of concrete surface filled with different material (red colour) and clear concrete (yellow and orange colours).

In consideration of the expected changes in values – from 5 cm, which is significant from hydrotechnical object condition assessment point of view – it was decided to perform digital processing for the data degraded (average) to pixel size of 5 cm × 5 cm and 10 cm × 10 cm. The 10 cm × 10 cm pixel size allows for optimum indication of changes within the object. The results of unsupervised classification for station 501 are presented in Figure 4.

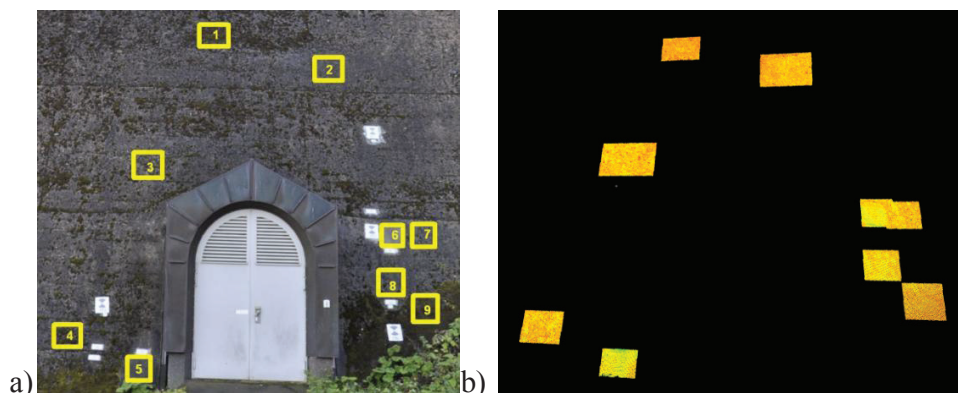
Figure 5: Reference fields Intensity images (with Leica C10, station 501): (a) reference fields marked on the concrete dam’s wall and (b) image of intensity of the reference fields.

Reference fields for surveyed surfaces were selected (Fig. 5; Table 1). They were indicated during concrete strength measurements using Schmidt hammer, performed directly after laser scanner surveys.

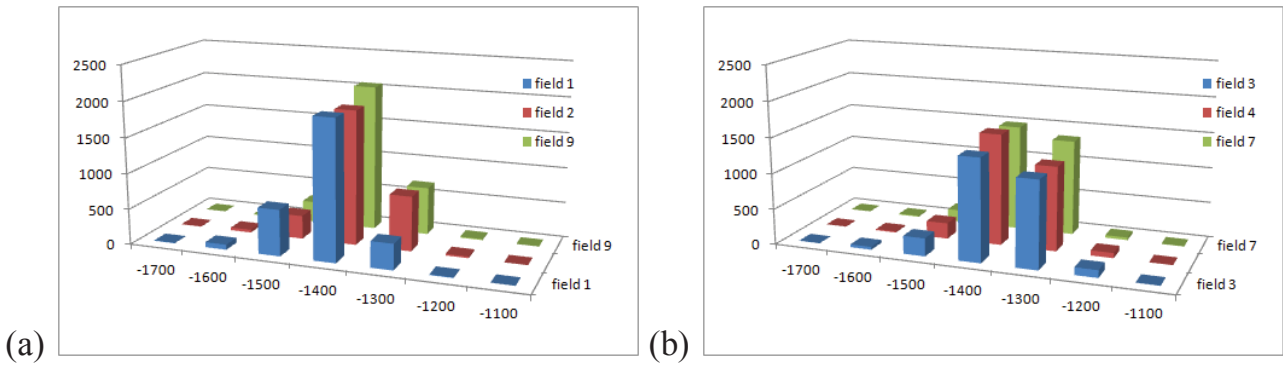
Figure 6: Classes 1 and 2 histograms (station 501, scanner Leica C10): X-axis – registered values range; Y-axis – occurrence number for sample area. (a) Class 1 – clean concrete; and (b) Class 2 – concrete covered with mosses to a small extent.

On the basis of the statistical characteristics of intensity value distribution and histogram similarity for the reference areas (Fig. 6) – method described in Zaczek-Peplinska (2011) – similar areas were defined and grouped accordingly in matching classes. For each class, an exemplar area was determined for supervised classification purpose (Table 2). This article presents scanning results for data obtained with Leica C10. The

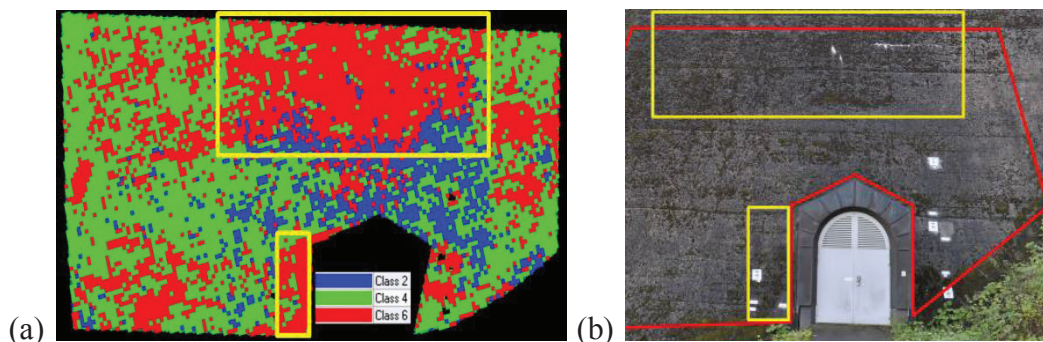
Figure 7: The areas indicated for preservation in station 505: (a) area highlighted with yellow colour was defined using supervised classification results, classes defined as follows: 2 – Class I (clean concrete), 4 – Class II (concrete covered with mosses to small extent), 6 – Class V (infill areas or significant surface erosion); and (b) area designated for preservation marked on the visible spectrum image.

Practical result of this research was to determine the areas of concrete within the surveyed surface that need to be repaired by infill, cleaned or preserved in order to avoid or stop erosion of the structure. Figure 7 presents areas of

Station 501 (Fig. 7) indicated areas around the inspection gallery entrance that require preservation, and an area of 42 m² (10-m wide by 4.2-m high) 5.2 m above the entrance.

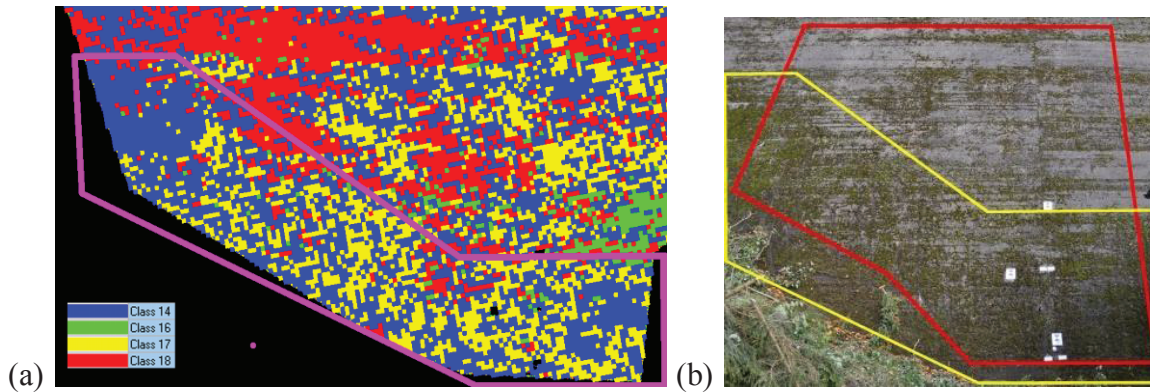
Figure 8: Areas indicated for cleaning in station 505: (a) area highlighted with magenta was defined using supervised classification results, classes indicated analogically to Figure 7, and (b) area designated for preservation marked on the visible spectrum image.

concrete surface designated for preservation – station 501. Figure 8 presents areas of concrete surface designated for cleaning – station 505. The selection was made according to the results of supervised classification using maximum likelihood algorithm in accordance to the intensity images obtained by different scanners.

Station 505 (Fig. 8) indicated area suitable for cleaning at the bottom of downstream face measuring around 73 m² (16 m × 4.6 m high).
