Restoration of medieval gords on the example of the “in the meadows” Gord in Wiślica: a case study

Nevertheless, there are general principles that should be followed. The authors of this paper discuss the development of the gord “in the meadows” in Wiślica, as related to the accessibility of the site to visitors in the context of the constraints arising from the impossibility of interfering with the historical fabric.

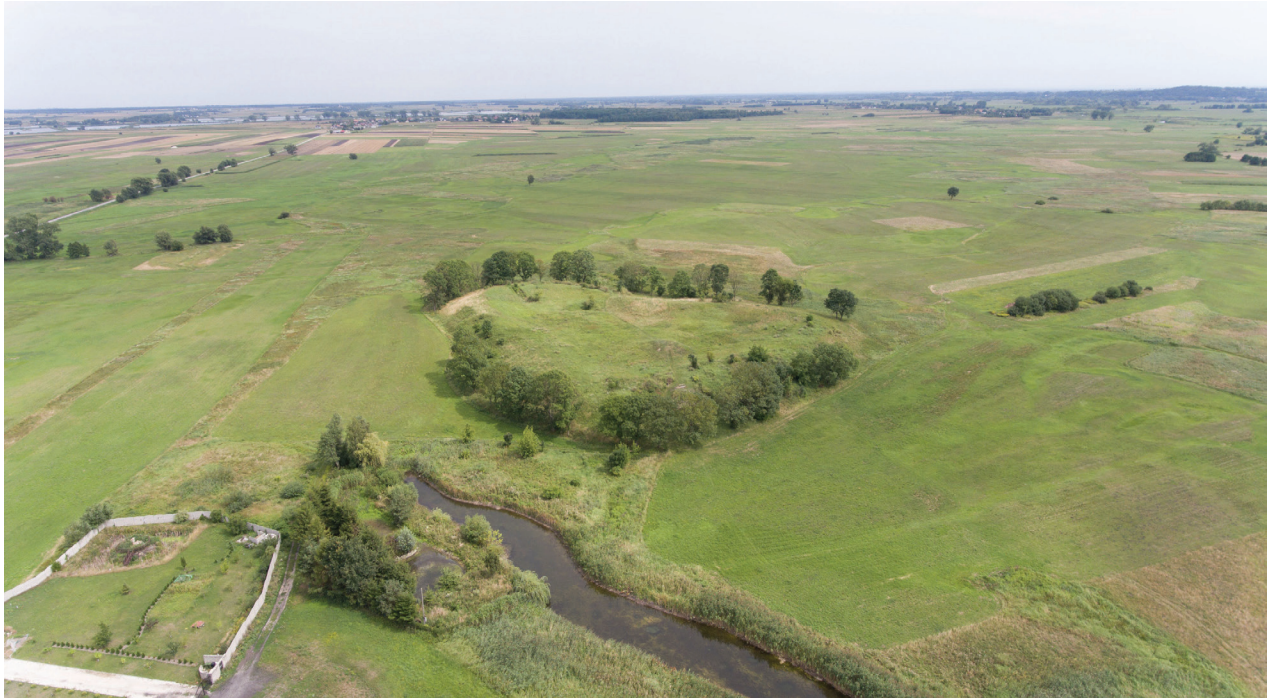
Fig. 1. Gord “in the meadows” in Wiślica, aerial view (photo by D. Przygodzki, 2018)

medieval gord known as “in the meadows” (Fig. 1). It is covered by statutory conservation via a listing in the register of monuments under No. Aa329/508. Archaeological investigations of the site have been carried out on several occasions. In the years 1949–1960, archaeological investigation was carried out as part of a broad research programme of the so-called millennium studies led by Włodzimierz Antoniewicz and Zofia Wartołowska [7]. They were focused, among other things, on identifying the techniques used to build the ramparts in the north and west sections. The study of the gord was revisited several more times by Dorota Górna, Joanna Kalaga and Zbigniew Pianowski and in 1996–1998 by Waldemar Gliński, whose aim was to identify the construction technique of the eastern line of fortifications [8], [9]. At the beginning of May 2021, archaeological work once again began on the gord, led by Nina Glińska on behalf of the Voivodeship Conservator of Monuments in Kielce. The aim of the non-invasive geophysical survey was to define the boundaries of the entire complex and to understand the construction of its ramparts. The form of the gord is well preserved and legible in the terrain. Unfortunately, its current state can be assessed as “neglected”. The site is overgrown with trees, self-sown plants and weeds, and there are mounds in the eastern part of the site which are the remains of former archaeological investigations. The municipality of Wiślica has made efforts to restructure the gord together with the adjacent area³ and to make the site accessible to the public by carrying out its revalorisation. Pursuant to the applicable *Ustawa z dnia 23 lipca 2003 r. o ochronie zabytków i opiece nad zabytkami* [Monument Protection and Preservation Act], [...] *the protection of monuments consists, in particular, of ensuring legal, organisational and financial conditions that enable the permanent preservation of monuments and their development and maintenance, and the preservation of a monument consists, in particular, in popularising and disseminating knowledge about the monument and its significance for history and culture* [10, art. 4, 5]. It is clear from the quoted sections of the Act that the owner of a monument is obligated to make the site available to the public and at the same time ensure its survival for future generations. The protection of gords consists, among other things, of preventing further damage to the site, [...] *because, regardless of its state of preservation, the form that has survived to our times is part of the historical fabric and is subject to conservation* [11, p. 274]. The restoration of gords is always a challenge for the designer. Adaptive reuse, associated with opening the site to visitors, must be performed without interfering with the historical tissue of the relic. Another consideration is the presence of the archaeological site in the cultural landscape, of which gords are a prime example. The relationship of architectural and urban heritage to the landscape is emphasised by the so-called Krakow Charter of 2000, whose authors stated that *Landscapes [...] are testimony to the evolving relation-*

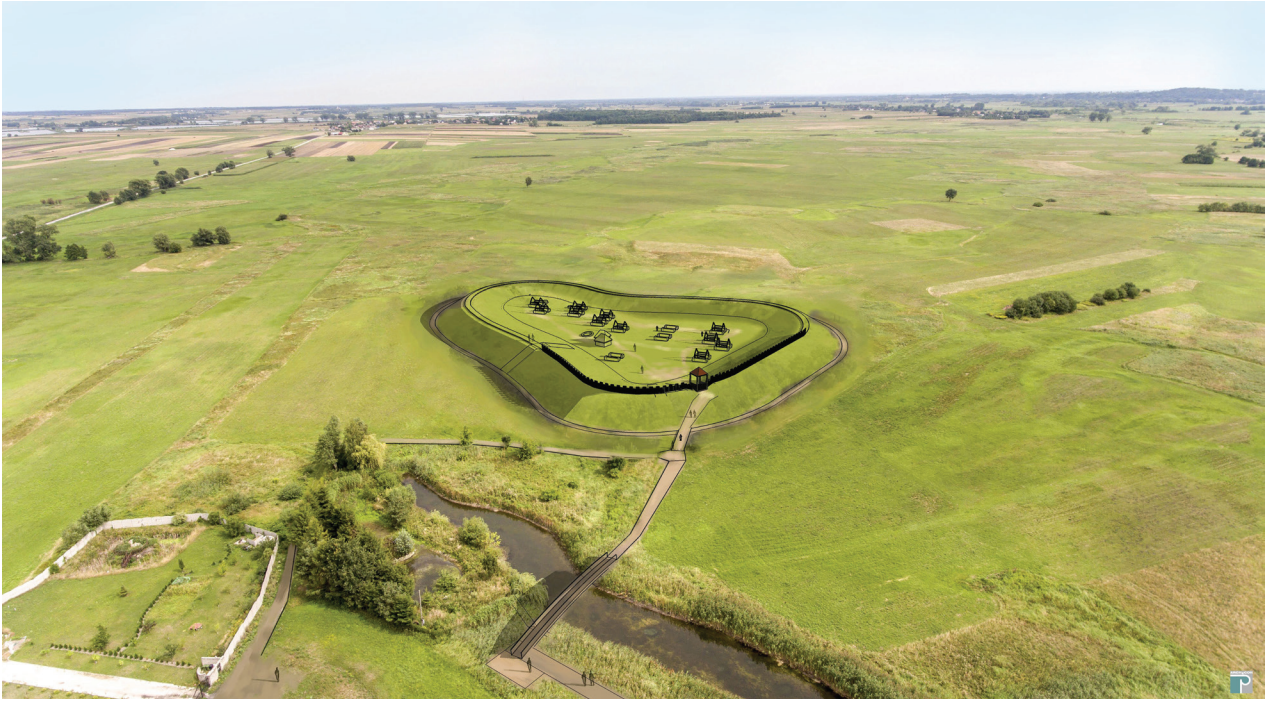
Fig. 2. Gord "in the meadows" in Wiślica, competition design (elaborated by Arche-con, 2018)

tribute to the establishment of new businesses, new jobs, and to increase the number of tourists visiting Wiślica. In advance, in 2005, the municipality, in consultation with the Voivodeship Office for the Protection of Monuments in Kielce, issued a public project siting decision [15]. In 2018, thanks to the efforts of the then mayor Stanisław Krzak, Wiślica regained its urban status, and the President of the Republic of Poland recognised the collegiate church complex of the Nativity of the Blessed Virgin Mary, together with the relics of the church of St. Nicholas and the Wiślica gord, as a Monument to History [16]. In the same year, the municipality of Wiślica announced a competition for an urban and architectural design proposal for the project entitled *Thousand-Year-Old Wiślica – in the footsteps of splendour – establishment of the “Through the Prehistory of Christian Wiślica” tourist route*. The competition was to select the best entry, which would become a basis for the preparation of further technical documentation. Following this, a conceptual design was drafted, which, as per the competition’s scope, included the adaptation of the site for tourist traffic, the restoration of the original angle of the ramparts and their elevation, the refurbishment of the main square and the rampart, the clearing of unnecessary greenery, the introduction of footpaths with educational elements, reconstructing the gate, the former buildings of the gord and the partial restoration of the palisade (Figs. 2, 3) [17, p. 6]. As a result of approvals of the planned project with administrative bodies, the Voivodeship Office for the Protection of Monuments in Kielce and the National Institute of Cultural Heritage (NID) issued their opinions and recommendations. The documents are a response to a design proposal developed by Arche-con, a Krakow-based architectural studio. Both documents confirm that

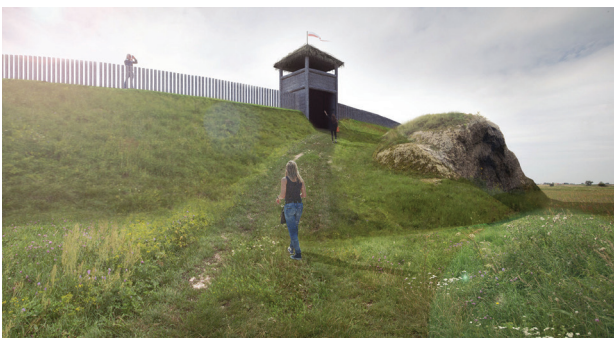
Fig. 3. Conceptual design of the restoration of the gord "in the meadows". The restoration of a stylised gate and palisade on the rampart crest (elaborated by Arche-con, 2019)

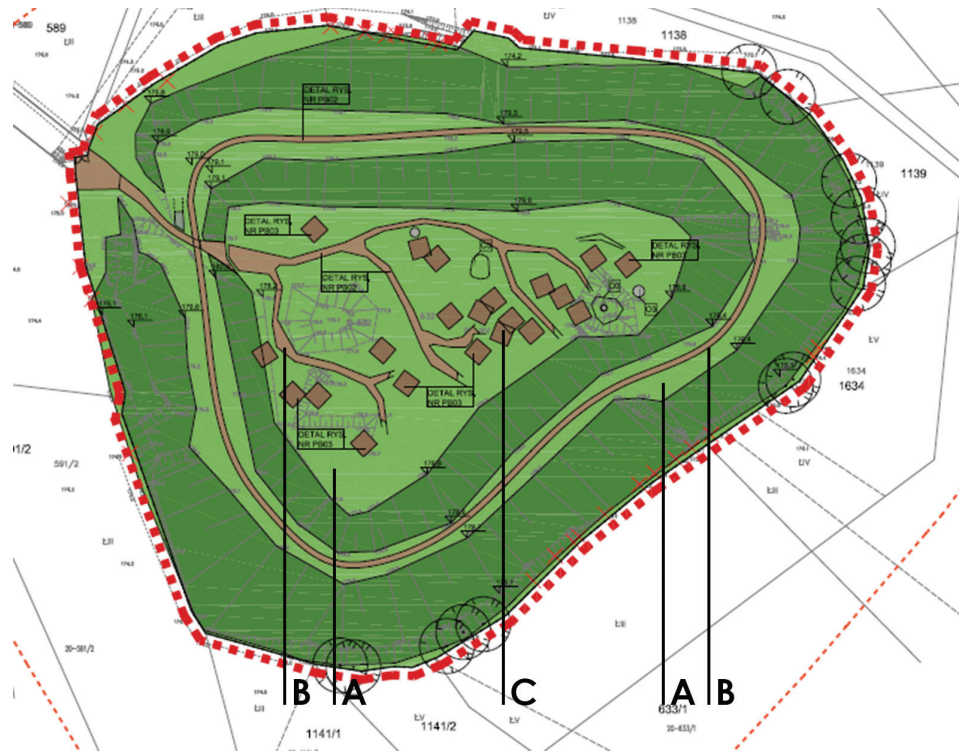
Fig. 4. The final version of the development project for the gord area:
 A – buffer layer on the rampart crest and the yard,
 B – path,
 C – platform,
 (elaborated by Arche-con, 2019)

damage the preserved historical substance of the site [18]. The guidelines [...] indicate the principle of maximum respect for the original substance of the monument and all its values, the principle of minimum necessary interference (refraining from unnecessary actions). These principles correspond with the 1989 International Charter for the Protection and Management of the Archaeological Heritage, which stipulates, among other things, that reconstructed structures should not be implemented directly as a part of authentic sites – archaeological monuments [19, p. 2]. The authors of both opinions emphasise that the Wiślica gord is one of the most important sites related to the formation of Polish statehood and deserves world-class presentation. Following discussions with representatives of the Voivodeship Monument Protection Office in Kielce, Arche-con created a design which combines the expectations of the municipality's representatives with the assumptions and requirements of the decision-making institutions (Fig. 4).
