# Laboratory tests and analysis of CIPP epoxy-resin internal liners used in pipelines – part I: comparison of tests and engineering calculations

**Abstract:** Tests that were carried out in order to obtain knowledge of the actual values of strength parameters obtained by CIPP liners that are used to repair pipelines. Specimens of liners made of high quality polyester felt cured with epoxy resin were subjected to tests. The scope of the performed studies corresponded with the scope of acceptance tests, which are carried out in the investment process during quality control of renovation works. Specimens of liners taken from sewers with 3 different diameters, i.e. 200mm, 350mm and 500mm were selected as representative for underground sewage networks. The obtained results enabled the calculations carried out in the course of design work to be verified, and differences between the model values of the strength parameters obtained from the calculations, and real values that are burdened with irregularities resulting from the conditions prevailing at a construction site and which were obtained for specimens taken from their built-in locations to be compared.

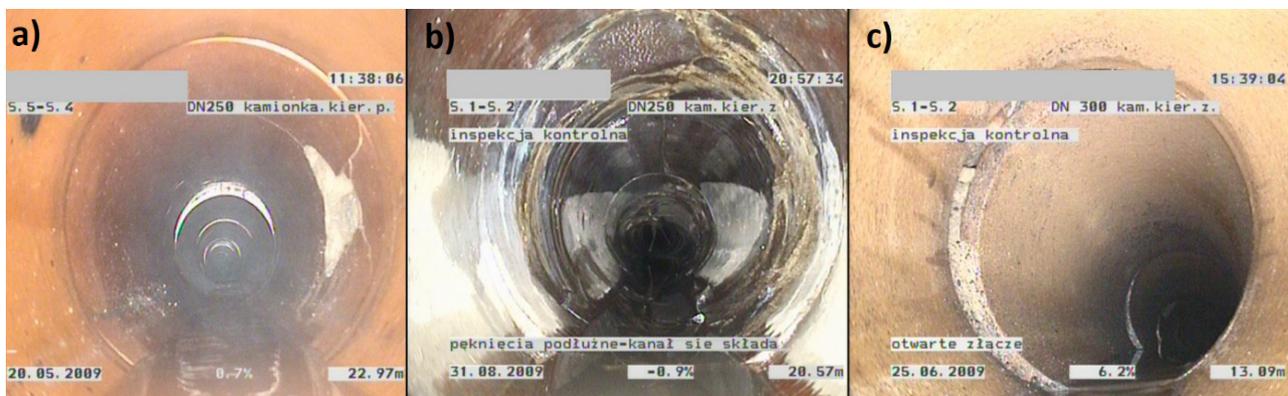
**Figure 1:** Examples of pipe damage: a), b) cracks and structure defects, c) damaged connectors.

Exemplary damage to sewers is shown in Figure 1, where there is longitudinal fracture and material loss (part a), transverse fracture (part b), damaged connections and joint movements (part c).

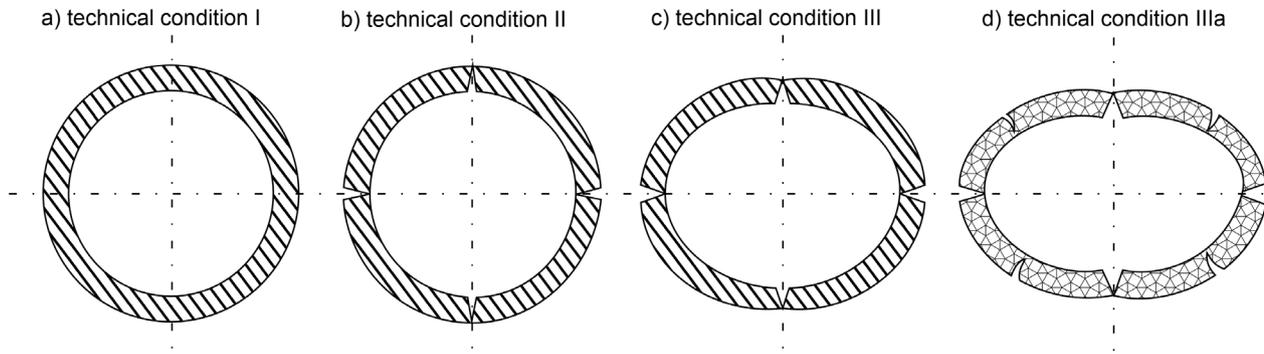
**Figure 2:** Technical conditions according to ATV 143-2; a) technical condition I; b) technical condition II; c) technical condition III; d) technical condition III a [5].

The technical condition of sewage pipes has been the subject of analyses carried out as part of many scientific works for years [4]. As a result of many years of research and assessments of the technical condition of underground networks, the classification of pipelines with regard to the scope and type of damage occurring in them has been adopted. This classification, which was indicated in the ATV 143-2 guidelines [5] and created for the purposes of selecting the appropriate technique of a sewer's repair in the design phase, divides pipelines into four technical conditions (see Fig. 2 [5]):

- Technical condition I – The existing conduit maintains its load capacity. There is only minor damage in the form of, for example, leaking joints or hairline scratches.
- Technical condition II – The existing conduit-soil system maintains its ability to transfer loads. The permissible damage for this state includes longitudinal scratches with small deformations of the cross-section  $\delta v < 6\%$ .
- Technical condition III – The existing conduit-soil system has lost its ability to carry loads independently; there are clear deformations of the cross-section  $\delta v \geq 6\%$ .
- Technical condition IIIa – The existing conduit-soil system has lost its ability to carry loads independently. There are clear deformations of the cross-section  $\delta v$

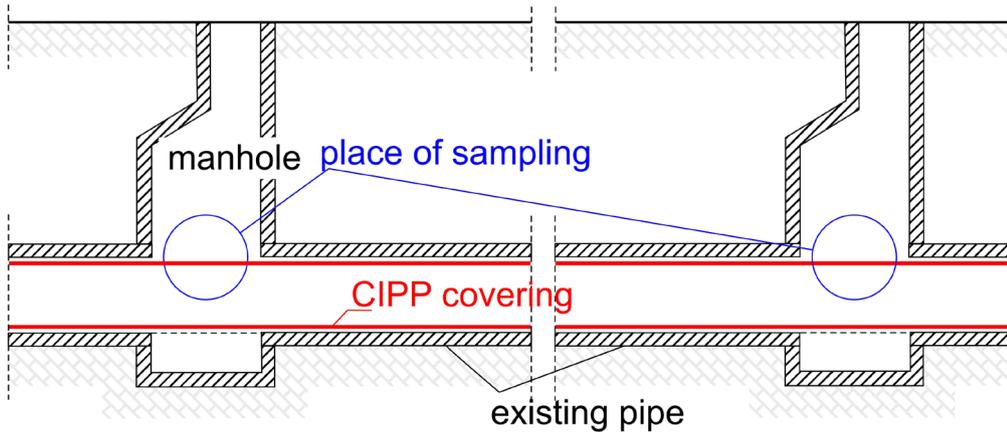
Figure 3: An overview sketch of the liner's installation.

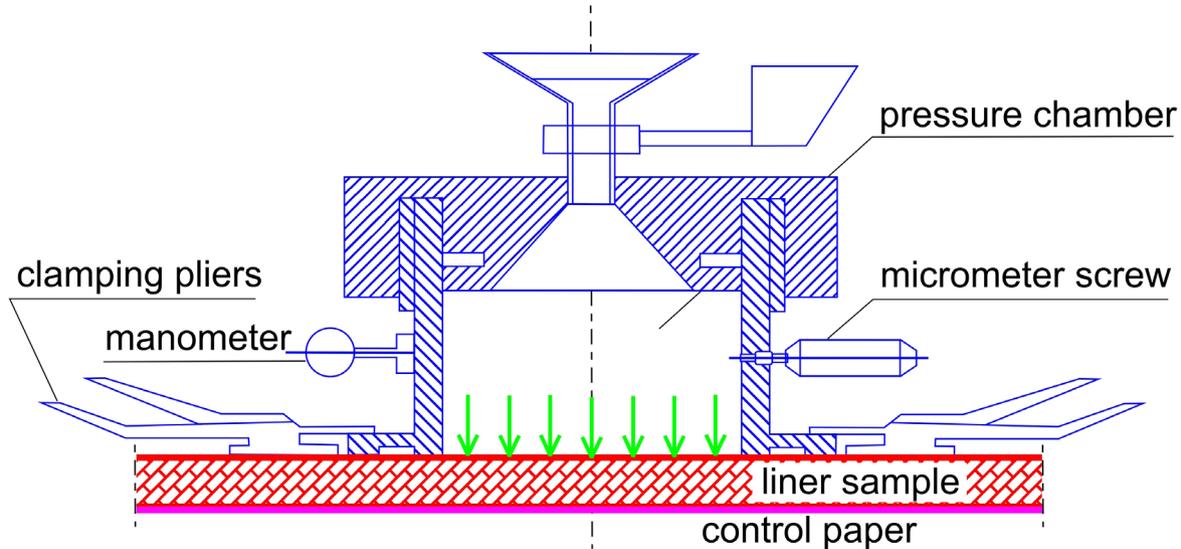
Figure 4: Illustration of the GWT method for measuring water permeability [30].

Water permeation tests were performed using the GWT method [30]. This test involves a sample surface being subjected to the forced action of the assumed pressure of water, which fills a specially constructed pressure chamber. The test scheme is shown in Figure 4 [30]. These tests are intended to check whether the installed CIPP liner will retain full water penetration tightness after abrasion.

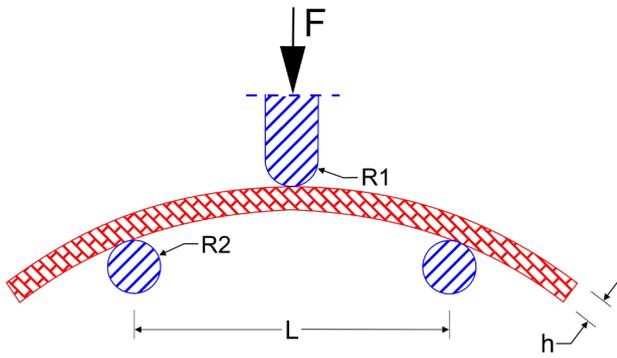
Figure 5: Three-point bending – test scheme.

During the three-point bending test (Fig. 5), the values of the applied force and the deformation obtained at a given moment were read in accordance with the graph below (see Fig. 6 [18]):

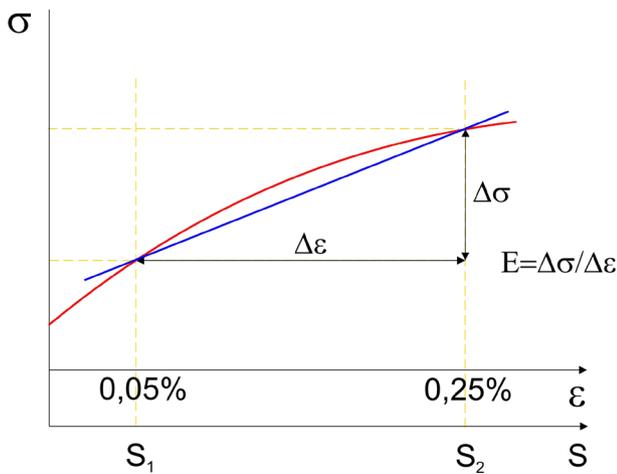
Figure 6: Accuracy requirements for the determination of the flexural modulus [18].

Values calculated during the tests are flexural modulus  $s_i$ , whose value is calculated for two load phases (see Fig. 6) and, being the final result, deflection  $E_f$ :

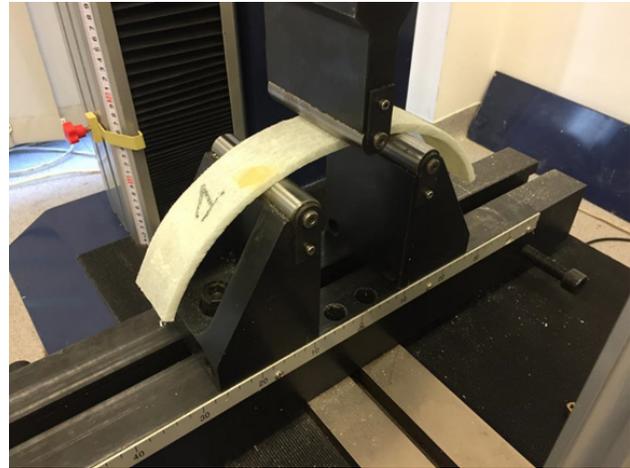
Figure 7: Laboratory test of a liner – diameter 200 mm.

thickness, 6 samples were taken from different places of the liner’s installation for testing. The test stand with sample in diameter 200 mm is shown in Figure 7:

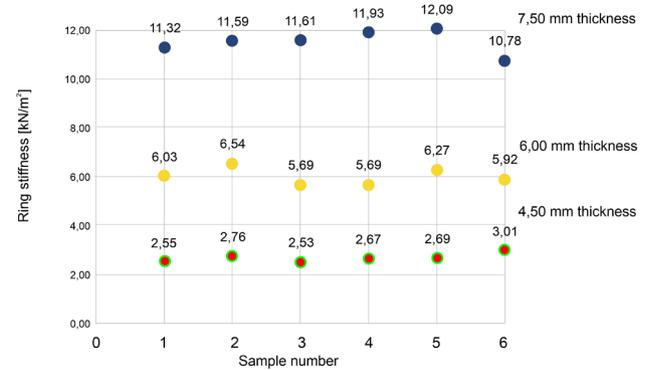
Figure 8: Ring stiffness for 200 mm diameter samples.

Tests of the liner samples taken from the DN 200 mm conduit confirmed the average elastic modulus declared by the manufacturer at a level of 2,524.50 MPa. In the case of a conduit with a diameter of 200 mm, the assessed liner is obtained, depending on the wall thickness. The obtained values of ring stiffness are shown on a collective graph (see Fig. 8):

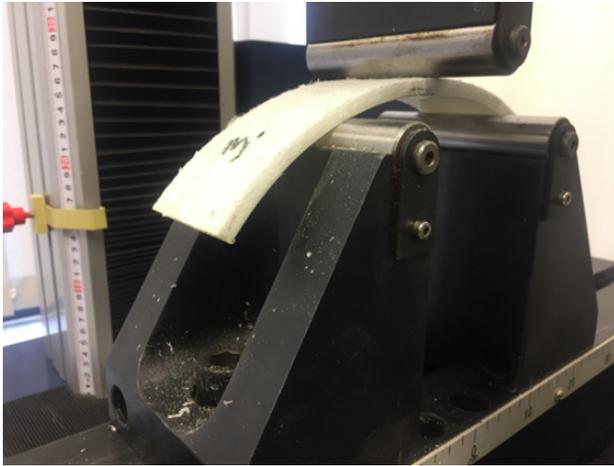
Figure 9: Laboratory test of a liner – diameter 350 mm.

thicknesses declared by the manufacturer, that is, 6,0, 7,5 and 9,0 mm, were installed. From each liner with a certain thickness, 6 samples were taken from different places of the liner’s installation for testing. The test stand with sample in diameter 300 mm is shown in Figure 9:

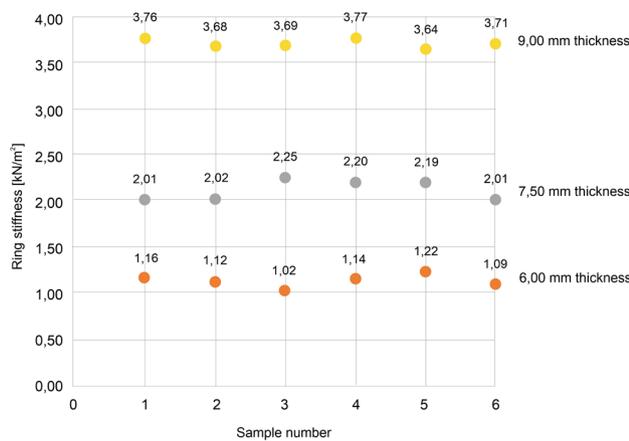
Figure 10: Ring stiffness for 350 mm diameter samples.

Tests of the liner samples taken from the DN 350 mm conduit confirmed the average elastic modulus declared by the manufacturer at a level of 2,515.23 MPa. In the case of a conduit diameter of 350 mm, the assessed liner is obtained, depending on the wall thickness. The obtained values of ring stiffness are summarised on a collective graph (see Fig. 10):

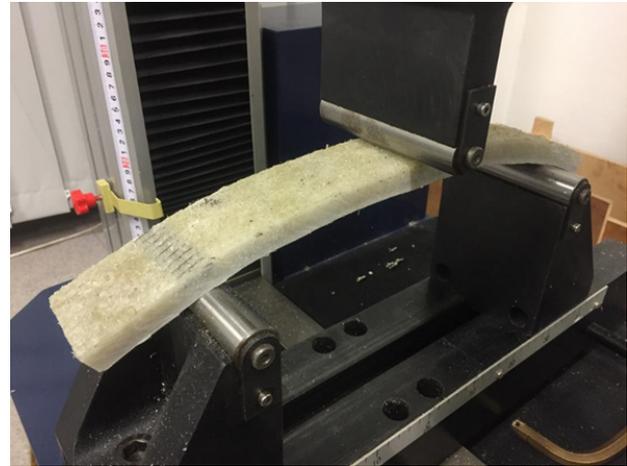
Figure 11: Laboratory test of a liner – diameter 500 mm.

thicknesses declared by the manufacturer, that is, 9.0, 12.0 and 14.0 mm, were installed. From each liner with a certain thickness, 6 samples were taken from different places of the liner's installation for testing. The test stand with sample in diameter 500 mm is shown in Figure 11:

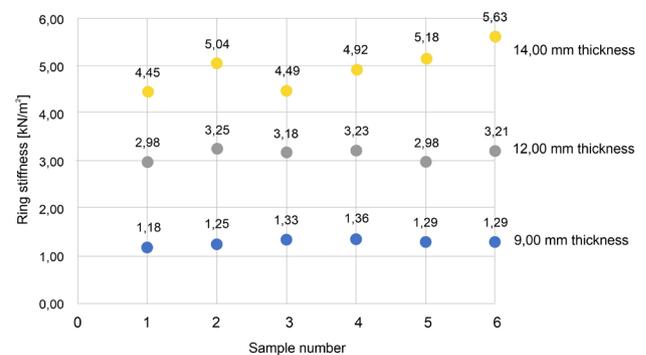
Figure 12: Ring stiffness for 500 mm diameter samples.

Tests of the liner samples taken from the DN 500 mm conduit confirmed the average elastic modulus declared by the manufacturer at a level of 2,549.10 MPa. In the case of a conduit diameter of 500 mm, the assessed liner is obtained, depending on the wall thickness. The obtained values of ring stiffness are summarised on a collective graph (see Fig. 12):

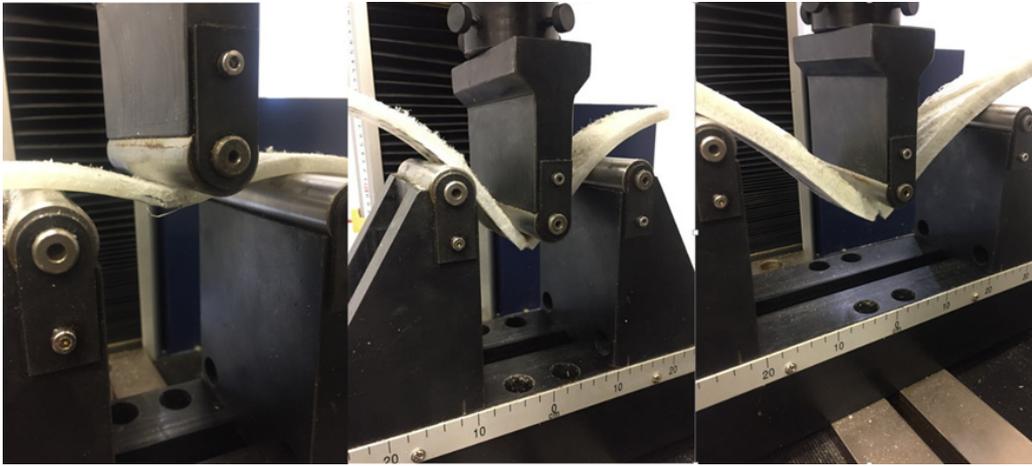
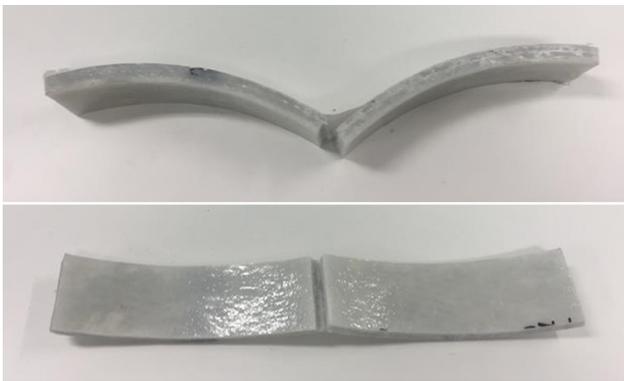
Figure 13: The mechanism of the sample's destruction.

Figure 14: Example of a damaged sample.

All the tested samples were destroyed in the final phase of deflection – cracking was observed on the stretched side of the tested material. Damage occurred in the phase of the increase of applied concentrated force. Exemplary photos of the mechanism of destruction of the liners samples are presented below – see Figures 13 and 14:

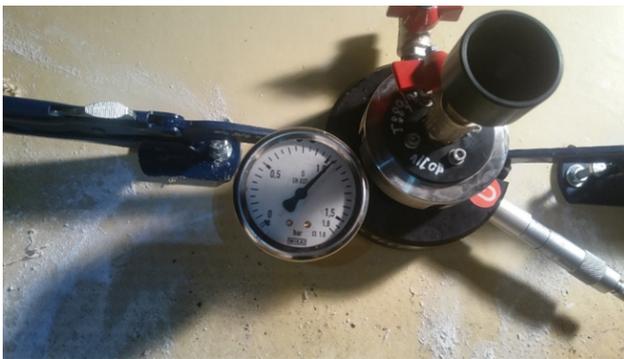
Figure 15: Sample test using the GWT device.

Positive permeability results were obtained for all the tested liner samples. Each of the tested samples turned out to be tight. There was no change in pressure in the chamber of the device, nor discoloration from the outside of the liner or the control layer. An exemplary test is shown in Figure 15:

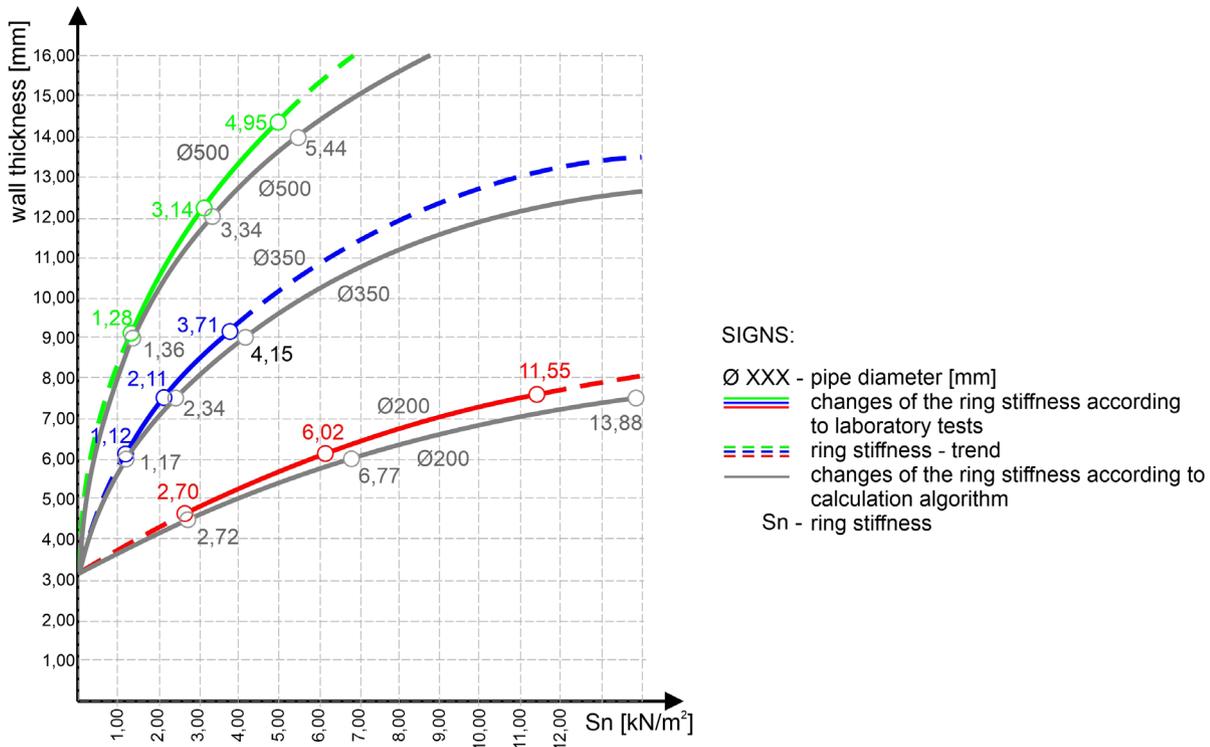
Figure 16: Real and computational ring stiffness for different diameters
