Jacek Kuśmierski*, Katarzyna Hodor**

Historical orangeries and greenhouses in Poland: typology and preservation

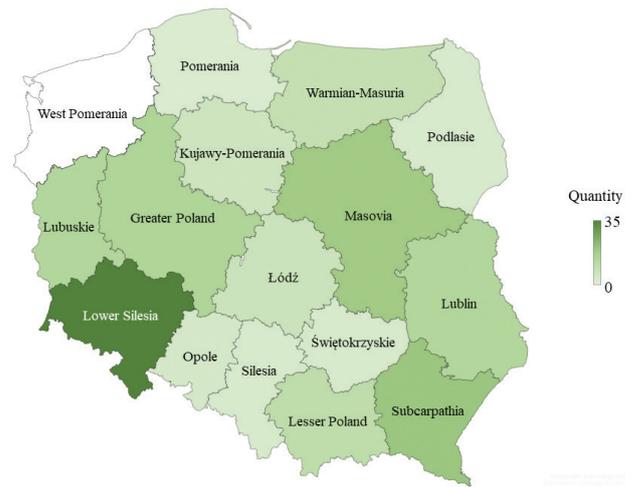
Fig. 1. Number of historical orangeries and greenhouses in Poland by voivodeship (elaborated by J. Kuśmierski, K. Hodor)

A total of 165 orangeries and greenhouses entered in the register of monuments in 15 of Poland's 16 voivodeships were identified. The highest number of structures was found in the south-western and south-eastern areas of the country. In terms of numbers, the Lower Silesian Voivodeship came first, with 35 structures, and the Subcarpathian Voivodeship came second, with 20. A dozen or so sites each are located in the Masovian Voivodeship – 19, the Greater Poland Voivodeship – 15, the Lublin Voivodeship – 14, the Lubusz Voivodeship – 14 and the Lesser Poland Voivodeship – 11. The voivodeships with only a few structures each included the Warmian-Masurian Voivodeship – 9, the Łódź Voivodeship – 7, the Kuyavian-Pomeranian Voivodeship – 6, the Opole Voivodeship – 4,

the Podlaskie Voivodeship – 3, the Silesian Voivodeship – 3, the Świętokrzyskie Voivodeship – 3, and the Pomeranian Voivodeship – 2. In the West Pomeranian Voivodeship, no orangeries or greenhouses were found listed in the register of monuments (Fig. 1).

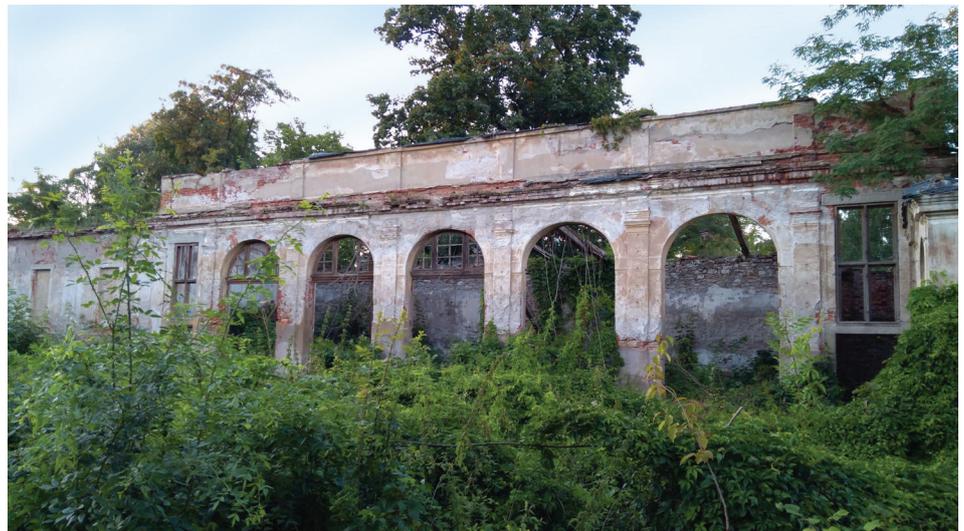
Fig. 3. Ruins of the Rozтока Palace Orangery, built in 1725 (photo by Ł. Przybylak)

Of the orangeries and greenhouses currently listed in register of monuments, only 17.6% of them come from the 18th century. The oldest are the two conservatories at Roztoka Palace, dating from 1725 (Fig. 3) and the orangery of the Cistercian abbey in Henryków, erected in 1727 (Fig. 4). Buildings erected in the 19th century predominate, constituting 64.8% of the sample. The remaining 17.6% are orangeries and greenhouses erected in the 20th century. The youngest structure listed in the register is greenhouse no. 2, a part of the Legnica Palm House complex, dating from ca. 1940–1949. It is also worth noting the historical buildings which were destroyed during World War II and almost completely reconstructed, such as the orangery of the Wilanów Palace rebuilt in 1951–1960 and that of the Puławy Palace from 1965–1966.

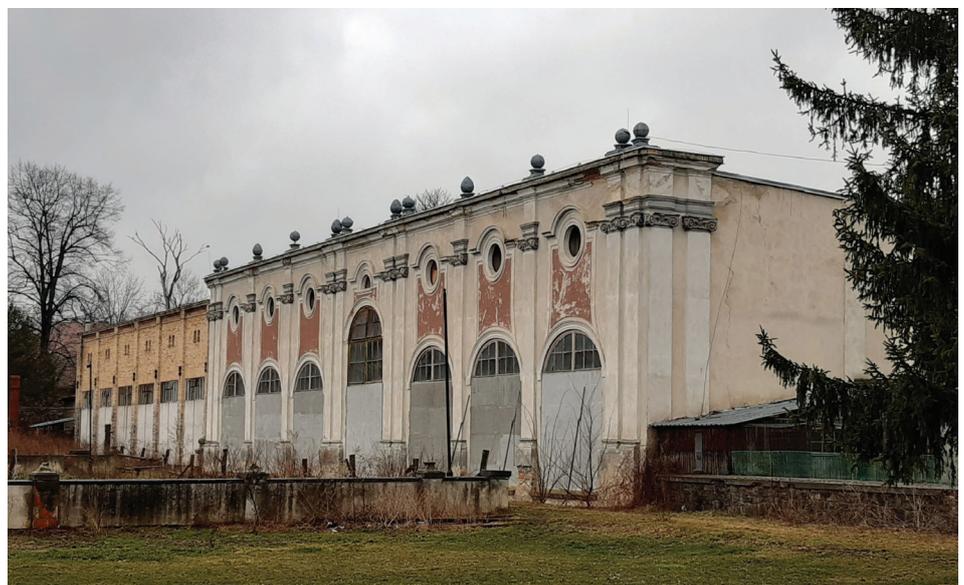
Fig. 4. Orangery of the Henryków Cistercian Abbey, built in 1727 (photo by Ł. Przybylak)

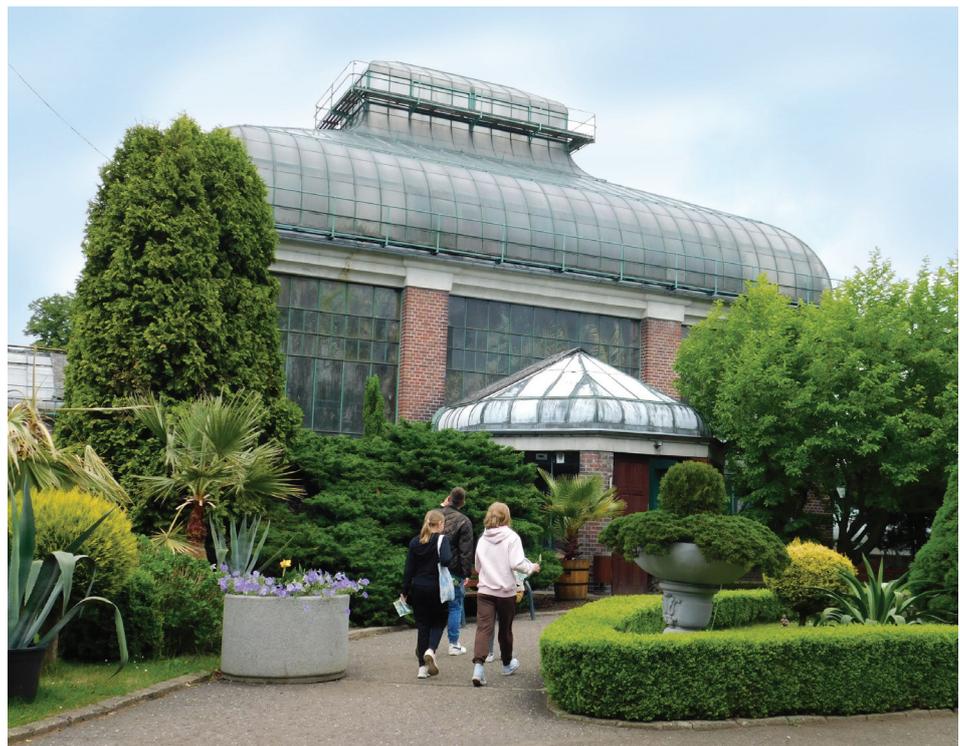
Fig. 6. The Walbrzych Palm House, Książ Castle (photo by J. Kuśmierski)
Il. 6. Palmiarnia wałbrzyska, Zamek Książ (fot. J. Kuśmierski)

Another best-preserved building is the complex of palm houses and greenhouses of Książ Castle in Wałbrzych-Lubiechów, built in the years 1911–1913 and founded by Prince Hans Heinrich XV von Hochberg (Fig. 6). It is the most extensive complex in Poland, covering 5000.0 m². The facility features an original structural system, heating systems, plant shelves and beds finished with tuff from the Mount Etna volcano in Sicily. Currently, 250 species of exotic plants from five continents are grown here.

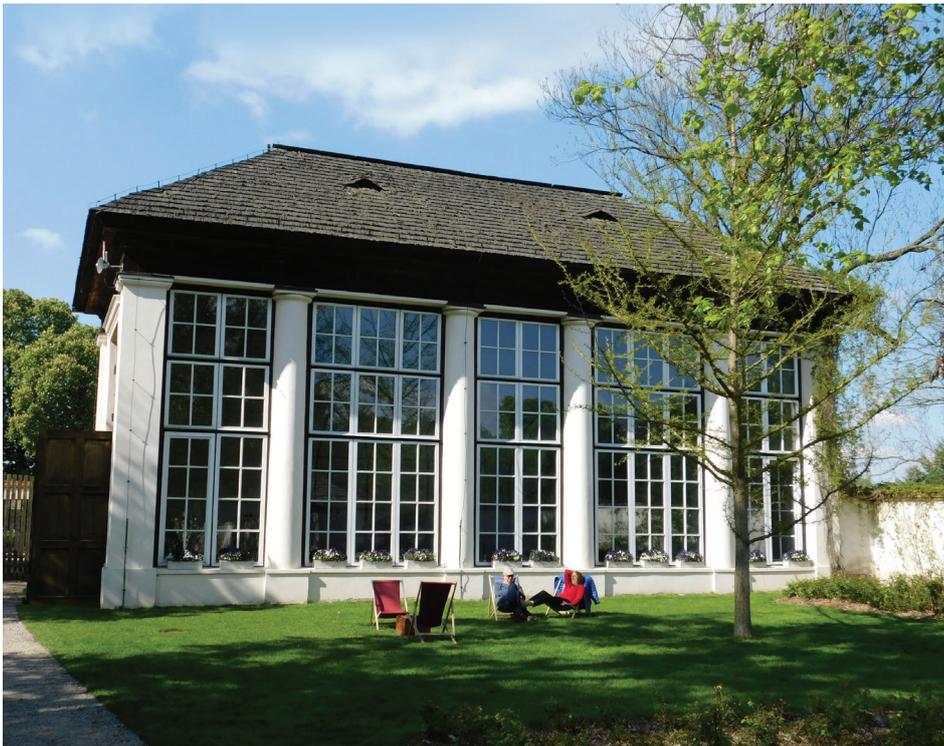
Fig. 7. New Orangery of the Radziwiłł Palace in Nieborów (photo by J. Kuśmierski)

The last of the highest rated buildings are the Old and New Orangery of the Radziwiłł Palace in Nieborów, built in 1790 and 1796 to a design by Saxon architect Szymon Bogumił Zug (Fig. 7). Their construction was linked to the purchase of a collection of exotic plants by the Radziwiłł family, which originally belonged to August II, King of Poland and Elector of Saxony. Although both buildings are faithful reconstructions of the original buildings (the Old Orangery was rebuilt after a fire in 1981 and the New

Orangery partially reconstructed in the 1950s), they retain many original elements such as Tuscan colonnades and duct-stack heating installations. To this day, their interiors are still used for growing and storing exotic plants.
