THE IMPACT OF JOINTS' QUALITY ON THEIR STRENGTH IN ST 3150 CONVEYOR BELTS

Abstract: Article discusses issues related to the weakened strength of the joints in conveyor belts. Joints are the weakest element of the belt and should be taken aimed at eliminating the errors made that may be caused by multiple factors. Every breakdown generates additional costs in the company so this is important to decrease their number.

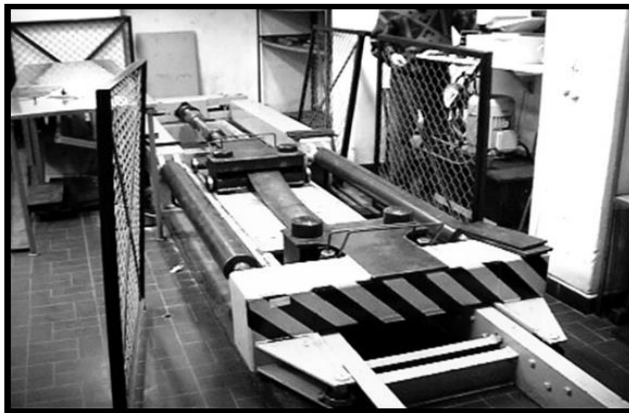
Fig. 1. ZP-40 tensile tester for belt joints (<http://www.ltt.pwr.wroc.pl>)

The joint's strength is tested by destroying a sample on the testing machine. The measurements are taken on a ZP-40 tensile tester for belt joints in the certified Conveyor Transport Laboratory at the Wroclaw University of Technology (Fig. 1). The test consists in snapping the joint of the belt using samples with dimensions of up to 300 mm in width and 1500÷4000 mm in length. On the contracting party's request, it was possible to analyse the causes for reduced strength of the joint.

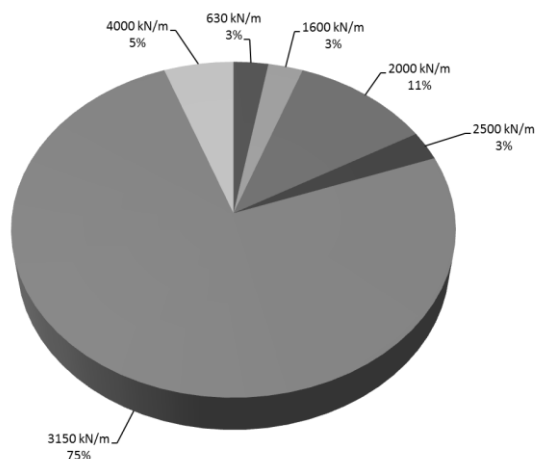
Fig. 2. Share of the theoretical strength of the joints

The results used in the analysis were obtained from the Conveyor Transport Laboratory at the Wroclaw University of Technology. The data comes from testing the strength of 36 vulcanised joints. All joints were made using belts with steel cords. According to the standard referred to above (PN-C-94147:1997), when ascertaining the joint's tensile strength, each test should be performed on three samples. Therefore, the 36 joints were used to obtain a database of 108 samples. The joints were made using tapes with various nominal strengths, and their share by number is presented on Fig. 2.

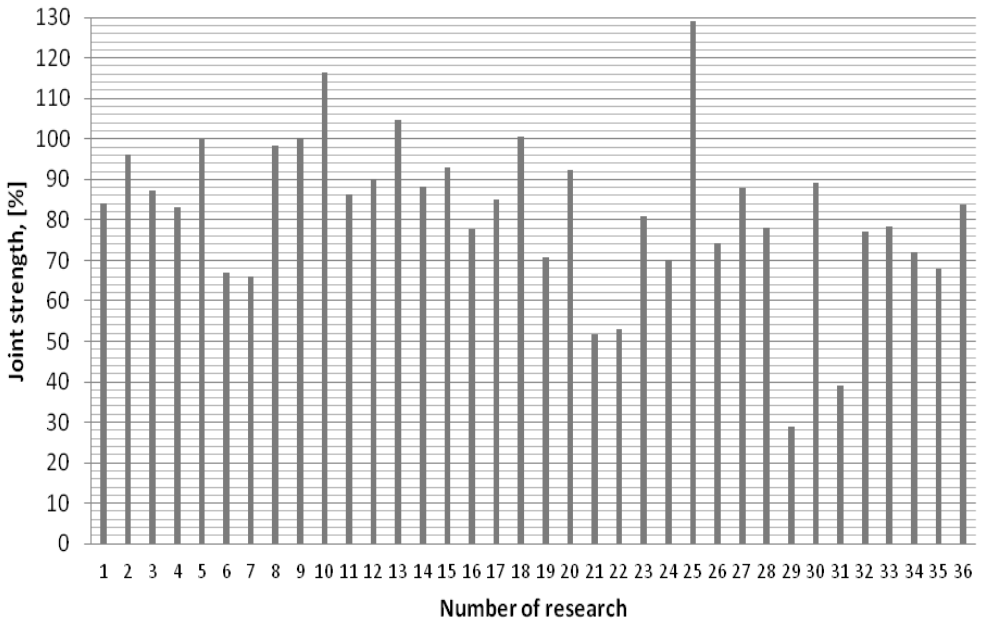
Fig. 3. The strength ratio of the tested joints to nominal strengths of the belts

Fig. 3. presents the strengths of the tested joints in relation to nominal strengths of the belts that were used to make them. The distribution of the results of joints' strength test is presented on Fig. 4. In order to obtain the information on the variance of those factors, the coefficient of variance was used. Its value for each test was presented on Fig. 5 and 6.

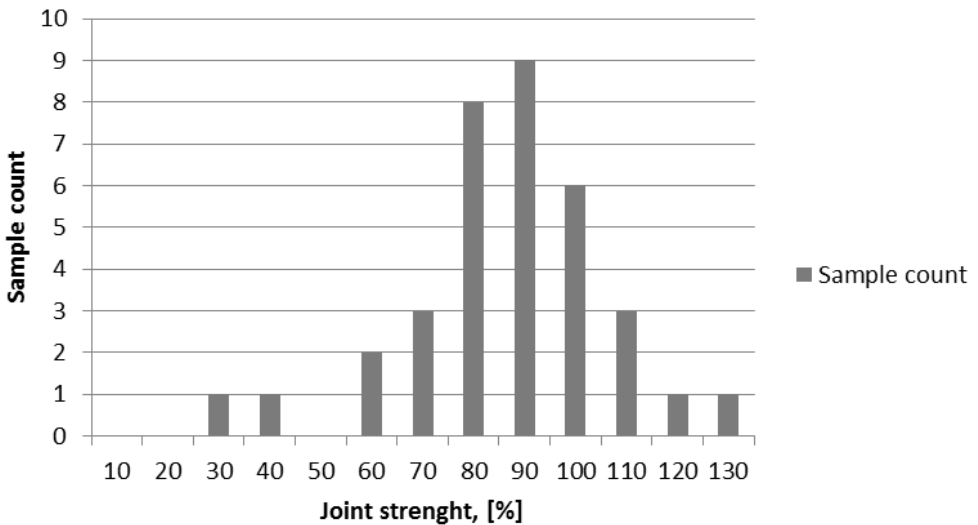
Fig. 4. The distribution of the strength ratio of the tested joints to nominal strengths of the belts

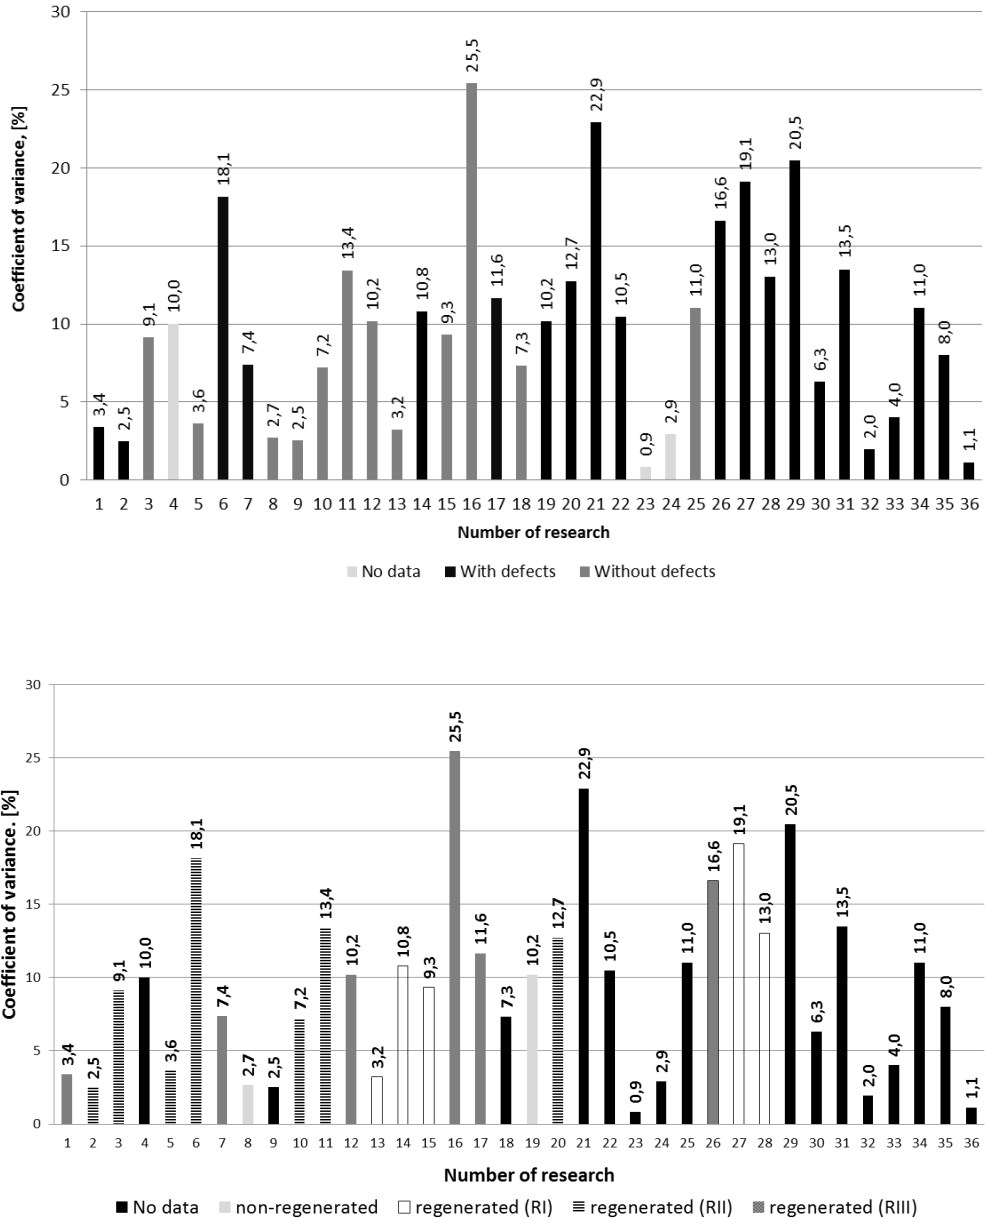
Fig. 6. Coefficient of variance for each test taking account of the degree of the belt's regeneration

The coefficient of variance took various values, regardless of the quality of the joint or the degree of the belt's regeneration. It was not possible to determine the dependencies between that data due to the low number of results.

The assessment of incorrectly made joints in bands with steel cords was conducted using data obtained from the certified Conveyor Transport Laboratory at the Wrocław University of Technology. The coefficient of variance took various values regardless of the quality of the joint or the degree of the belt's regeneration (Fig. 5 and 6). It was not possible to determine the dependencies between that data due to the low number of results.

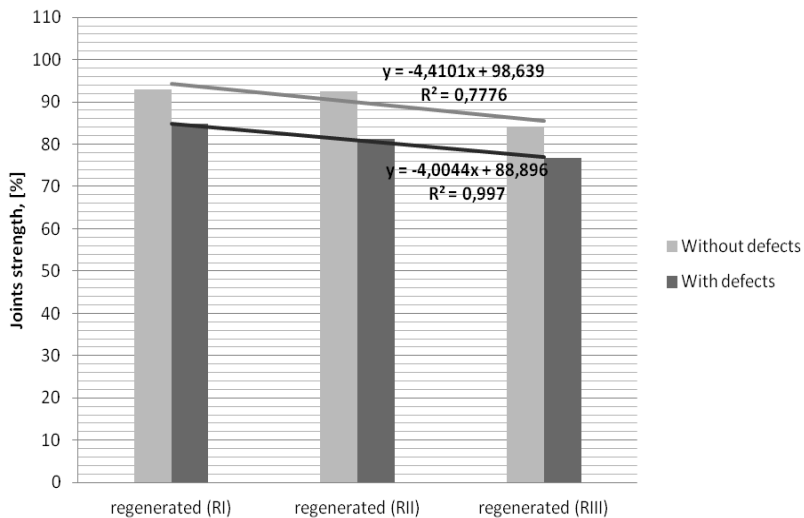
Fig. 7. Average joint strengths in regenerated belts (RI+RII+RIII)

The results for regenerated belts cannot be used for further analysis due to their low number. The trend analysis (Fig. 7) showed that for regenerated belts, joint strength drops linearly with the degree of regeneration according to the following dependence:

- $y = -4.4101x + 98.639$ with correlation coefficient $R^2=0.7776$; for joints with no defects,
- $y = -4.0044x + 88.896$ with correlation coefficient $R^2=0.997$; for defective joints.

A detailed analysis was related to joints of St 3150 belts, as this sample covered both non-regenerated and regenerated belts (RI, RII, and RIII). The assessment showed a significant impact of the working defects on joint strength. The decrease in the joint strength in RI, RII, and RIII bands was respectively at 8.1%, 11.4% and 7.2%. The trend analysis performed on the samples of regenerated belts showed a linear decrease in strength along with the degree of regeneration. The linear functions describing this dependency have a high correlation coefficient: $R^2=0.7776$ for joints with no defects, $R^2=0.997$ for defective joints.
