ASSESSMENT OF TECHNICAL CONDITION OF FORKLIFT TYRES USED IN INTERNAL TRANSPORT BY STUDYING DAMAGES AND OPERATING CONDITIONS

DOI: 10.15611/nit.2019.2.03

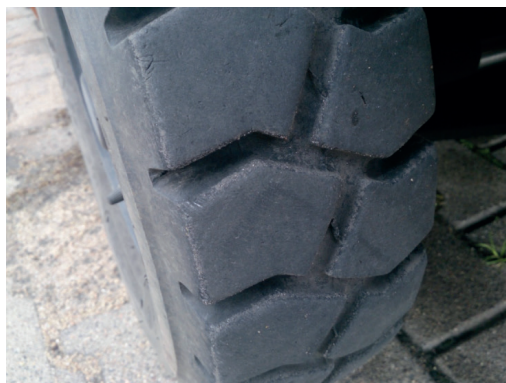
Fig. 5. Test object

The subject of the research concerns pneumatic tires of all forklifts used in internal transport in the tested manufacturing company (Figure 5). They function in the unloading, transshipment and loading process as well as during the movement of materials within the warehouse. The tested tires work in partially closed warehouse conditions, i.e. part of the work is carried out inside and outside of the warehouse.

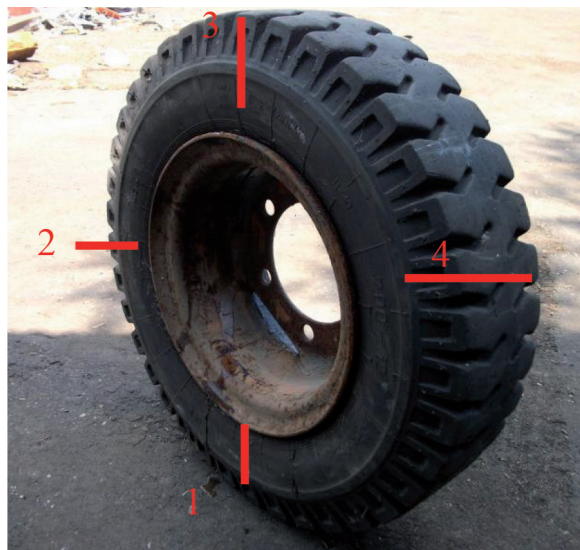
Fig. 6. Location of tread depth measuring points

Each of the tested tires was subjected to a visual inspection test and tread height measurements. During the visual inspection examination, all types of damage to the tire were searched for and the age of the tires was determined. In addition, tread depth was tested using a universal caliper. The measurement was performed in four places around the circumference of the tire (every 90 degrees, points 1 to 4) (Figure 6), where the tread depth was read on the tread face in its recess, and the average results are presented in the table and in the figure below. The tested objects did not have the TWI (Tread Wear Indicator) indicator, therefore it was not used for the measurements.

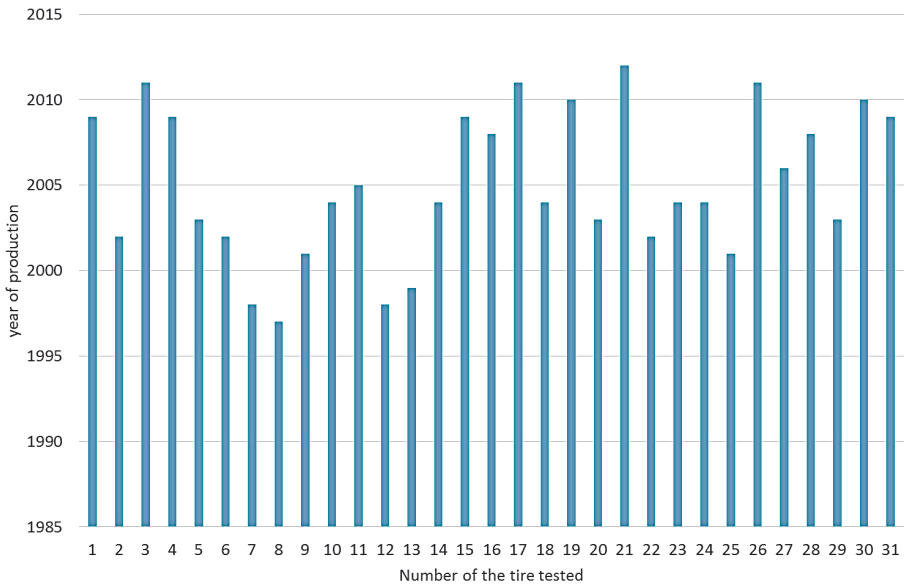
Fig. 7. Year of production of tested tires

Figure 7 shows the current tread depth of the tires of the tested objects, and one can see that their diversity is very large. There are tires that have a tread depth at the level of the new tire, but there are also tires that have virtually no indentation. The obtained values should be related to the level of 1.6 mm, which is the minimum permissible tread height above which the tire can be used; below this value, the tire should be taken out of service. At the beginning of use of the tires, all tires had the same tread height and were run for the same period of time. The red line in Fig. 8 shows this value.

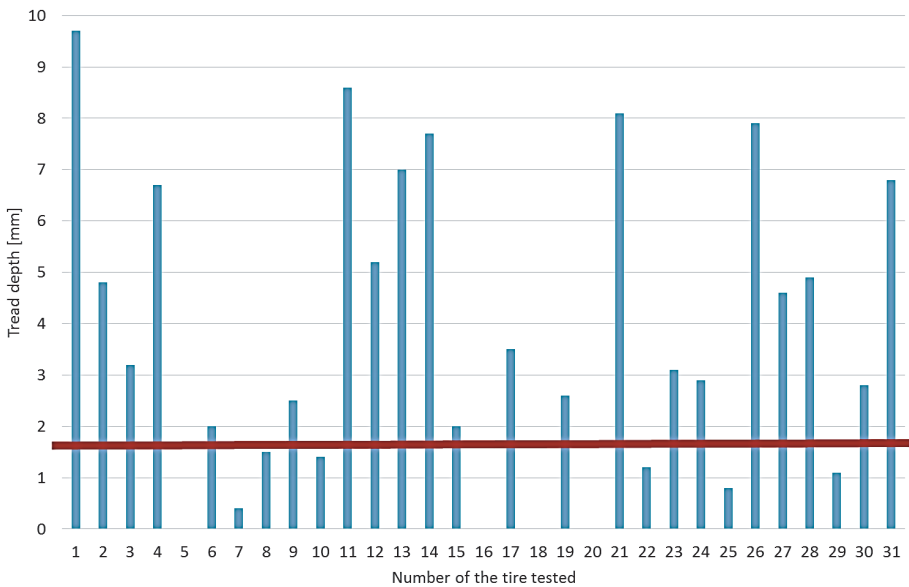
Fig. 8. Tread depth of tested tires

After measuring the tread depth and their visual inspection review, it was noted that some of the tested objects are in poor technical condition. Objects numbered: 5, 7, 8, 10, 16, 18, 20, 22, 25, 29 have an unacceptably low tread, which virtually eliminates them from further use. Moreover, objects numbered: 6, 9, 15, 19, 24, 30 are close to the maximum allowable tread wear, so one should consider removing them from further use in the near future. The tread height is closely correlated with the age of the tire, usually the older the tire, the smaller the tread. This is confirmed by the fact that the tires are operated in similar conditions.
