THE IMPACT OF THE LOW THROW FAULT ON THE STABILITY OF ROADWAYS IN A HARD COAL MINE

Key words: fault, roadway stability, roadway convergence, floor heaving

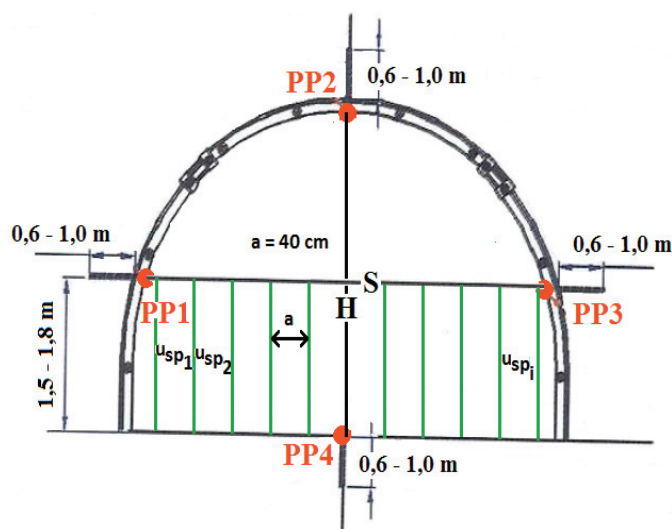
Fig. 1. Scheme of measurement base and the measurement methodology in D-2 maingate

Seven measurement bases were installed in the roadway, each placed within the 25 m distance from the other. Roadway convergence was measured on each measurement base containing four measurement points – PP1, PP2, PP3, PP4 (Fig. 1), carried out on the basis of three different measurements including: change of the roadway height H , change of the roadway width S and the change of floor heaving value u_{sp} (Fig. 1).

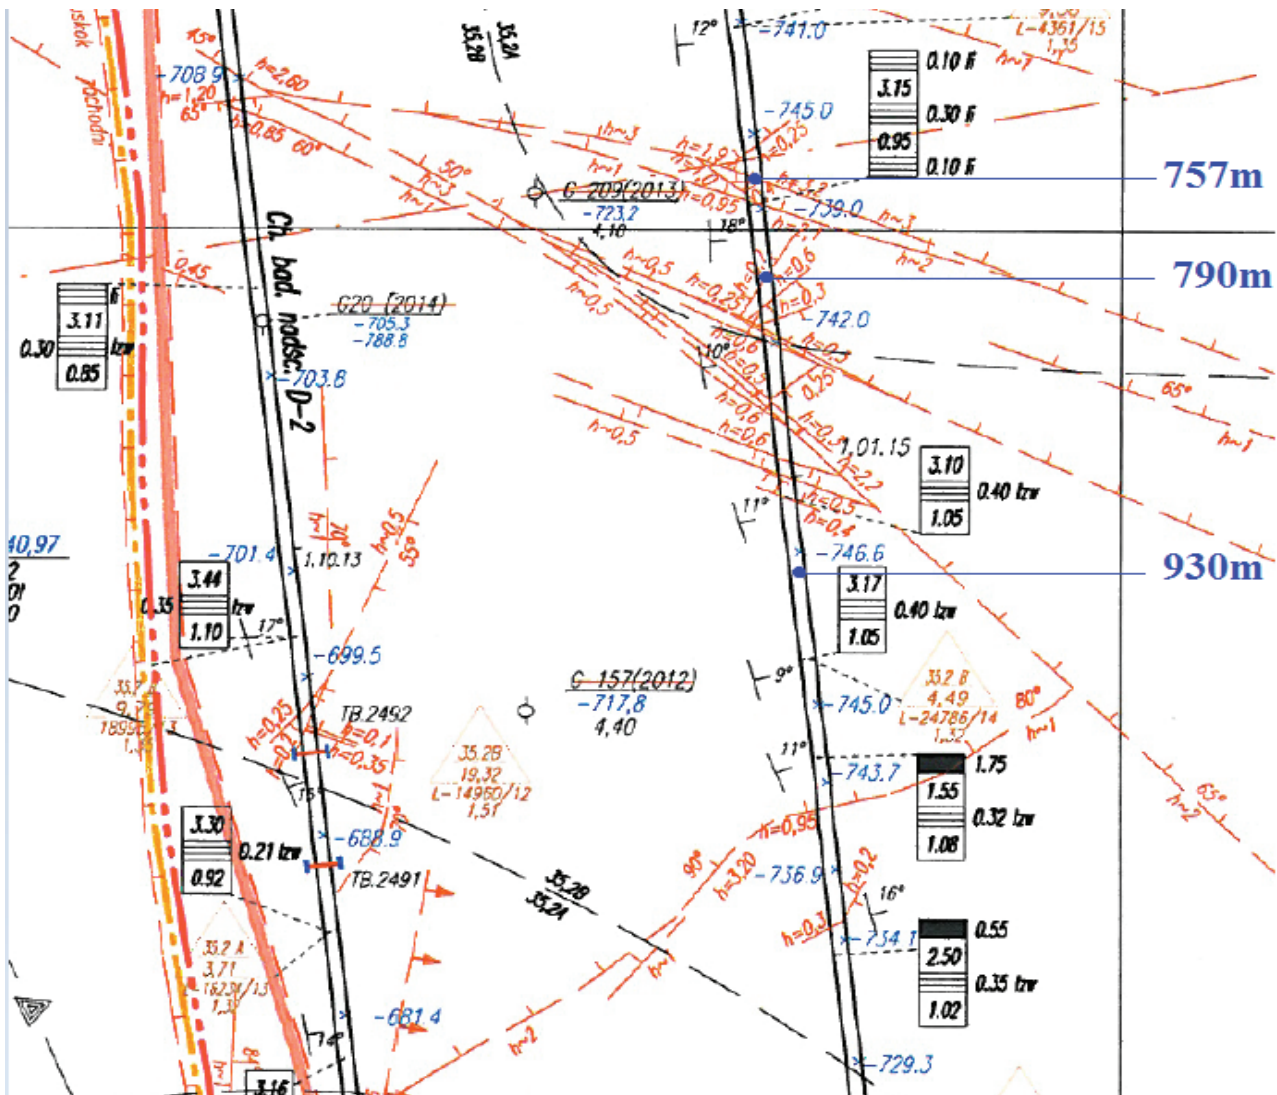
Fig. 2. The mining map of 403/1 seam with analyzed D-2 maingate and measurement bases

In relation to the subject of this paper, results from three measurement bases were presented (Fig. 2). Namely: base 930 (roadway without the impact of additional mining and geological factors), base 790 m (fault with a 0.7 m throw and the impact zone of the exploitation edge of the 409/3 seam) and base 757 m (a series of low throw faults from 0.4 to 3.2 m, creating a series of faults along the length of 12 m).

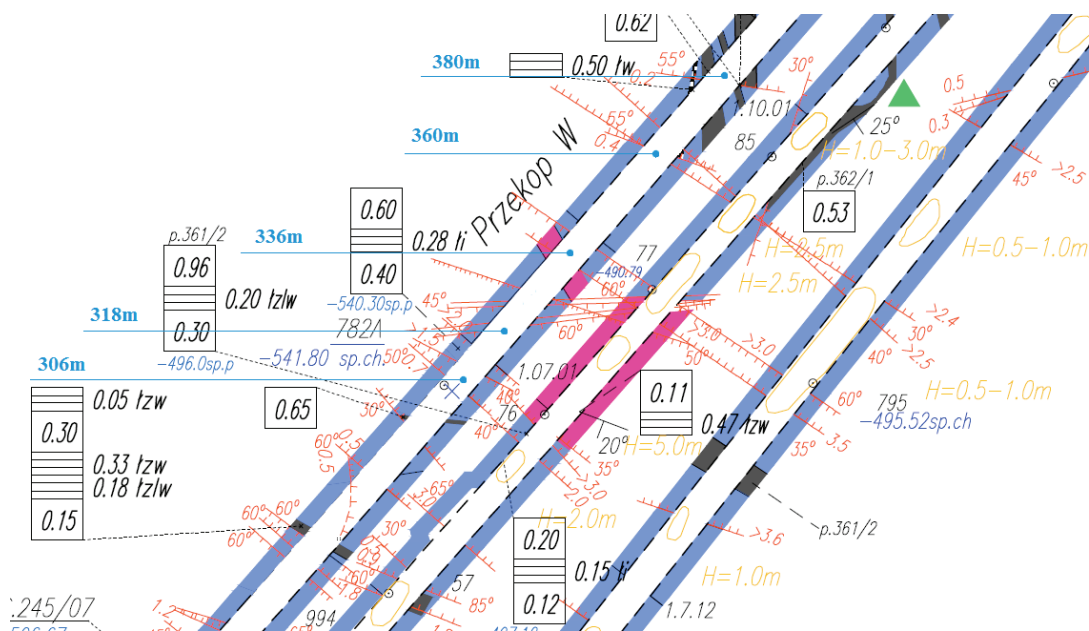
Fig. 8. The map of the analyzed section of drift W level 838

The drift W level 838 is located at the average depth of 780 m. Roadway drivage was commenced in October 2013 and terminated after 11 months [20]. On 28 June 2016, an inventory of the section between 300 and 400 m of the working was carried out in order to determine the impact of discontinuity in the form of numerous low throw faults on the stability of the roadway in the area of their occurrence. The inventory reflects the condition of the section after around 22 months from its drivage. Due to a specific purpose of the inventory, several characteristic sections were identified, in which geological disturbances significantly influenced the deterioration of functionality of the roadway. The map in Fig. 8 shows points presenting the location of the above-mentioned sections.
