# THE RECONSTRUCTION OF THE HISTORICAL BUILDING OF THE LATIN SCHOOL IN MALBORK

ZENON DUDA, KATARZYNA KRYZIA

AGH University of Science and Technology, Kraków.

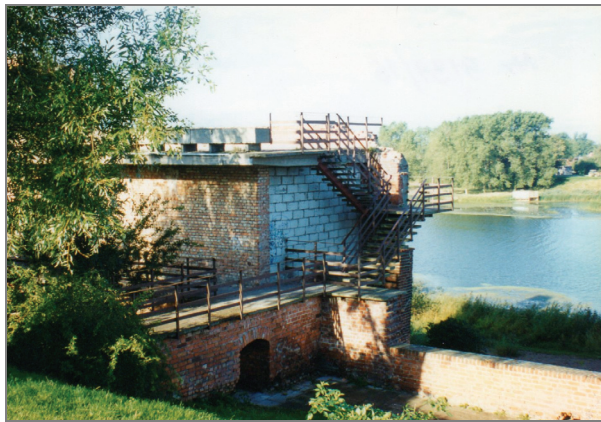
Fig. 2. The Latin School after its partial restoration in the 1970s (photograph by Z. Duda)

Originally, Malbork, a medium-sized town concerning its area, settlement development and economy being artisanal, commercial and agricultural in character, developed owing to its favourable waterway connections with the Nogat and Vistula Rivers. At that time the building in question presumably acted as a seat of the Merchant Guild, where grain, timber, animal skins, horses and wine were traded among other things. For a long time, supposedly, a Patronage of Saint George was based there as well. Next, from the 16th century until 1864, the building functioned as a school where basic Latin was taught. It was destroyed in the fire which spread through the town in 1899, and was rebuilt in 1900 as a typical warehouse [1], [2], [8]. Another fire in 1945 ruined the building. Due to its heritage value, a documentation of its reconstruction and site planning was prepared in 1971, but the construction works carried out by Historical Monuments Preservation Department (Pracownia Konserwacji Zabytków) were suspended because of the lack of sufficient funding and were restricted only to a partial restoration and reconstruction of the doors and staircases. In 1978, the building was taken over by the Youth Centre (Młodzieżowy Dom Kultury), which converted it into a water sports centre (Fig. 2) [4], [7].

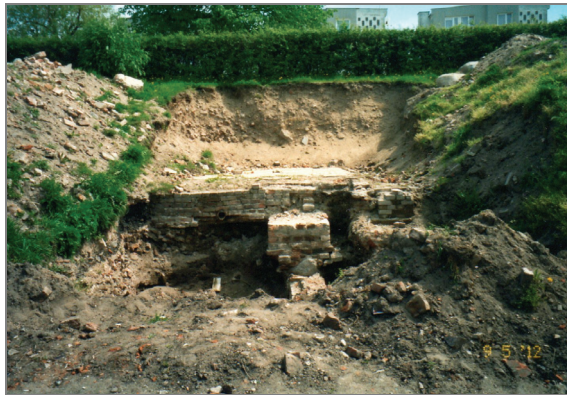
Fig. 3. Excavation site, May 2012 (photograph by Z. Duda)

The preliminary stage of the reconstruction of the Latin School included archeological (Fig. 3) and geological studies which allowed the selection and application of the proper kind of foundations and the drainage system in the existing soil and hydrological conditions [3], [14].

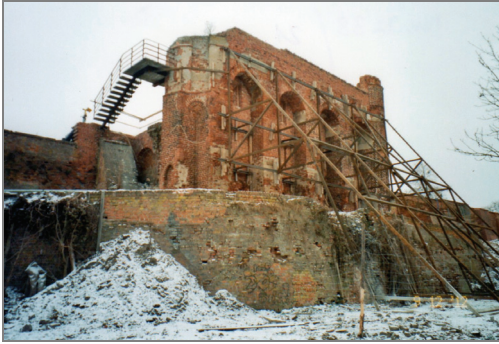
Fig. 6. The state of progress of the construction works, December 2012; the north-west side view (photograph by Z. Duda)

The foundations of the building will be located on a system of reticulated root piles with reinforced concrete skeleton construction and a slab on grade. Further construction works will involve a partial removal of the original walls and ceilings and then constructing a four-storey slab-on-grade building with a pitched roof. The building, fitted with all the installations, will be reconstructed in accordance with the traditional brick-and-mortar technology with reinforced-concrete columns supporting the structure of the pitched roof. Figures 6 through 9 show the current state of progress of the construction works and the “to be” situation.

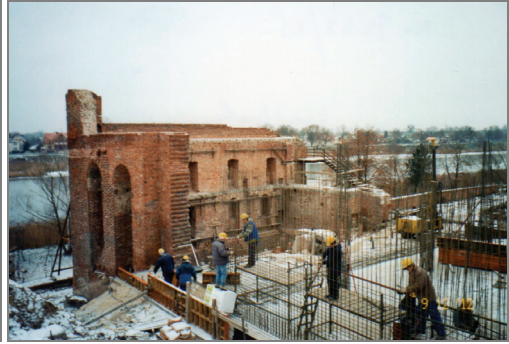
Fig. 7. The state of progress of the construction works, December 2012; the south-east side view (photograph by Z. Duda)

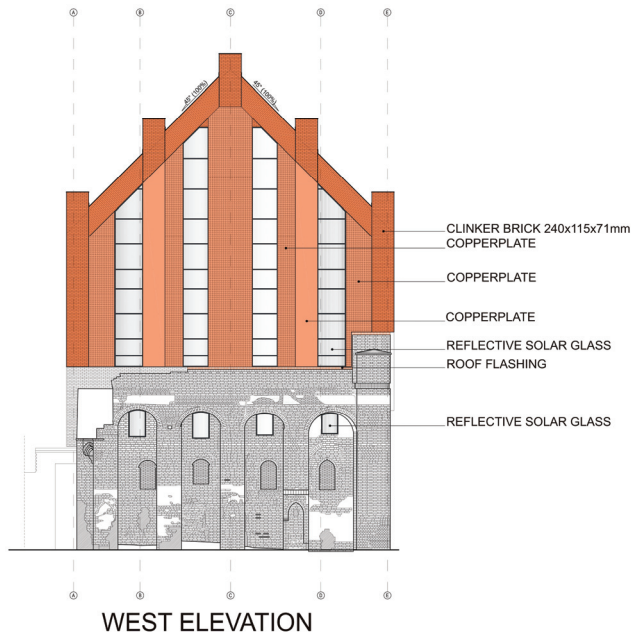
Fig. 8. The west facade design of the Latin School in Malbork [3]
